Nederlandse
Archeologische
Rapporten

Roman bathing in Coriovallum

The thermae of Heerlen revisited

K. Jeneson and W.K. Vos (eds.)

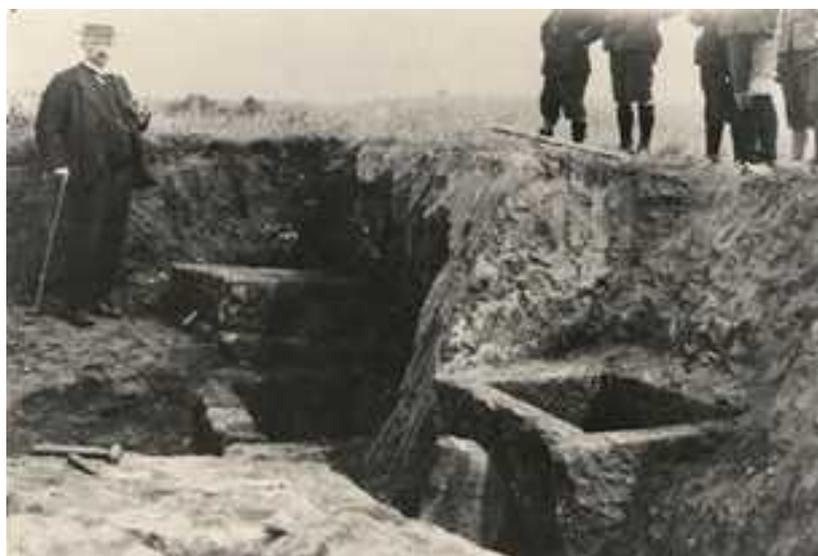
Figure 1.5 Peters' findings from Kruisstraat, on the 'Bergerode site' in 1935. Number 8 is probably the *laconicum*; the masonry that Peters interpreted as 'probably barracks' (7) is in fact part of a wall of the western *palaestra* (source: Peters 1936, 15.)

A reconstruction of his findings shows that Peters had seen part of the round *laconicum*, and the drainage channel and some masonry belonging to the *palaestra*. The reconstruction also shows that the construction work in 1935 on the plot purchased by the company Bergerode had caused some damage. A lot of the earth covering more or less the entire western *palaestra* of the bathhouse was removed when the site was prepared for construction. A photograph taken during the preparation work shows that at least a metre of earth was excavated. Bergerode had bought the land to build houses on it. Photographs of the bathhouse taken in 1941 (Fig. 1.6) show that one new home was built, to the south of the *palaestra*. It is a miracle that only one house was built.

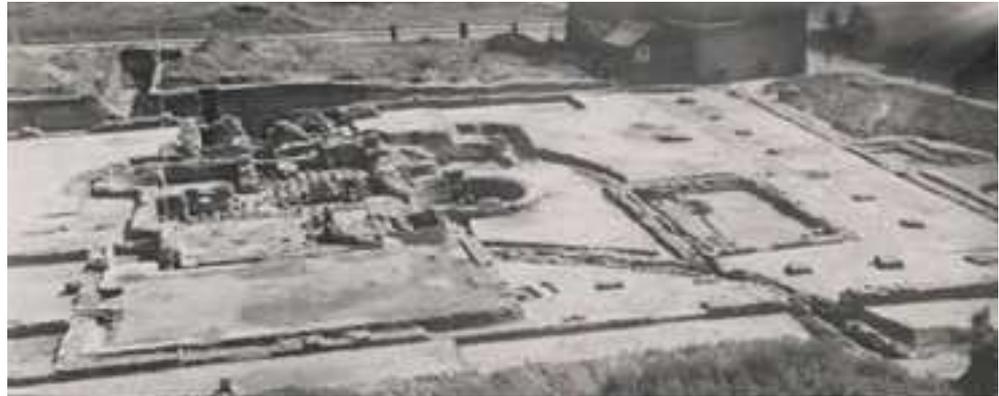
Figure 1.6 Picture of the exposed bathhouse in 1941, with the house built by Bergerode in the late 1930s visible in the top right corner (source: Thermenmuseum archives).

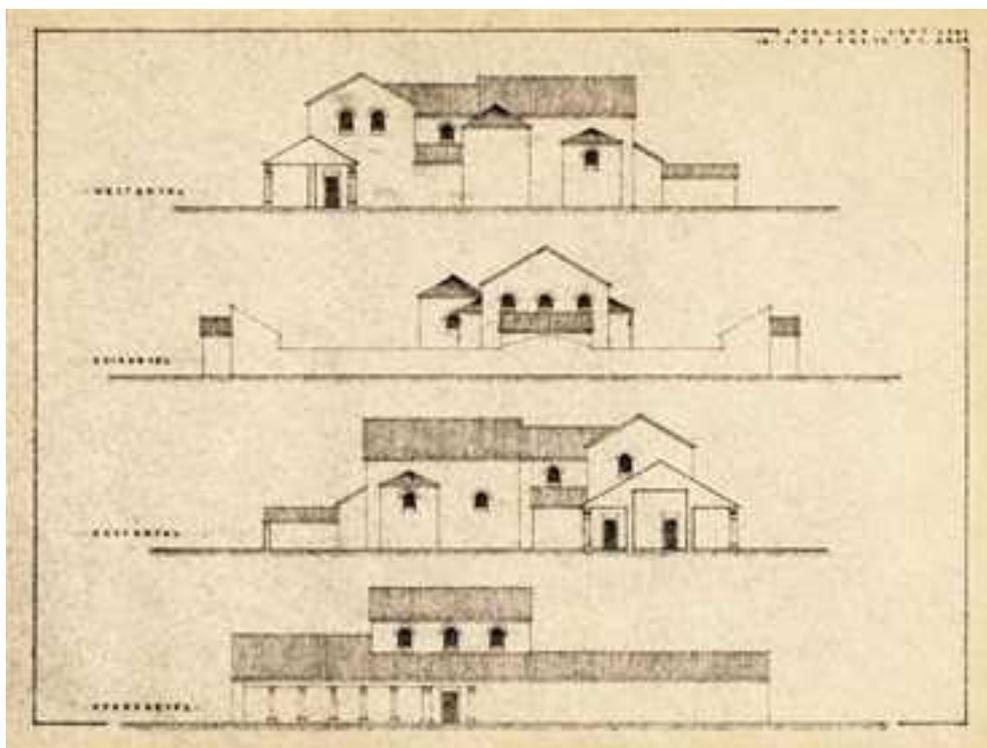
Figure 1.12 To produce a three-dimensional reconstruction of the bathhouse Peutz made an entire series of drawings showing views of the different façades. This is one of those drawings (source: Thermenmuseum archives).

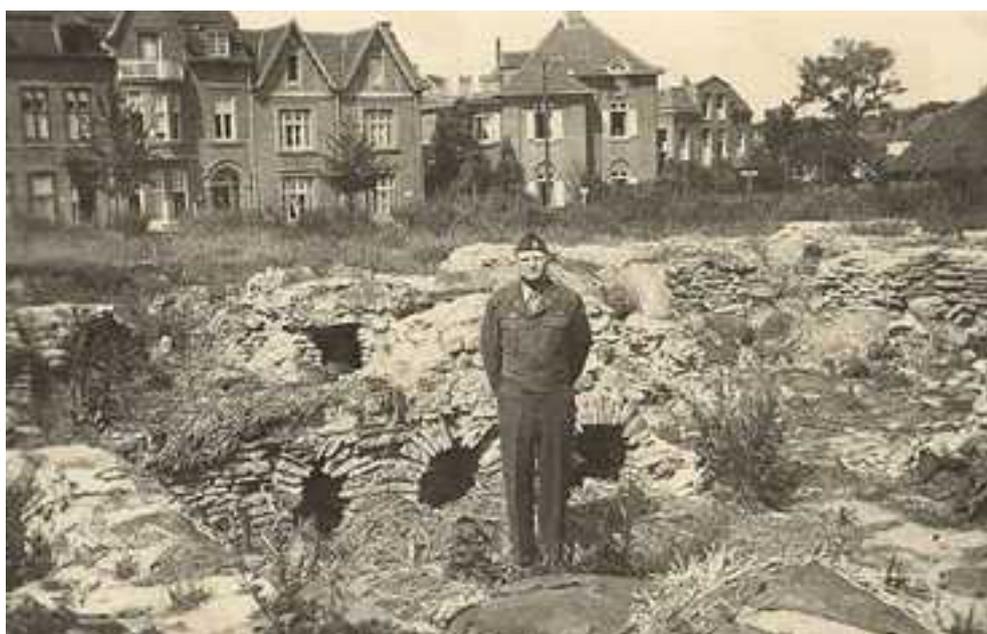
Figure 1.13 The Roman baths shortly after the liberation, with an allied soldier standing in the *caldarium*. The straw and tar paper can be seen in a number of places (source: Thermenmuseum archives).

covered with tar paper. This turned out to be inadequate, however, as evidenced by a letter Van Hommerich later wrote to the municipal authority, and it can also clearly be seen on a 1944 photograph, taken just after the liberation of southern Limburg (fig. 1.13). The straw was set alight several times and the Roman masonry was unable to withstand the destructive force of children playing on the site. Van Hommerich noted exactly which parts had since disappeared on copies of the section drawings of the various walls. They included the vertical masonry of the arches in the middle of the *caldarium*. A new covering was applied to the site in 1945, in the form of silver sand.²⁰

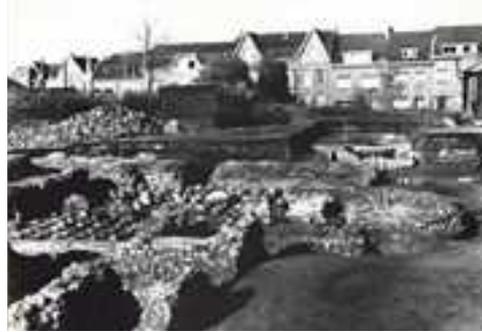
Figure 1.14 The bathhouse exposed for a second time in the early 1950s, by the ROB. Only the main building and the eastern *palaestra* were exposed; the *apodyterium* and *frigidarium* remained largely covered (source: Thermenmuseum archives).

in the Rhineland. Photographs from that time show that part of the main building was exposed again, and signs put up (Fig. 1.14). It was in this period that Bogaers excavated the immediate surroundings of the bathhouse during three campaigns, in 1952, 1954 and 1957. The details of these excavations, which were not analysed and interpreted until recently, are in the report by Wouter Vos (see appendix VII for the complete report and Section 7.2 for a summary). Heerlen also welcomed a number of visiting dignitaries during this period, including the young

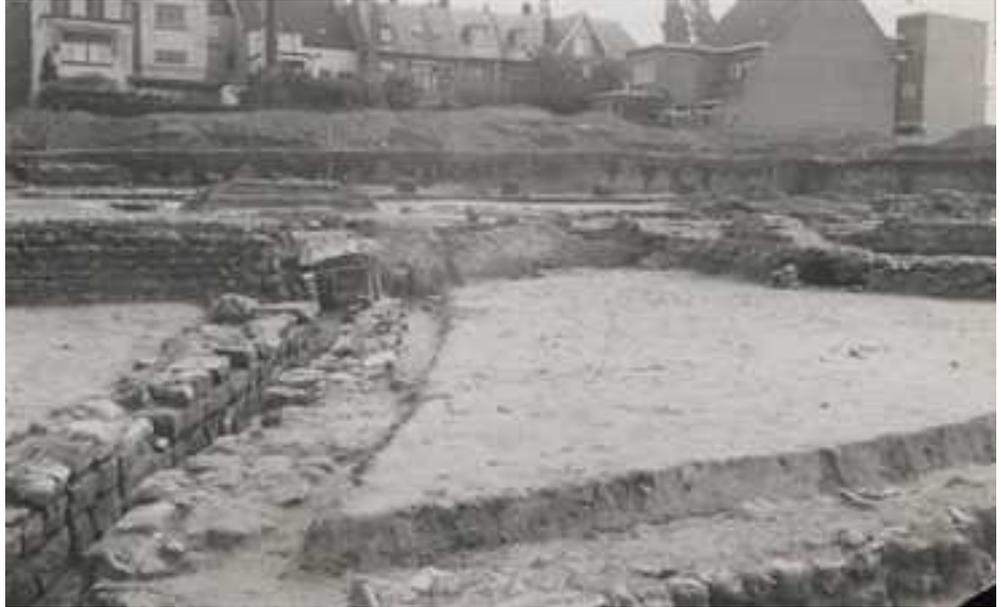
Figure 1.17 The archaeological level exposed beside the large drainage channel in 1941 (source: Thermenmuseum archives; original photo by GIA Groningen).

palaestrae with those taken in 1977, one is immediately struck by the fact that on the earlier photographs the surface was considerably higher than in 1977. Pictures from 1941 (Figs. 1.17 and 1.18) clearly show that structures like the gutters and the footings in the western *palaestra* still lay beneath the archaeological level created at that time, while on the photographs taken in 2015 they protrude above the archaeological level (Fig. 1.18). Each time, the covering and uncovering of the site unintentionally caused the removal of part of the first archaeological level on either side of the core building. This explains why new finds were made whenever the covering was removed.

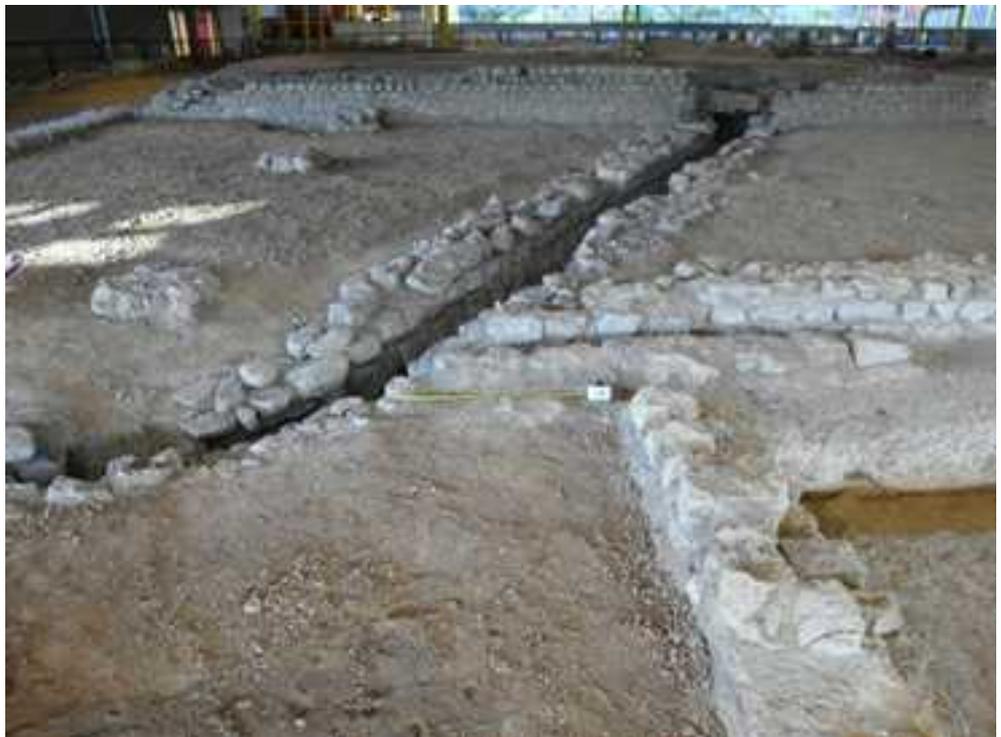
Figure 1.18 The archaeological level exposed beside the large drainage channel in 2015 (source: Thermenmuseum archives).

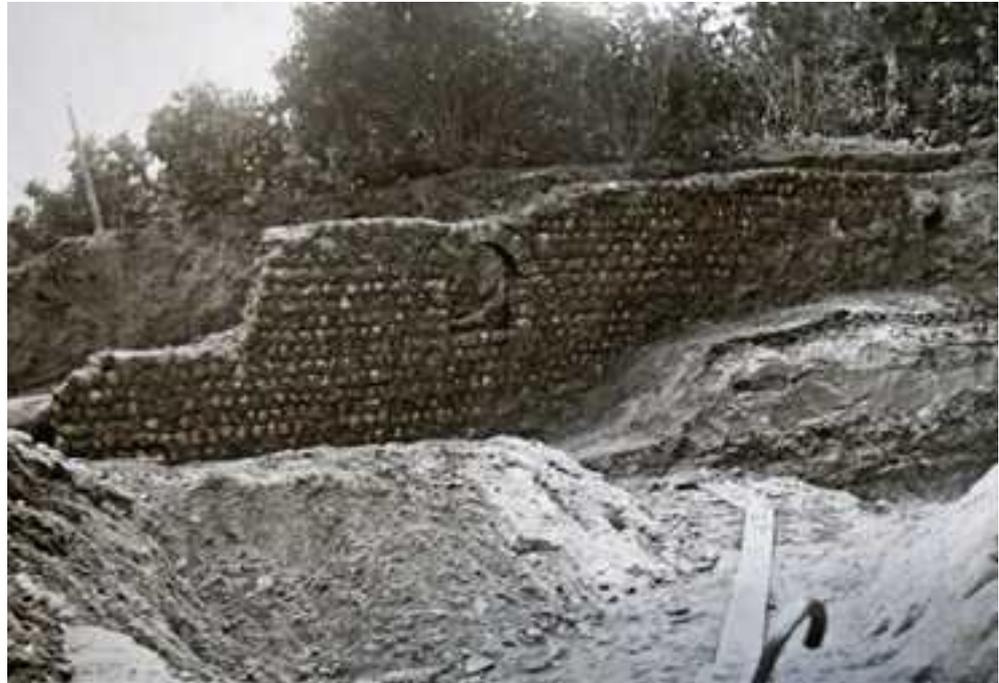
Figure 2.1 Roman wall discovered in 1928 in the hamlet of Caumer near Heerlen (source: National Museum of Antiquities, Leiden).

when in 1928 a tall standing section of wall was revealed in Caumer (Fig. 2.1).⁴⁰

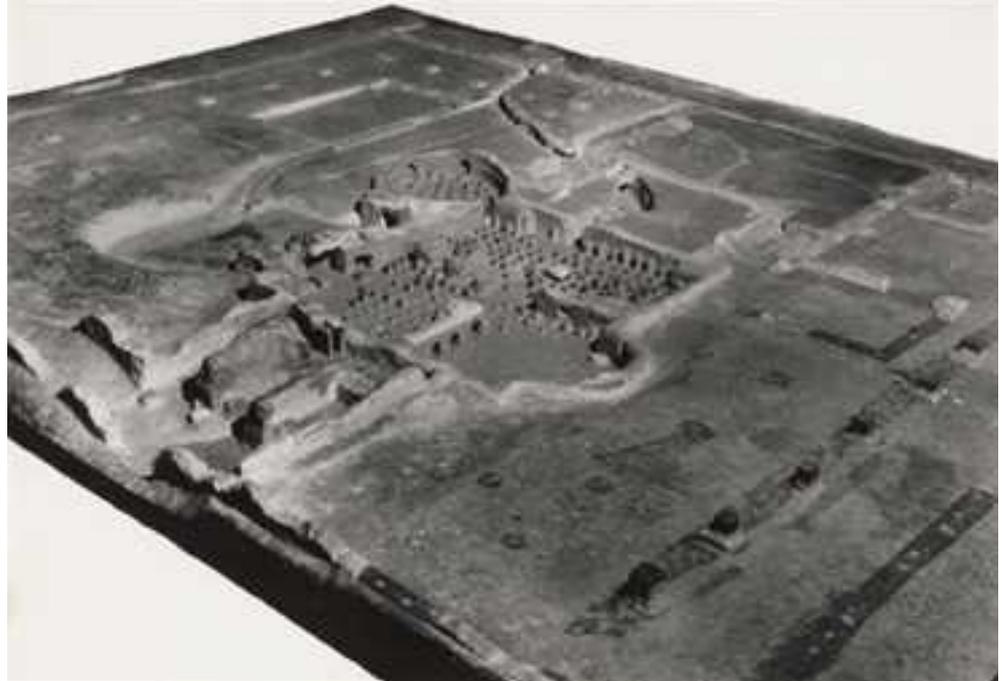
Figure 2.8 One of the two models of the Roman baths in Heerlen made in 1943 (source: Thermenmuseum archives).

models.¹³⁹ One would be for Heerlen and the other would be given to the RMO, which in exchange would transfer the model of Kaalheide Villa to Heerlen. However, it was unclear to the RMO and the BAI who held copyright on the Heerlen models. In June 1943 Van Grunsven resolved the matter by awarding copyright to the official excavation leader and investigator of the Roman baths, Van Giffen (Fig. 2.8).¹⁴⁰

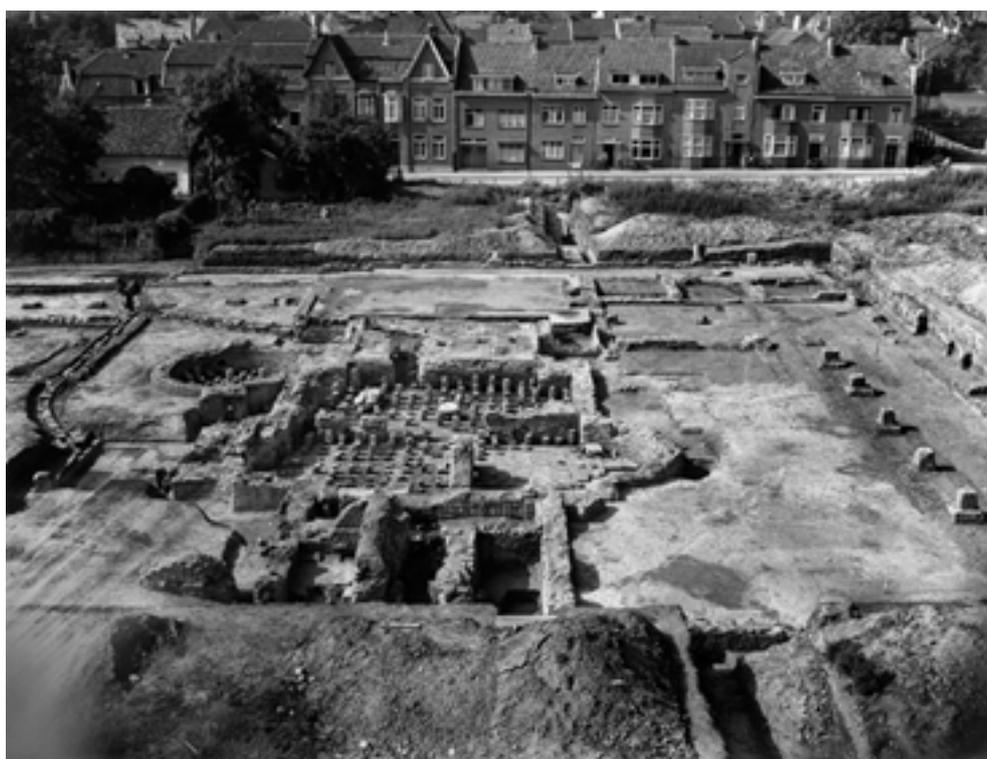
Figure 3.1 The Roman baths at Coriovallum immediately after the excavations in 1940-1941 (source: Thermenmuseum archives; original by GIA Groningen).

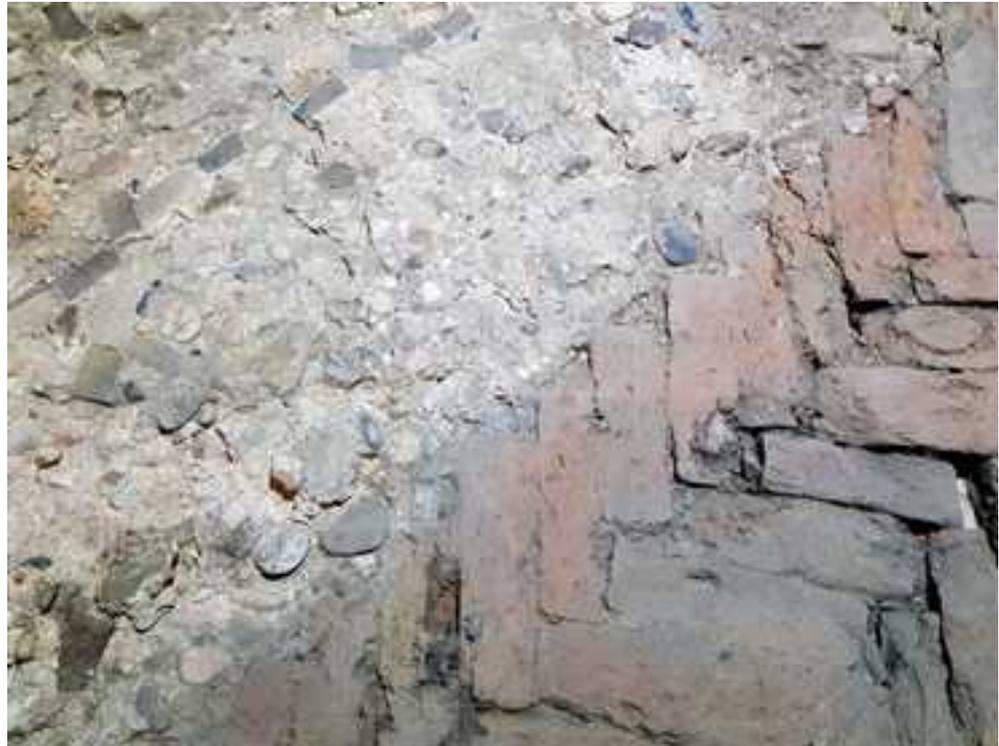
Figure 4.1 There are triangular gaps where the *opus spicatum* meets the mortar floor (source: K. Peterse).

The floor of the *apodyterium* consists of carelessly laid *opus spicatum* surrounded by a 90 cm wide mortar floor with an inlaid geometric motif. The combination of *opus spicatum* and a mortar floor with a decorative motif is unusual, as floors made of *opus spicatum* would generally be laid from wall to wall in rooms that were not used to receive visitors and where many people would pass through, such as latrines, kitchens and service corridors.¹⁶⁸ In a number of places triangular gaps can be observed at the point of transition between the *opus spicatum* and the mortar border. They resulted from the fact that the bricks forming the edge of the *opus spicatum* are set at an angle (Fig. 4.1). These triangles were filled with the same material – probably a

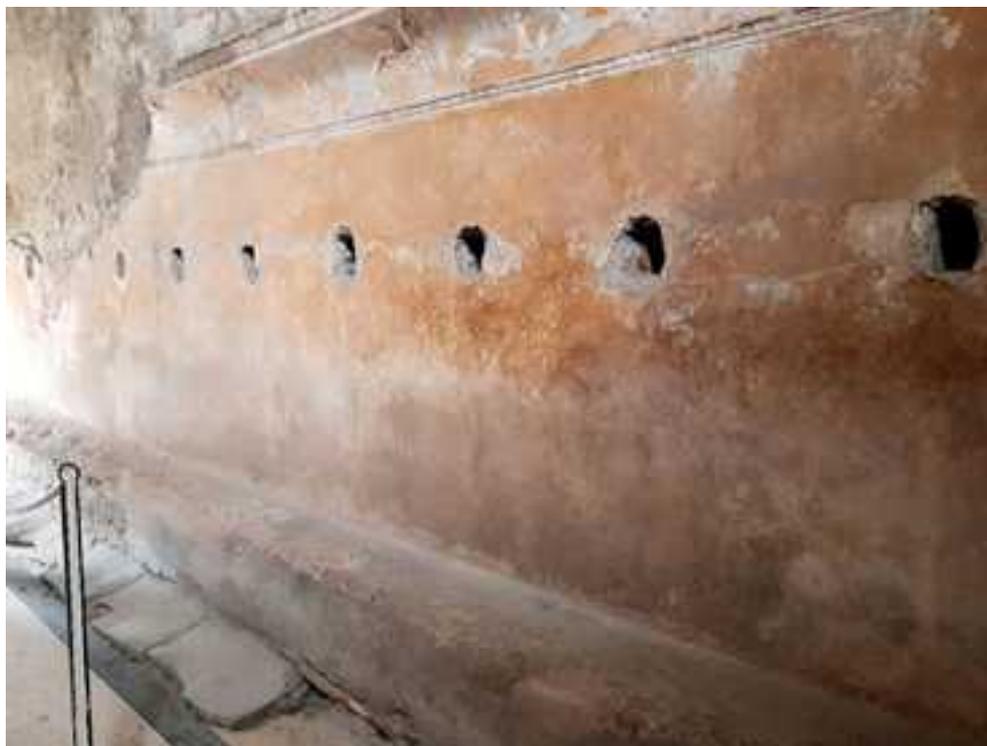
Figure 4.2 Stone bench and footrest in the *apodyterium* of the Forum Baths in Pompeii. The secondary footrest stood on the mosaic floor (source: K. Peterse).

This raises the question of why, when the central part of the floor was replaced with *opus spicatum*, the mortar floor at the edge of the room was left in place. It is quite possible that there was a wooden bench along the walls, with a wooden footrest in front of it, like the stone bench and footrest in the *apodyterium* of the Forum Baths in Pompeii (Fig. 4.2). The bench and footrest together are approx. 90 cm deep there. If the *apodyterium* did indeed have such a bench and footrest, there was no need, when the floor was replaced, to also replace the part under the bench, as the bench and footrest would be kept in place and used afterwards.

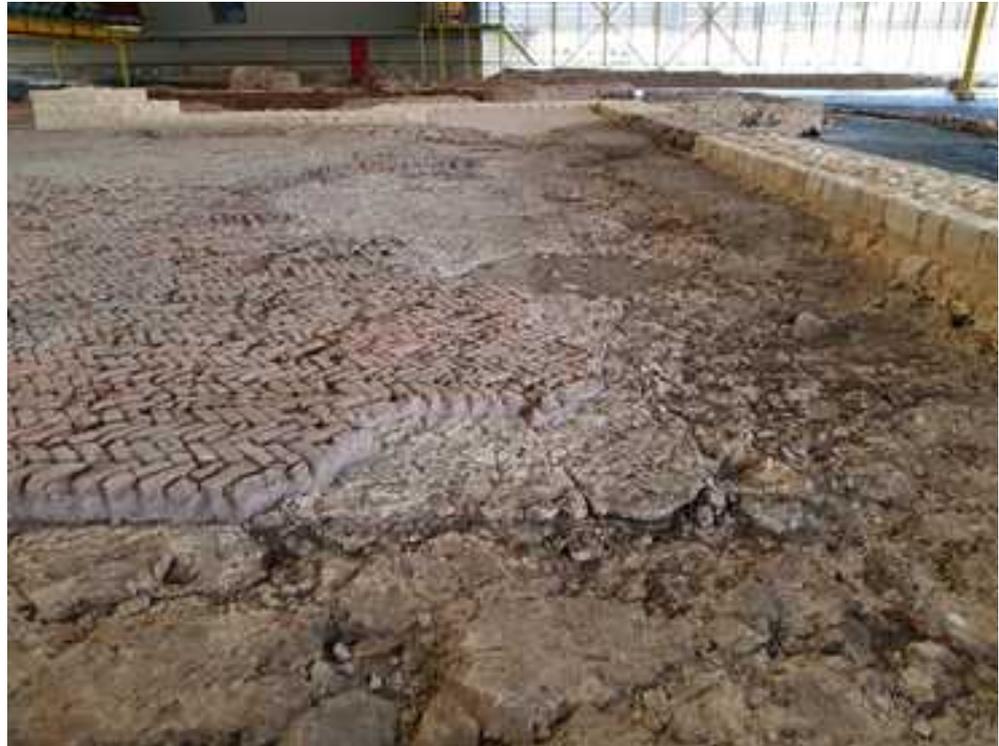
Figure 4.3 The westernmost part of the floor of the *apodyterium* has subsided substantially (source: K. Peterse).

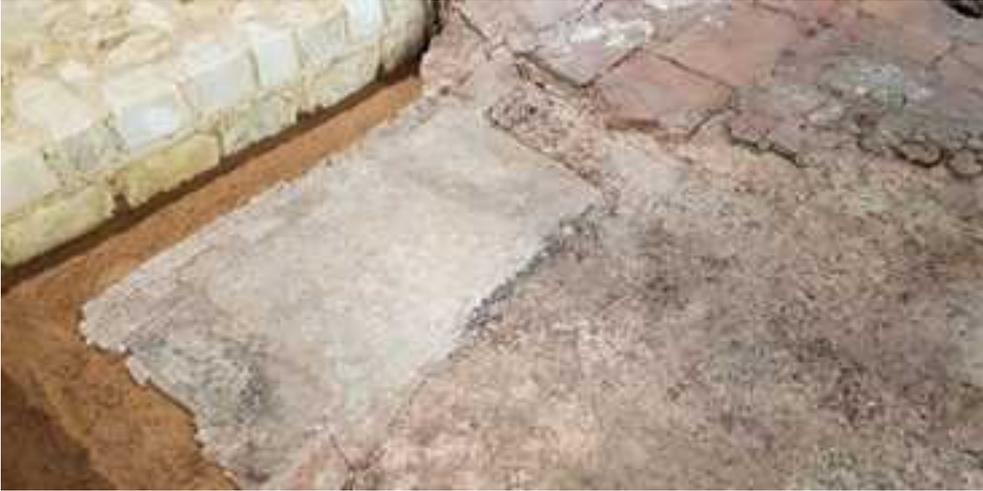
Figure 4.4 Remains of the mosaic floor in the northeast corner of the *frigidarium* (source: K. Peterse).

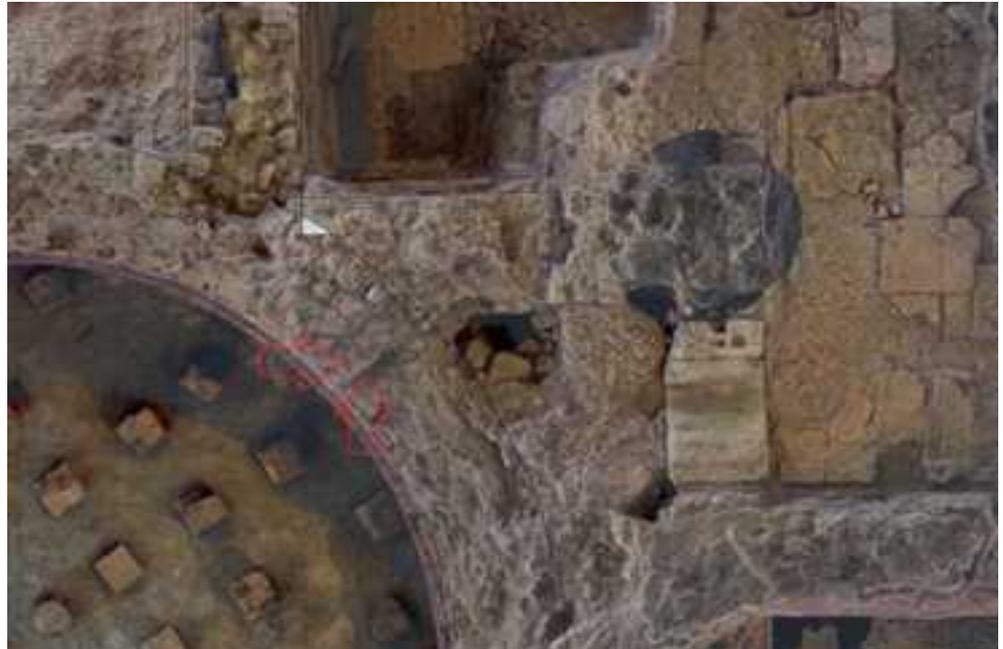
Figure 4.5 The place where the door sill of the entrance lay can be seen in the circular wall of the *laconicum* (source: Delfttech/K. Peterse).

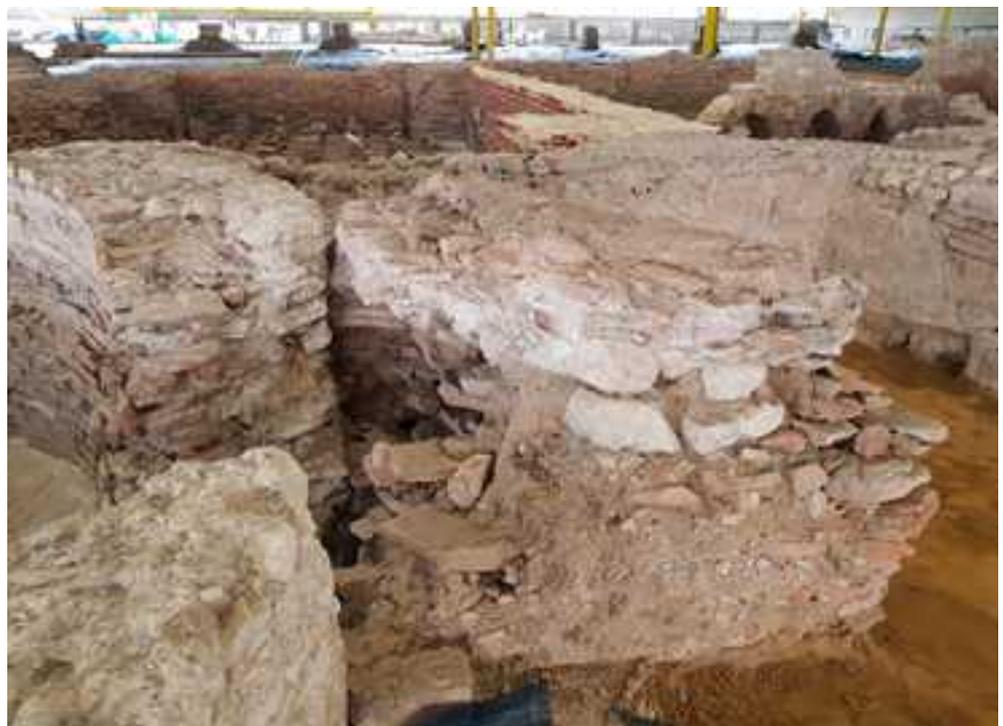
Figure 4.6 The circular wall of the *laconicum* was breached when *praefurnium* III was installed (source: K. Peterse).

surrounding wall (Fig. 4.6). To prevent the hot air from flowing away to the hypocaust of the *tepidarium* the air vent between the two rooms was bricked up. Further openings were made in

the masonry on the north and northwest sides, possibly to allow fumes to escape. The purpose of the alterations was essentially to achieve a more direct supply of hot air, thus raising the

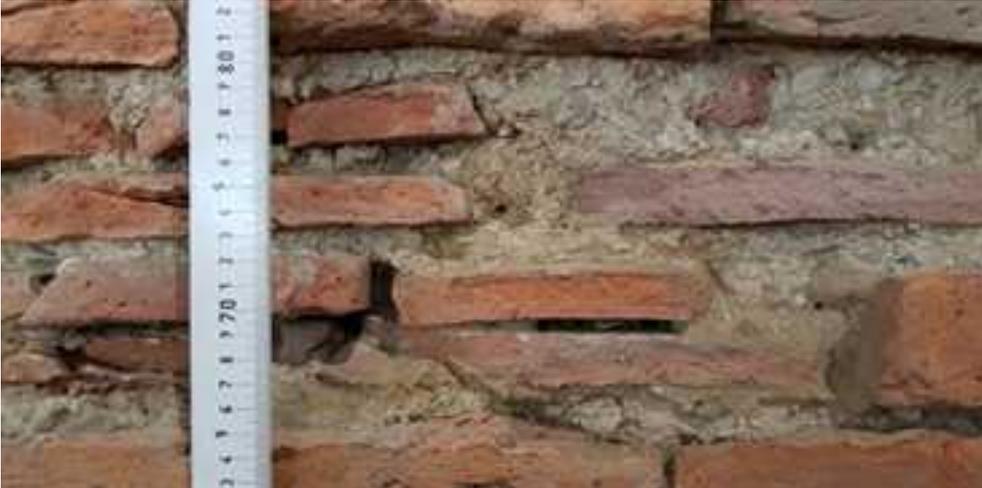
Figure 4.7 The mortar in the masonry of the *tepidarium* has varying (source: K. Peterse).

It has been observed that in the walls of the *tepidarium* (including the four reinforced corners) the *tegulae* interlock alternately with those in the adjacent wall over a short distance at the corners. The walls and the corner reinforcements are thus a single structural unit, which means they belong to the same phase of construction. Nevertheless, differences in the composition of the mortar have been observed (Fig. 4.7). Since the walls and the corner reinforcements all belong to the same phase of construction, the differences in the composition of the mortar are probably not significant and indicate that the different batches of mortar used during construction were not meticulously made following a single recipe.

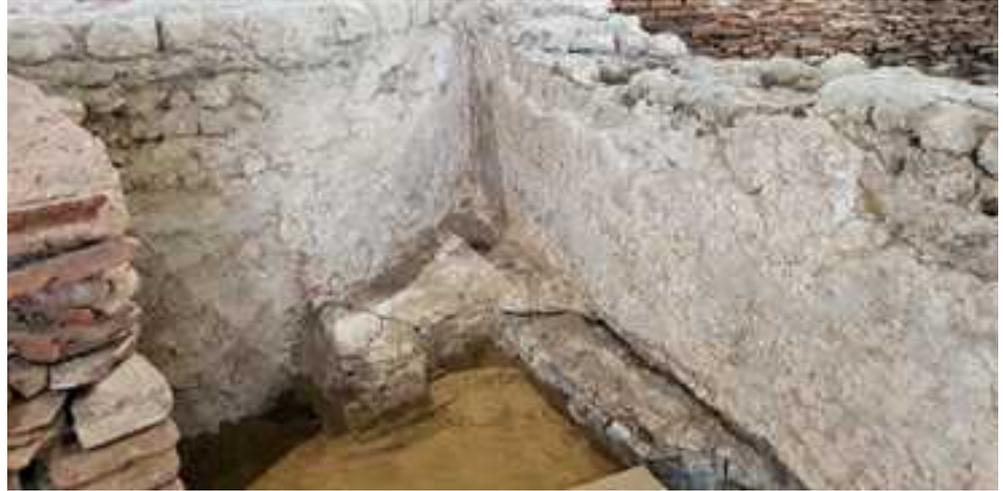
Figure 4.8 Secondary plasterwork on the west wall of the *tepidarium* and on part of the circular wall of the *laconicum*. The plasterwork was applied to prevent rising damp (source: K. Peterse).

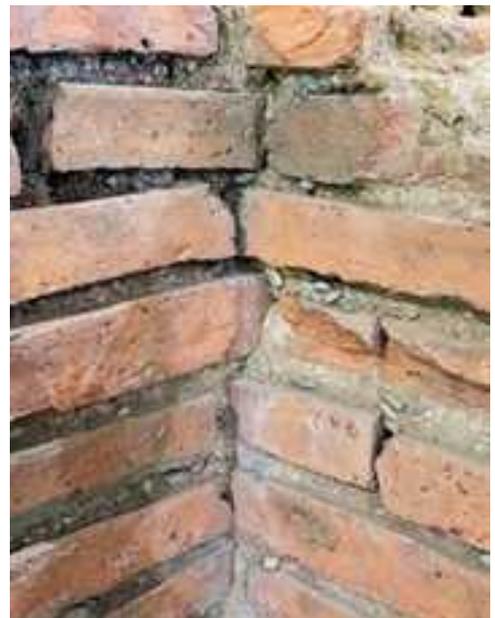
Figure 4.9 *Tegulae* used as bricks extend alternately from one wall into the other, showing that both walls belong to the same phase of construction (source: K. Peterse).

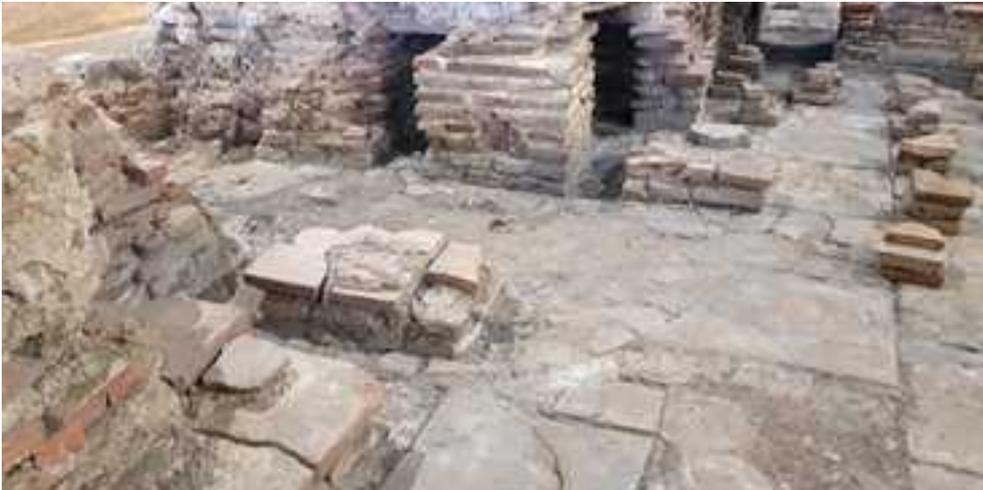
Figure 4.10 A circular feature in the underfloor of the hypocaust in the former west apsis of the *caldarium* indicates the spot where the foundation of a stone *labrum* once stood (source: K. Peterse).

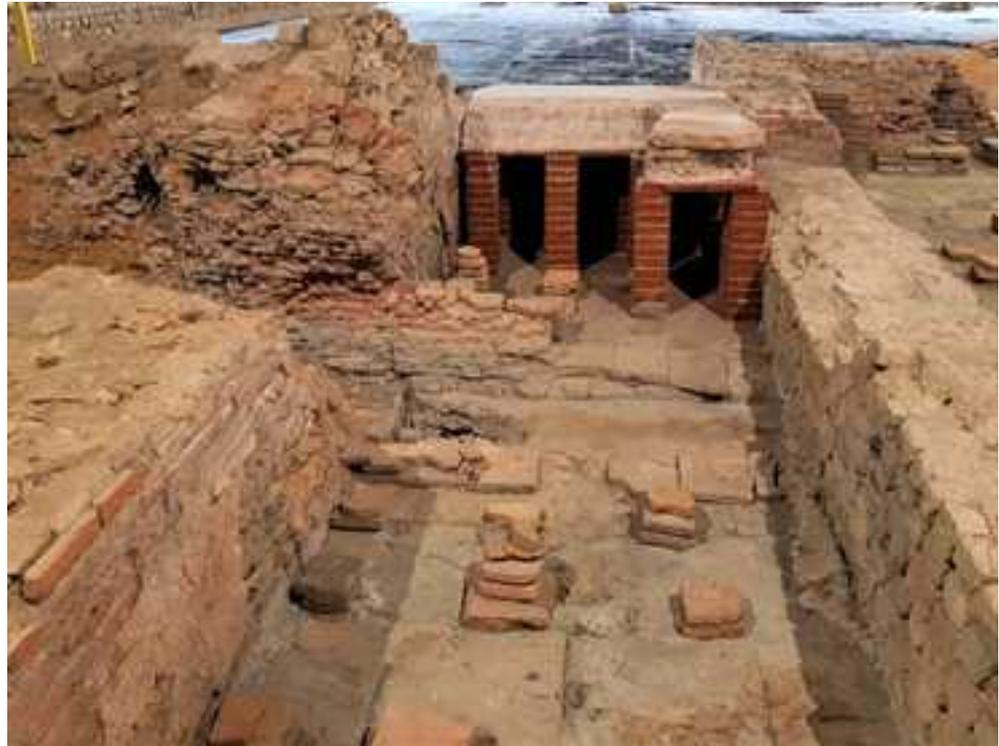
Figure 4.11 The extension of the hot air duct to the south edge of the *caldarium* can be seen in the hypocaust of the *alveus* (source: K. Peterse).

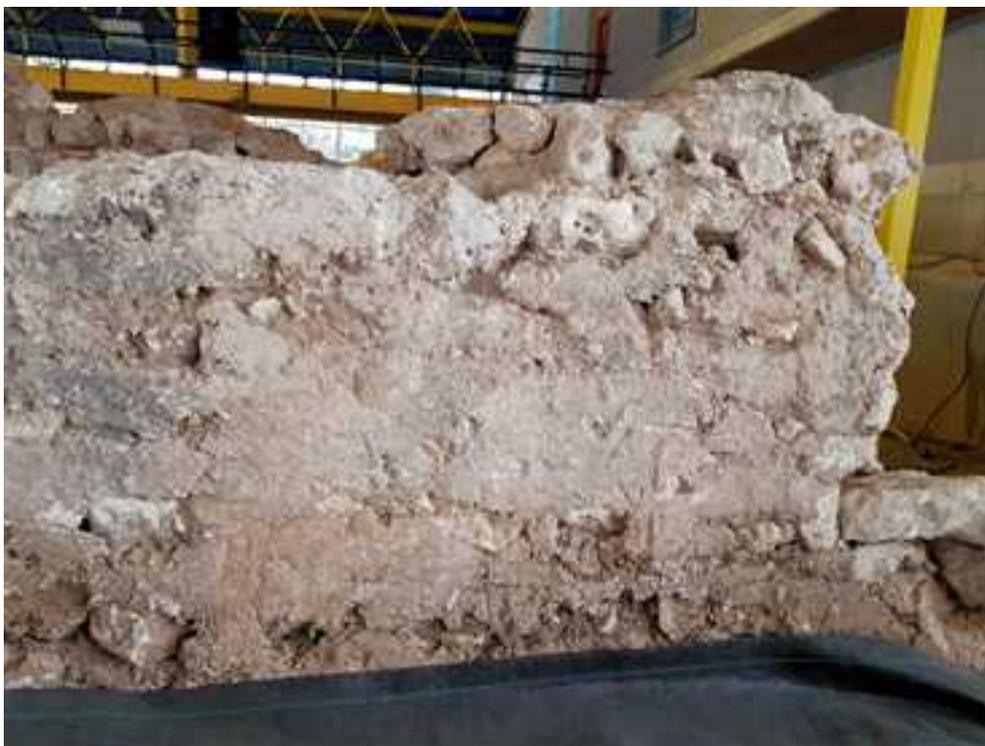
Figure 4.12 The mortar in the west wall of *praefurnium* I is also found on the wall surface, where it has seeped out into vertical, more or less smooth patches. This suggests that this part of the west wall was built against the vertical cut into the soil, which served as casing for the wall (source: K. Peterse).

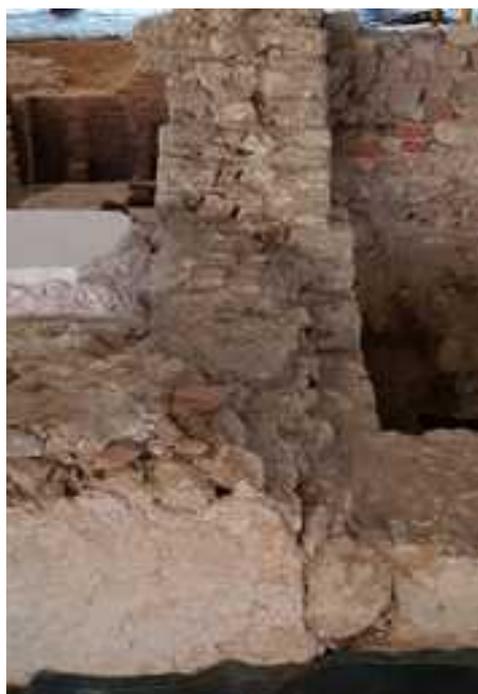
Figure 4.13 The damp-proof plasterwork on the west wall of the heated rooms ended at the transition from the *alveus* to *praefurnium* I (source: K. Peterse).

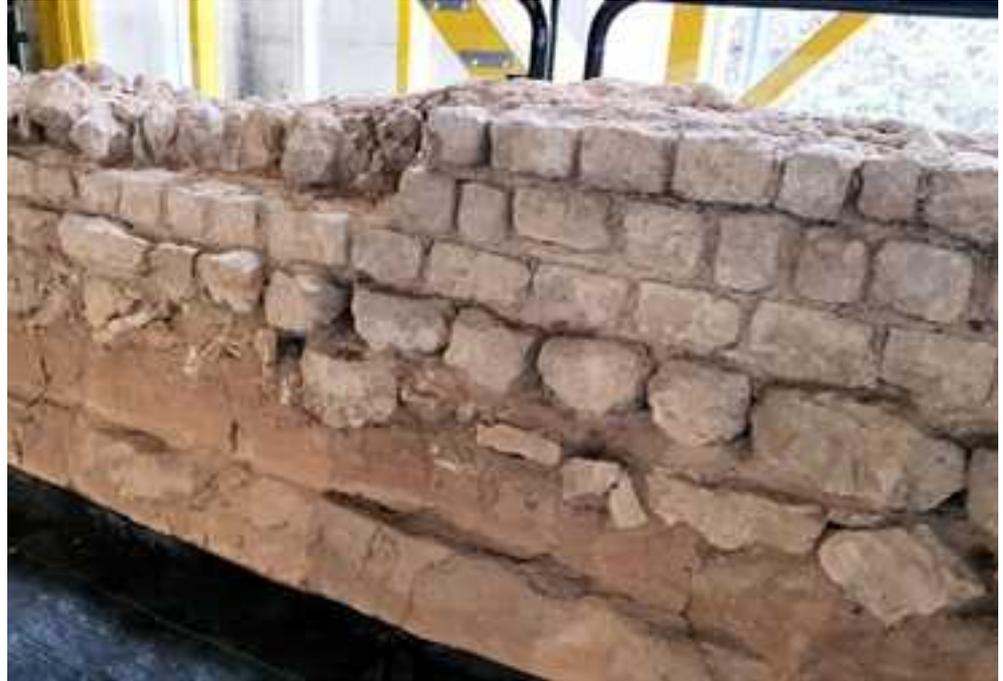
Figure 4.14 The south wall of the west *palaestra* (source: K. Peterse).

The masonry on the side of the south wall facing the *palaestra* was *opus vittatum simplex* made of Kunrade stone (Fig. 4.14). The exterior was made of irregular broken stone, however. This difference in execution suggests a difference in height between the *palaestra* and the higher ground to the south. Given the natural contours of the ground, this difference was particularly apparent in the eastern part of the south wall.

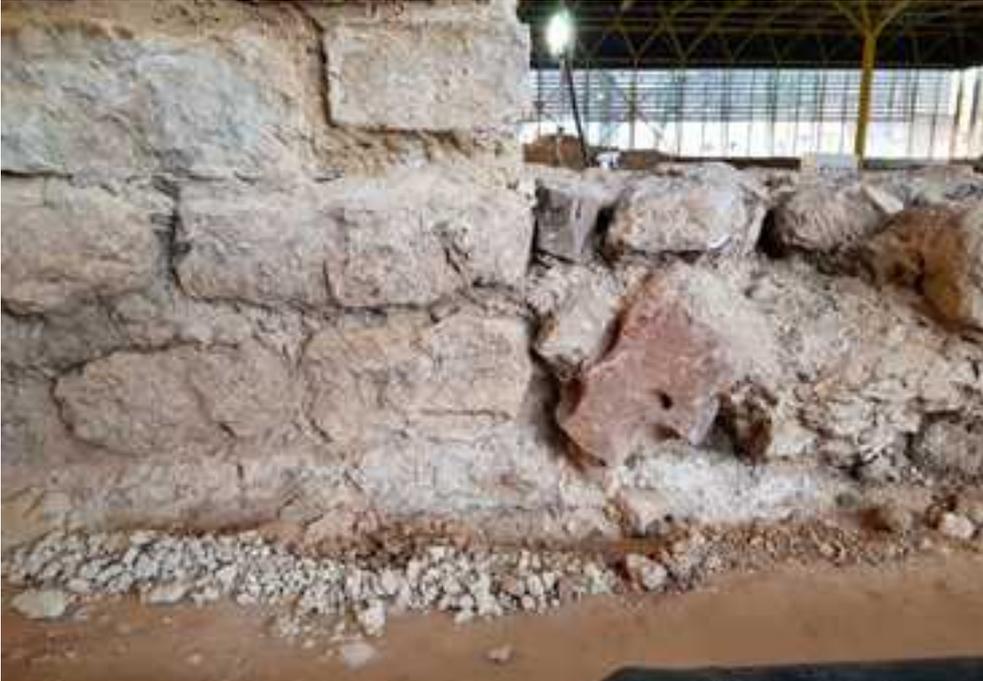
Figure 4.15 The north wall of the west *palaestra* butts against the *apodyterium* (source: K. Peterse).

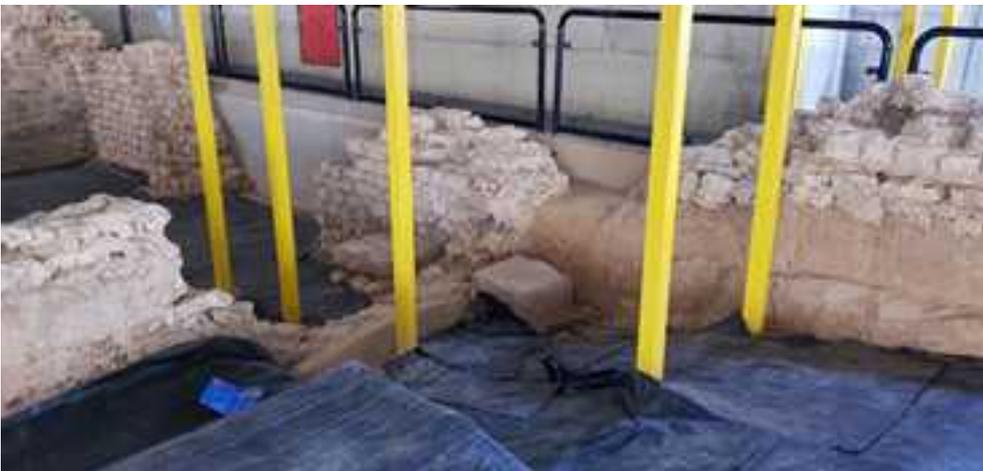
Figure 4.16 The southeast corner of the west *palaestra* (source: K. Peterse).

removed. However, enough has been preserved to be able to conclude that there was no building joint between this wall and the south wall of the *palaestra*, and that they should therefore be regarded as a single unit. The extension on the west side, the *exedra*, is also part of this unit.

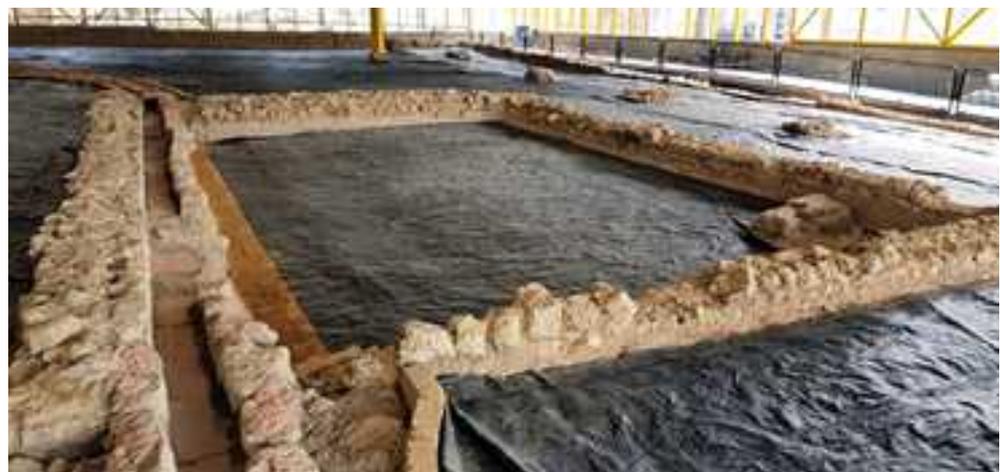
Figure 4.17 *Natatio*, view from the north with, on the left, the east wall and the drain installed later (source: K. Peterse).

Given the major difference in the mortar and the fact that the south and north walls are conjoined to the east walls by different methods, the east wall must belong to another, earlier phase of construction (Fig. 4.17). There is no evidence that the east wall ever continued as far as the south or north wall of the west *palaestra*. The east wall of the *natatio* is probably the remains of a former retaining structure or terrace wall. When the west *palaestra* was created and the northwestern part of the construction site was raised for the purpose, this retaining structure would have become superfluous. Only the part of this structure that could be reused as the east wall of the *natatio* was left intact.¹⁸⁰

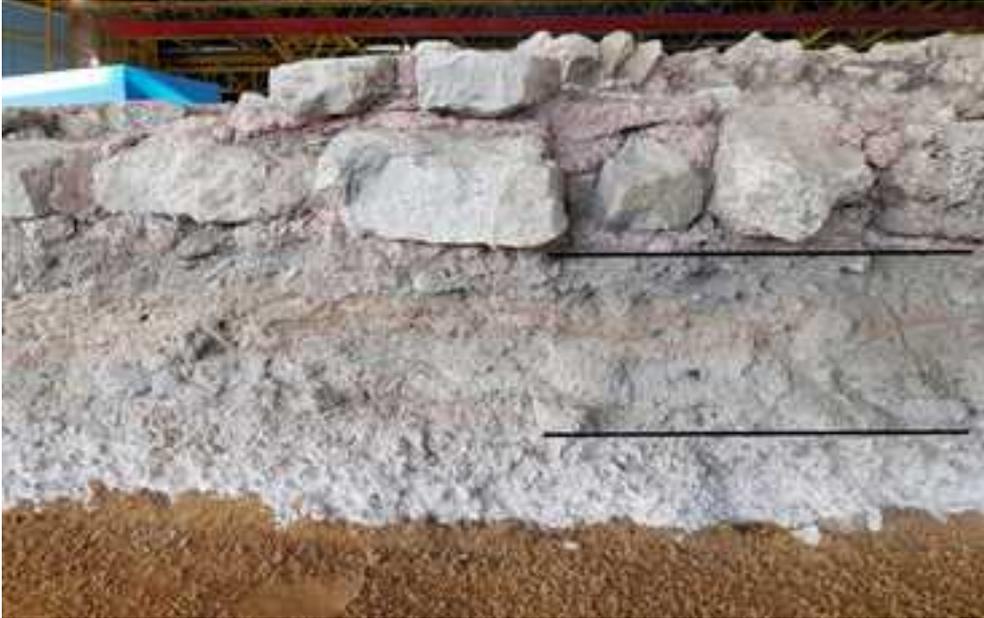
Figure 4.18 East side of the *natatio*. From the bottom: to the lowest black line: secondary bottom of the *natatio*; between the two black stripes: backfill on secondary bottom; above the top black line: west wall of drain (source: K. Peterse).

even occasionally with sherds. This layer served as a basis for a drain that probably linked the secondary *alveus* above *praefurnium* II with the main drain (Fig. 4.18). When it was installed, the east foundation of the *natatio* was used as one of the sides of this channel.

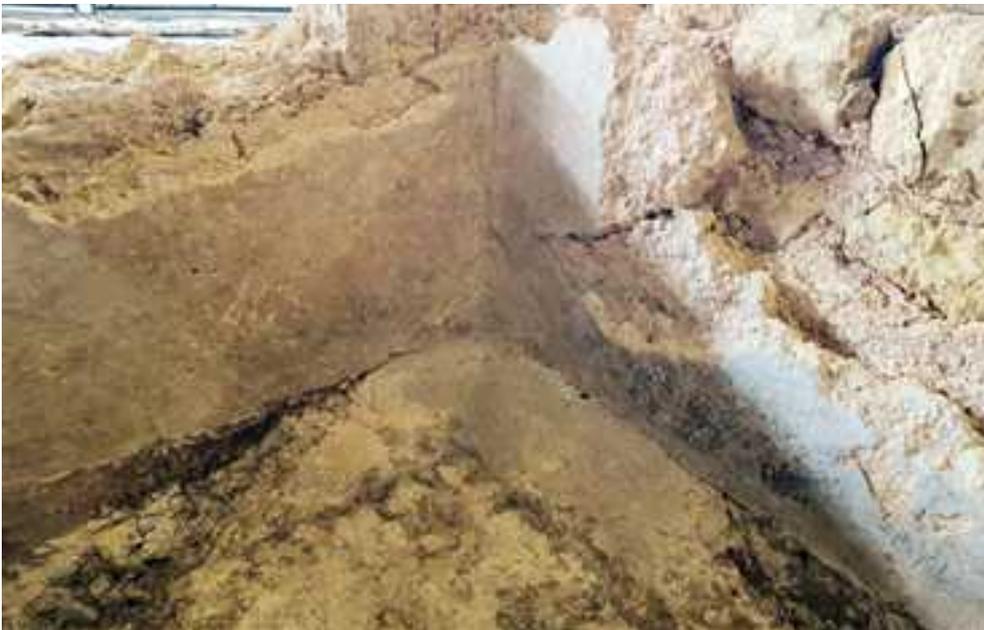
Figure 4.19 Northwest corner of *natatio* with raised cordon (source: K. Peterse).

The inside of the walls was finished with two layers of plaster. Remnants have been preserved, particularly in the northwest corner. The top layer has a smooth surface on which dark patches – probably pigment residues – can be seen. The plasterwork also has traces that suggest the painted interior of the *natatio* was marked with a painted vertical band in a different colour in the northwest corner. We can assume that this was also the case in the other corners (Fig. 4.19).

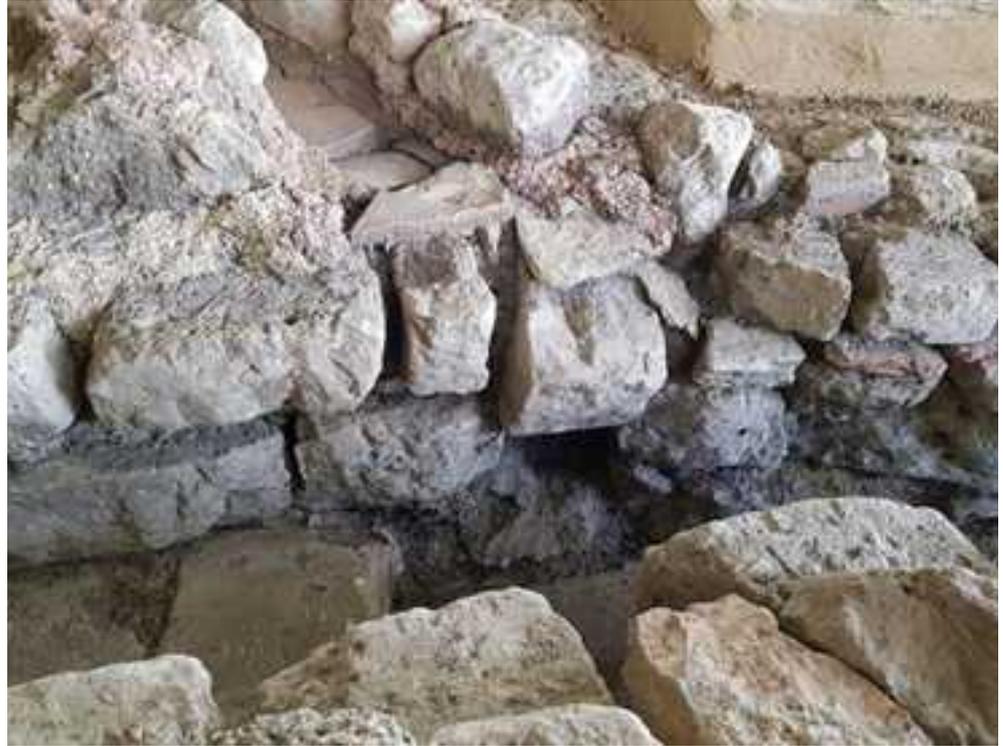
Figure 4.20 Transition in the main drain from the relatively shallow to the deep section, into which the drain of the *natatio* most probably emptied (source: K. Peterse).

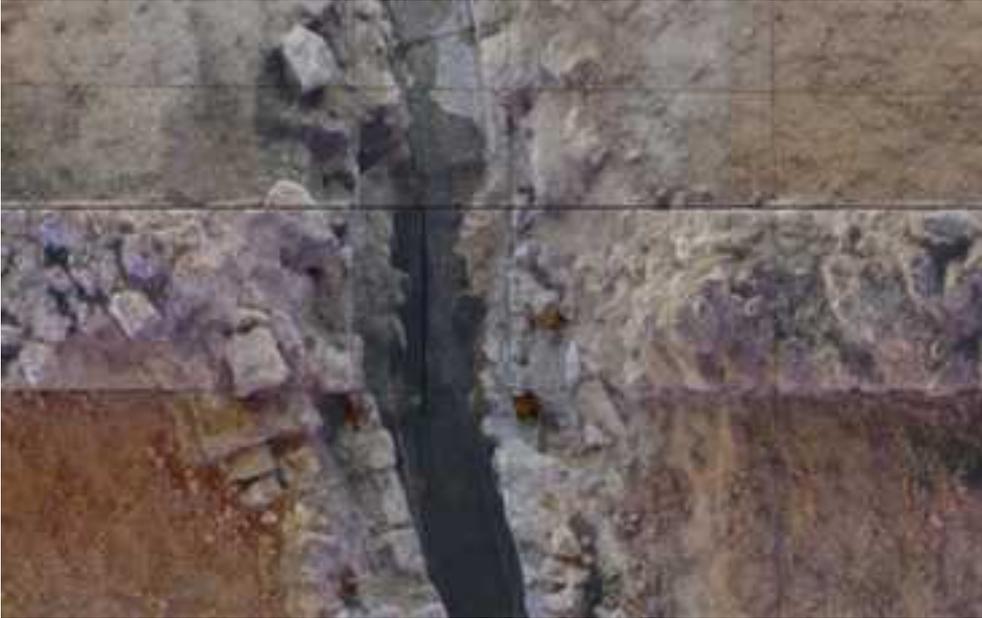
Figure 4.21 Original and secondary opening for the main drain through the south wall of the portico (source: Delfttech/K. Peterse).

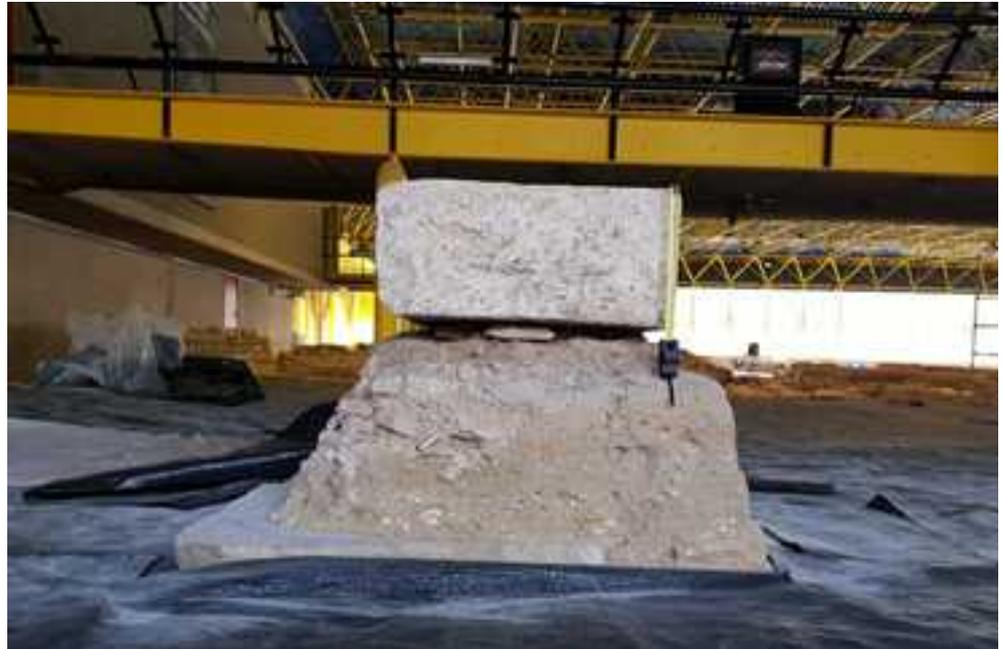
Figure 4.22 Southernmost base in the pillar configuration in the east *palaestra* (source: K. Peterse).

There is a grey-brown heterogeneous substance on both slabs of sandstone at the foundations of *caementa* made of Kunrade stone (Fig. 4.22). This is part of a backfill spread on the original bottom of the construction pit over a large proportion of the long wing of the portico. Above this backfill is a layer on which – or rather
