Nederlandse
Archeologische
Rapporten

Roman bathing in Coriovallum

The thermae of Heerlen revisited

K. Jeneson and W.K. Vos (eds.)

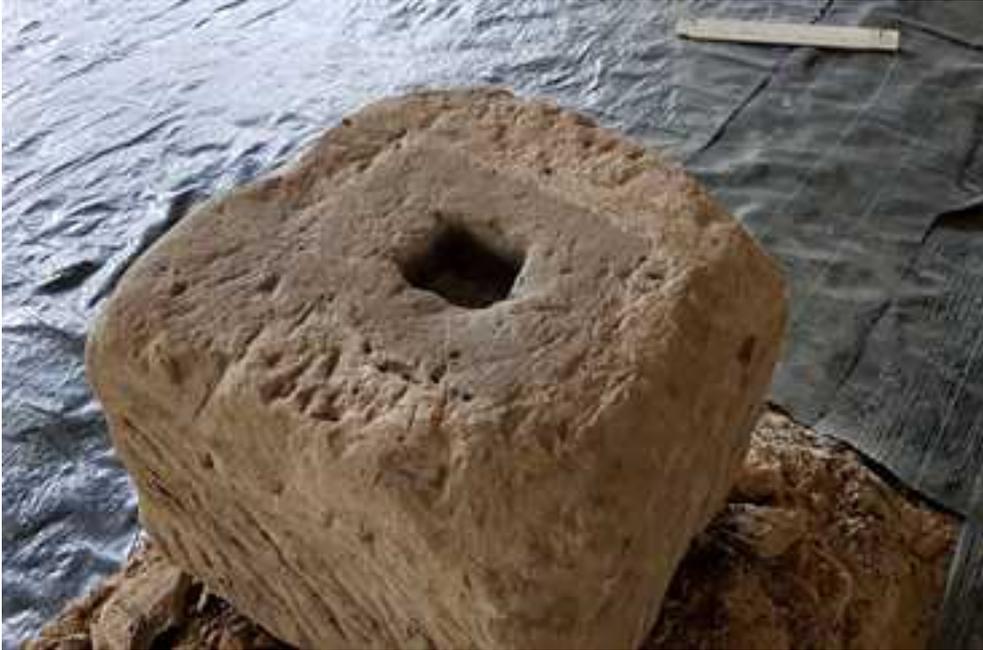
Figure 4.23 Imprint of a square pillar on the top of the sixth basal block of the pillar configuration in the east palaestra (source: K. Peterse).

On top of each of the basal blocks is an imprint roughly 1 Roman foot (29.6 cm) square, with a mortise in the centre (Fig. 4.23). This suggests that the blocks supported square pillars rather than columns. The sixth and seventh bases are positioned in such a way that the pillars they supported were in line with the side walls of the *exedra*. The same correspondence was also found in the west *palaestra*.

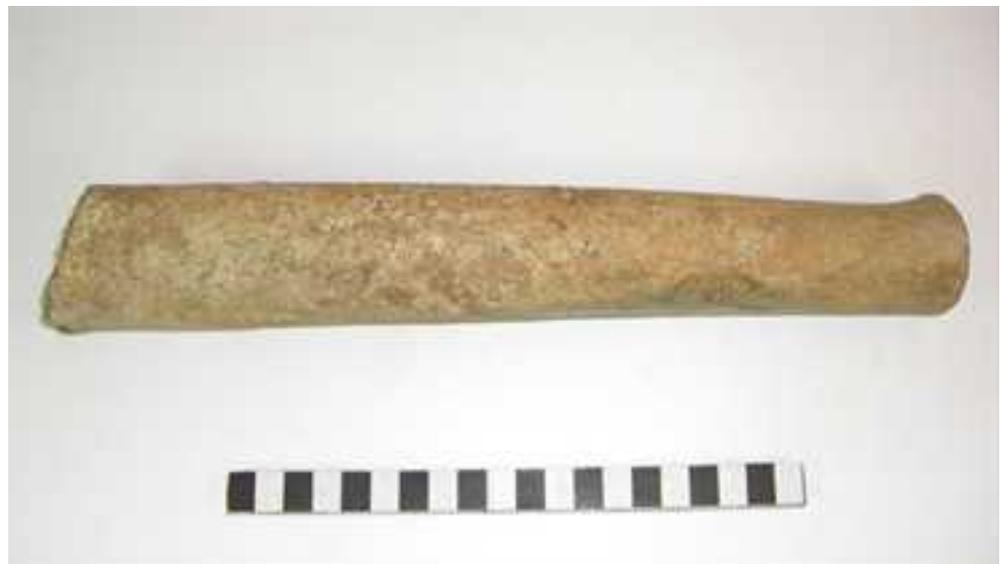
Figure 5.1 Heerlen: 30 cm section of lead water pipe (source: National Museum of Antiquities, Leiden).

slowly, continuously, and therefore reliably. It is not however certain that Coriovallum used this source. There is for example barely any evidence that Coriovallum had a network of water pipes, as only one piece of lead water piping approx. 30 cm long has been found (Fig. 5.1).²⁴³

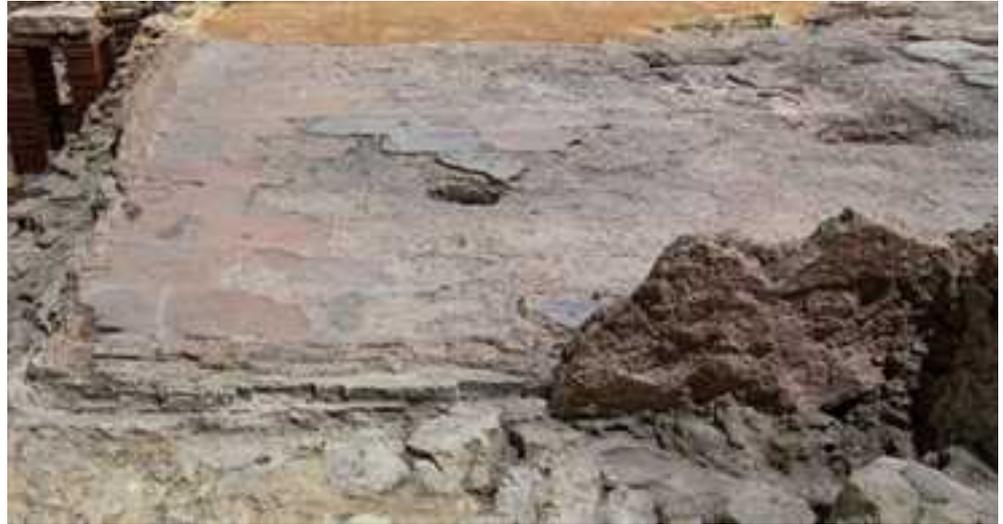
Figure 5.2 Photograph showing an overview of the *frigidarium*, with the tiled floor (#3) and the seal made of *opus signinum* (source: Thermenmuseum, A. Steen).

The *frigidarium* (#3) contained two small built-in cold water baths, the *piscinae* (#4 and #5). The floor and wall coverings in the *frigidarium* were water-resistant, the floor having been originally covered with mosaic, and later with large and small tiles. The join between the wall and floor was sealed with a strip of *opus signinum* in order to prevent leaks (Fig. 5.2). The walls were covered with layers of *opus signinum*. This all suggests that a lot of water was splashed around there. Both *piscinae* were rectangular, almost equal in size, though they did differ slightly.

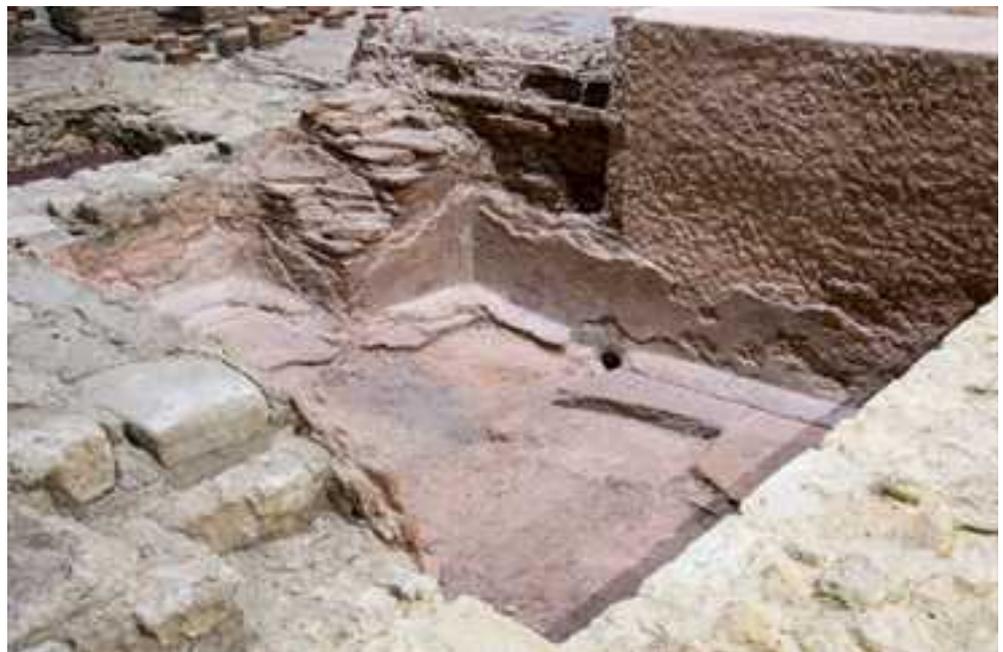
Figure 5.3 Overview of the eastern *piscina* (#4). The stairs can be seen in the top right and the drain at floor level (source: Thermenmuseum, A. Steen).

Access to the eastern *piscina* was via a 32-35 cm high step at the front. The bather would then jump into the water from the side, or descend a set of steps into the bath. These steep steps were made of tiles covered with *opus signinum*. At 47 cm, the drop of the final step was quite big. The corners of the walls have a vertical sealing strip that was applied during the final phase of construction (Fig. 5.3).

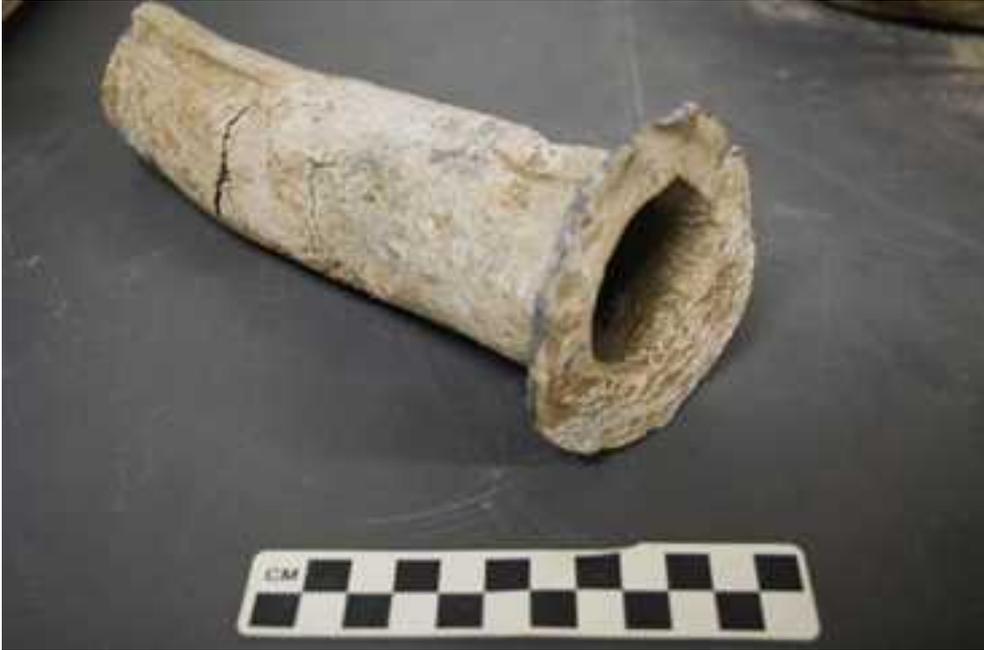
Figure 5.4 Heerlen: the lead pipe with 'flange' (source: G. Jansen).

23 cm of which has remained preserved and was found in Heerlen (Fig. 5.4).²⁵² The flange meant the pipe could be fixed between the wall and the layer of plaster or *signinum*. The signs of breakage around the drainage hole suggest something was removed from there.

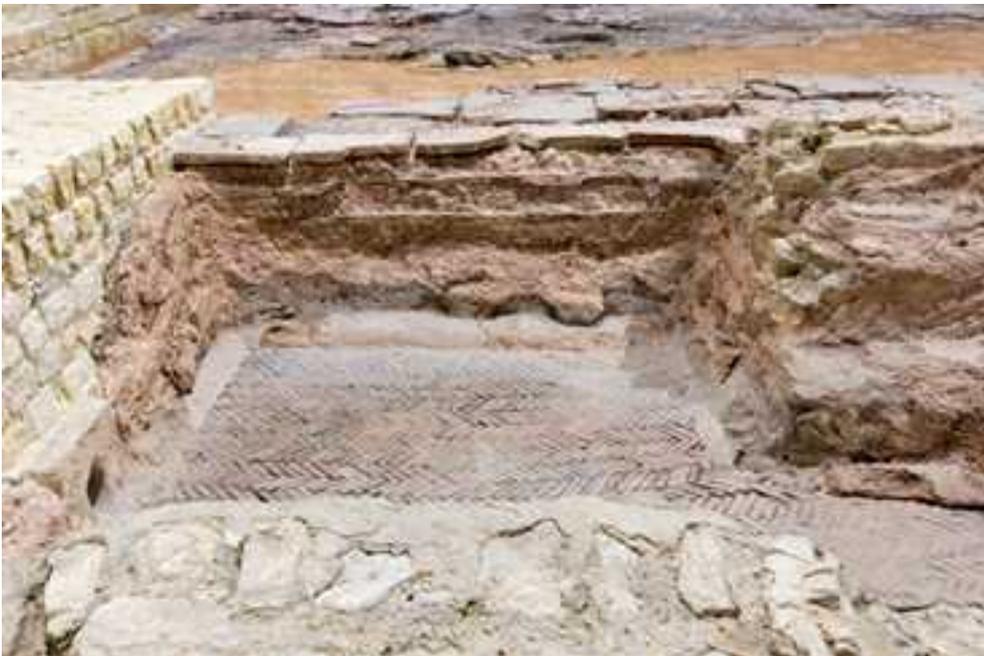
Figure 5.5 Photograph showing an overview of the western *piscina* (#5) (source: Thermenmuseum, A. Steen).

some 5.000 litres of water. This is based on its internal dimensions (260 x 182 x 92 to 108 cm). The volume of the stairs has to be subtracted from this. Assuming that the water flowed continuously, a multiple of this volume would be required each day to keep the *piscina* full.

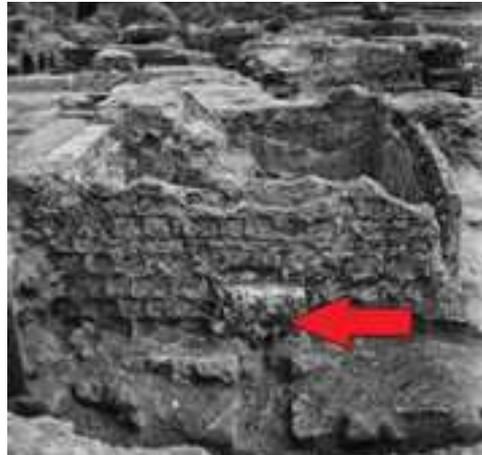
Figure 5.6 Photograph showing an overview of the western *piscina* (#5). In the top left are the steps, at the front is the drain to the main drain of the bathhouse (red arrow). Situation in 1941 (source: Thermenmuseum archives; original photo by GIA Groningen).

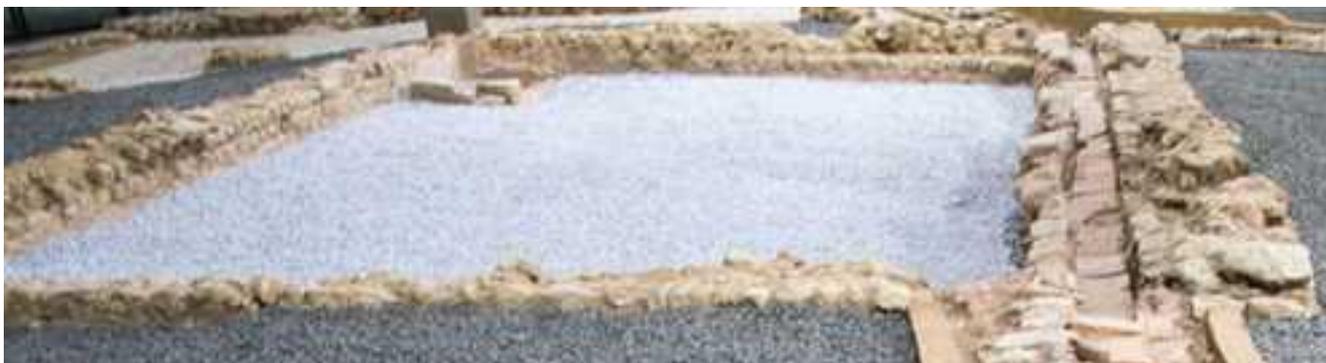
Figure 5.7 Photograph showing an overview of the *natatio* (#15), with the steps visible in the back left (source: Thermenmuseum, A. Steen).

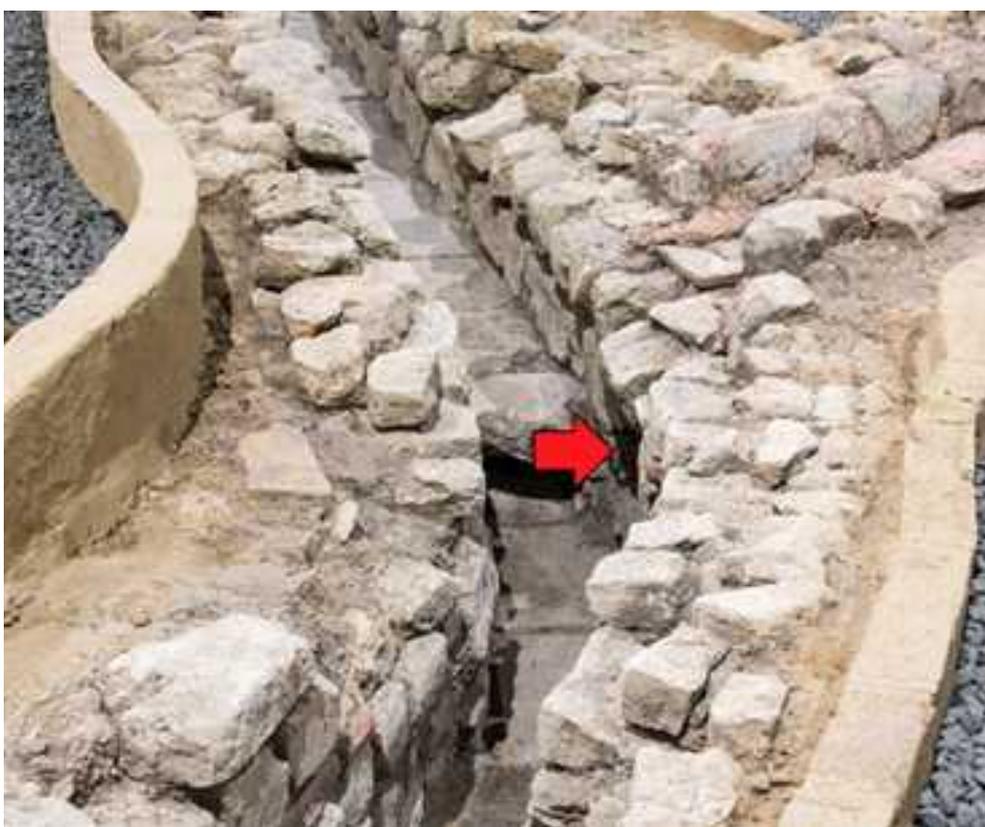
Figure 5.8 The drain at the bottom of the *natatio* (#15) indicated by the red arrow. It emptied into the main drain (source: Thermenmuseum, A. Steen).

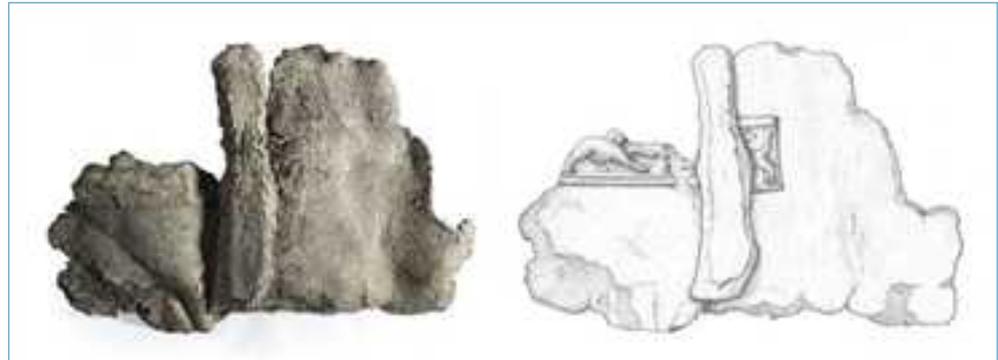
Figure 5.10 One of the large fragments of the lead boiler from Heerlen (source: Centre Ceramique Maastricht (photo), Thermenmuseum, P. Delnoy (drawing)).

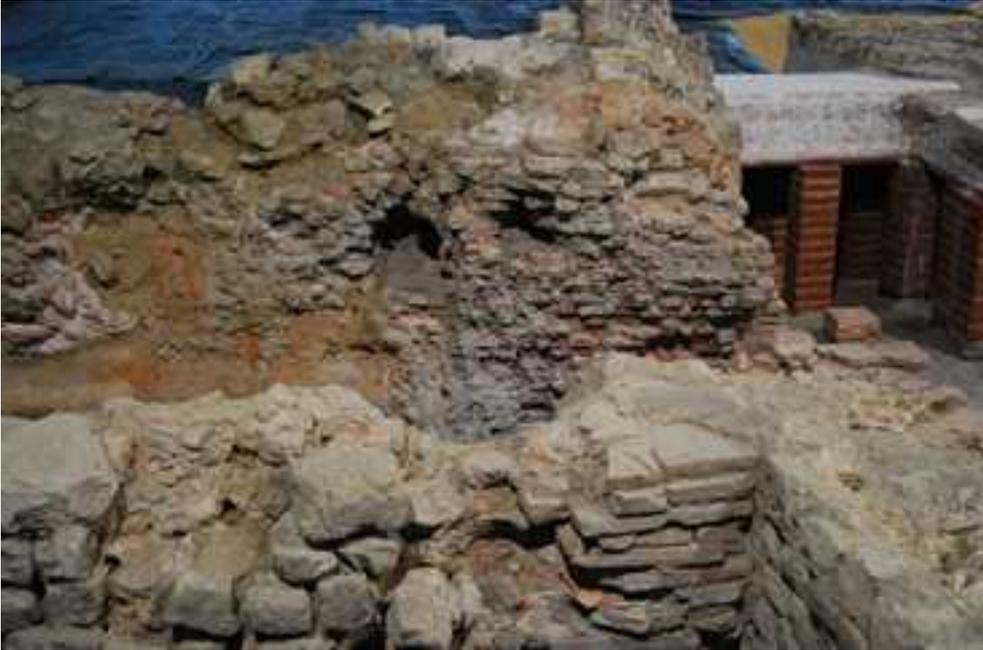
Figure 5.12 *Praefurnium I* (#11), view of the left wall (west wall) with holes, possibly associated with the support for the boiler (source: G. Jansen).

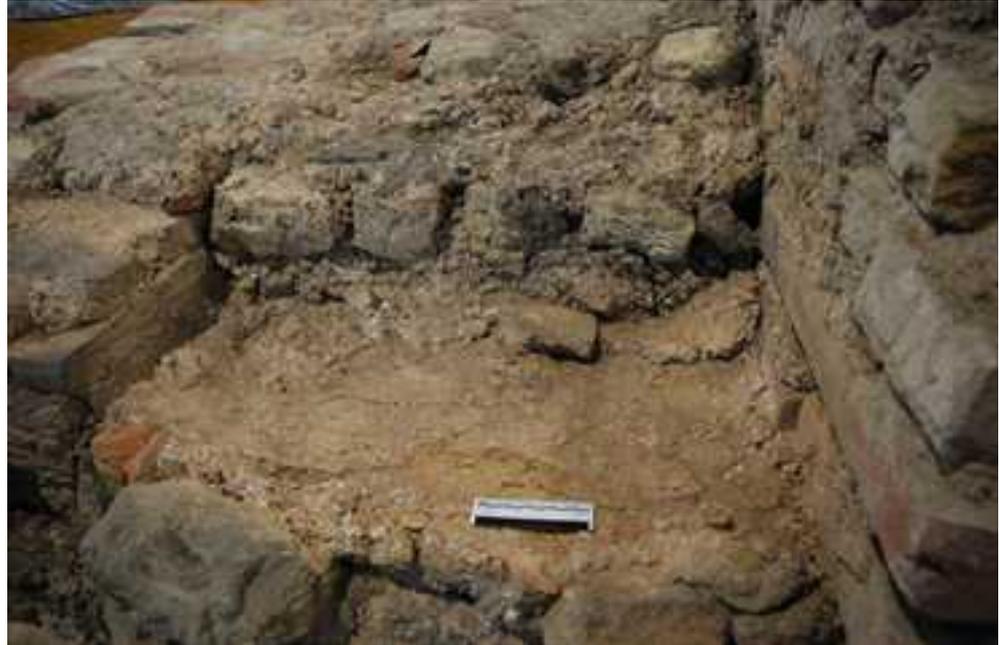
Figure 5.13 Impression made by the support for the lead water tank beside *praefurnium* II (#12), north side (source: G. Jansen).

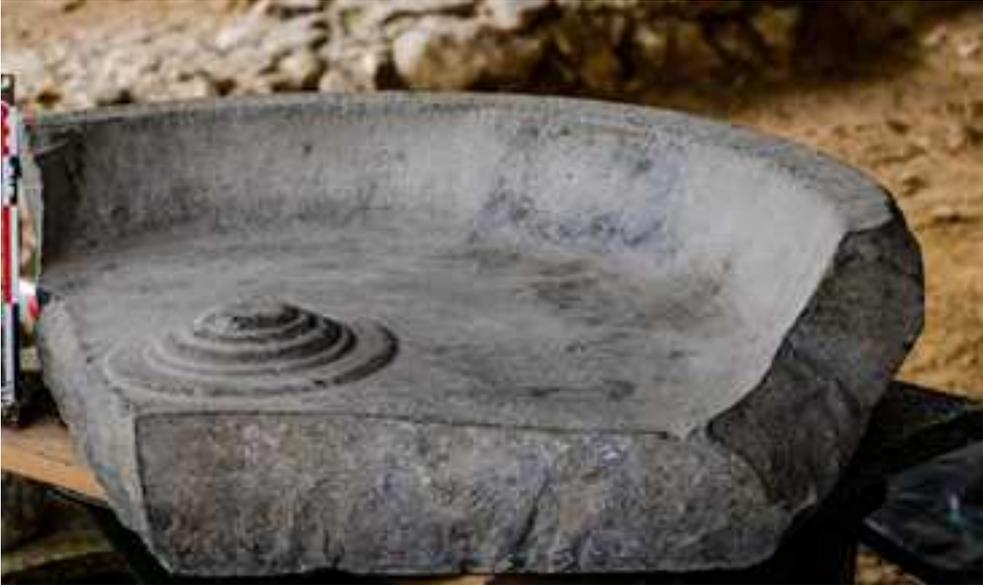
Figure 5.14 Fragment of the *labrum* in Heerlen (source: Thermenmuseum, Ph. Debeerst).

²⁷⁶ Garbrecht & Manderscheid (1994, B 184) describe this *labrum* and quote a diameter of 126 cm, whereas Van Giffen (1948, 215-216) had an external diameter of 130 cm. Manderscheid (2009, 44-49) mentions *labra* in Pompeii with diameters of 145 to 237 cm.

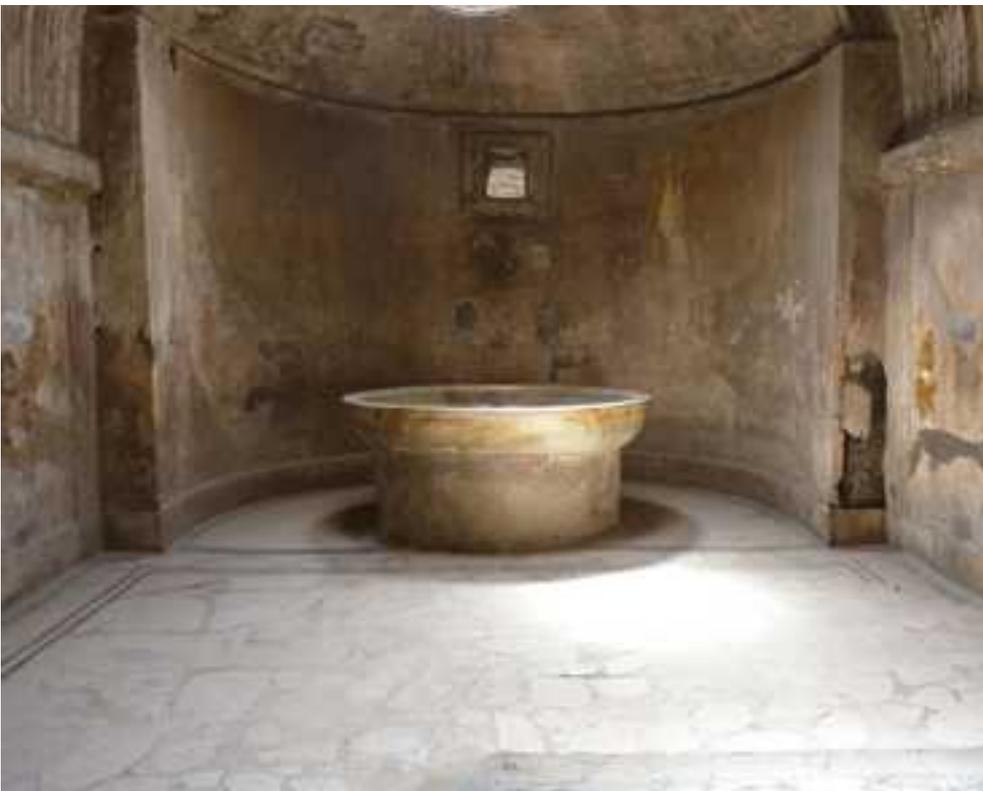
Figure 5.15 Pompeii, Forum baths: stonework base beneath a large *labrum* (source: W.K. Vos).

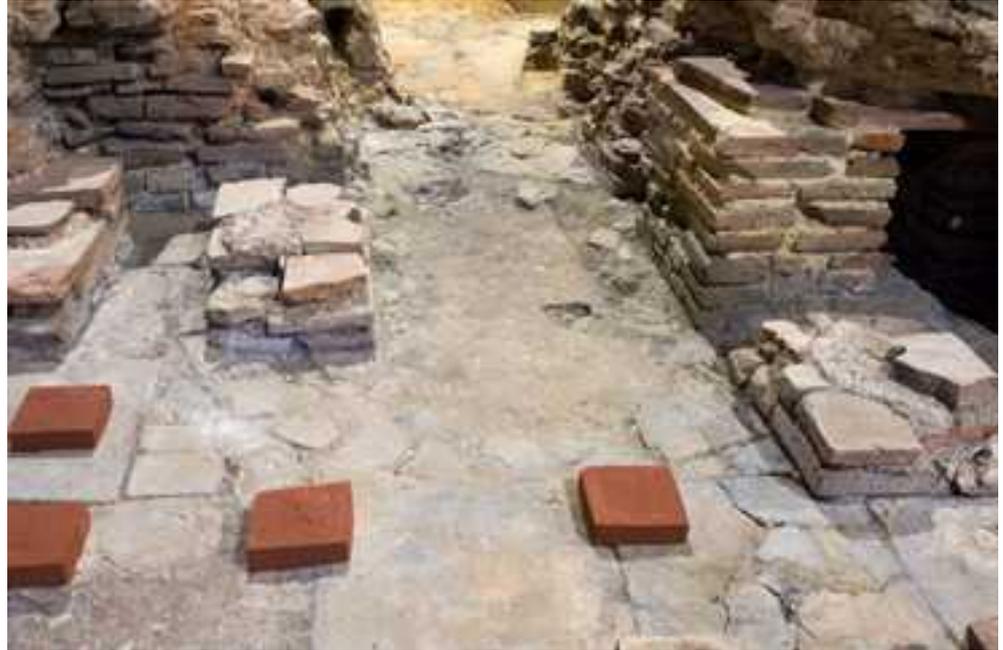
Figure 5.16 Remains of the round foundation of the *labrum* in the eastern *schola* of the *caldarium* (#9) (source: Thermenmuseum, A. Steen).

Labra are common in *caldaria*, though they would also be located in other rooms at the bathhouse, and sometimes in the toilet area. The Heerlen *labrum* was originally situated in the western *schola* of the *caldarium*, where a

round foundation for a *labrum* was found under the hypocaust floor (Fig. 5.16).²⁷⁸ When the western *alveus* was built here at a later stage and a furnace was installed in this *schola* the *labrum* and most of the foundation were moved. It is

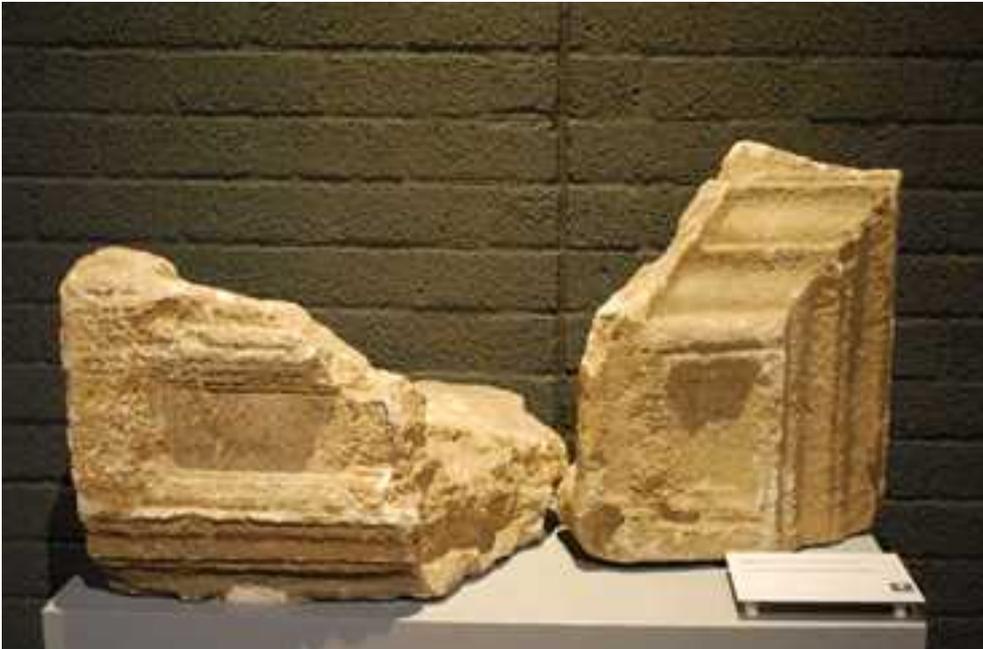
Figure 5.17 The two fragments of basins from Heerlen that would have collected water from fountains (source: G. Jansen).

In 1940 two large stone fragments of rectangular basins with decorated fronts were found in the northern part of the bathhouse (Fig. 5.17). They are made of Norroy limestone and come from two different basins, as they are both front left corners.

certainly not a standard feature. Manderscheid and Garbrecht do not discuss them in their standard reference work.²⁸¹ It is therefore highly unusual for them to have been found in Heerlen. The Heerlen basins are both the same height and their rim is the same thickness (8 cm on the side, 6 cm on the front), but the thickness of the sides differs and the decoration of the bas-relief on the front is not identical. They may have been positioned symmetrically so that they could be seen together. There is still a small amount of *opus signinum*, with pink mortar, on one of the basins. It might be possible to ascertain the rooms where they were located on the basis of this. The basins were at least 106 cm wide (front) and at least 54 cm deep (towards the rear). Both were 41-42 cm high. As far as we are able to ascertain, they were 26-27 cm deep. We do not know whether the water flowed over the edges as a kind of curtain, or there was an overflow in the middle or on the side.

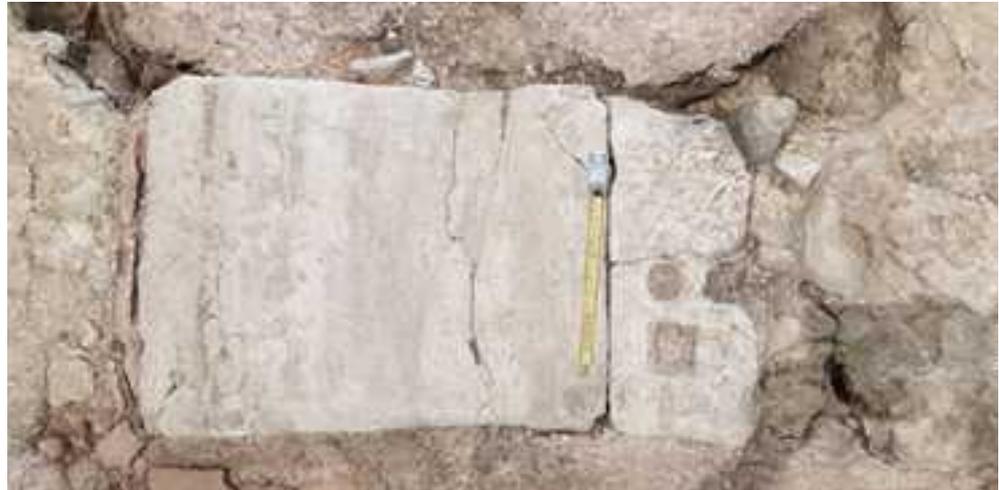
Figure 5.18 Door sill of the sweating room (#7) (source: Thermenmuseum, A. Steen).

The floor of the *laconicum* (#5) has not survived, but the sill is still there. It has a low ridge that would conduct water from the sweating room to the room with cold water baths (Fig. 5.18).

on the floor of the *frigidarium* via the floor of the *caldarium* and the *tepidarium*, possibly flowing over the sill of this chamber, and then have been conveyed to the drain drawn by Van Giffen via a grate (no longer present). In his contribution to this publication, Peterse reconstructs the sill between the *tepidarium* and the *frigidarium* and places it precisely above or at the start of this drain. The *laconicum* (#7) also drained onto this part of the floor of the *frigidarium*, as evidenced by a low ridge (10 cm high) in the sill (Fig. 5.18). This water might also have flowed away via the drain sketched by Van Giffen.

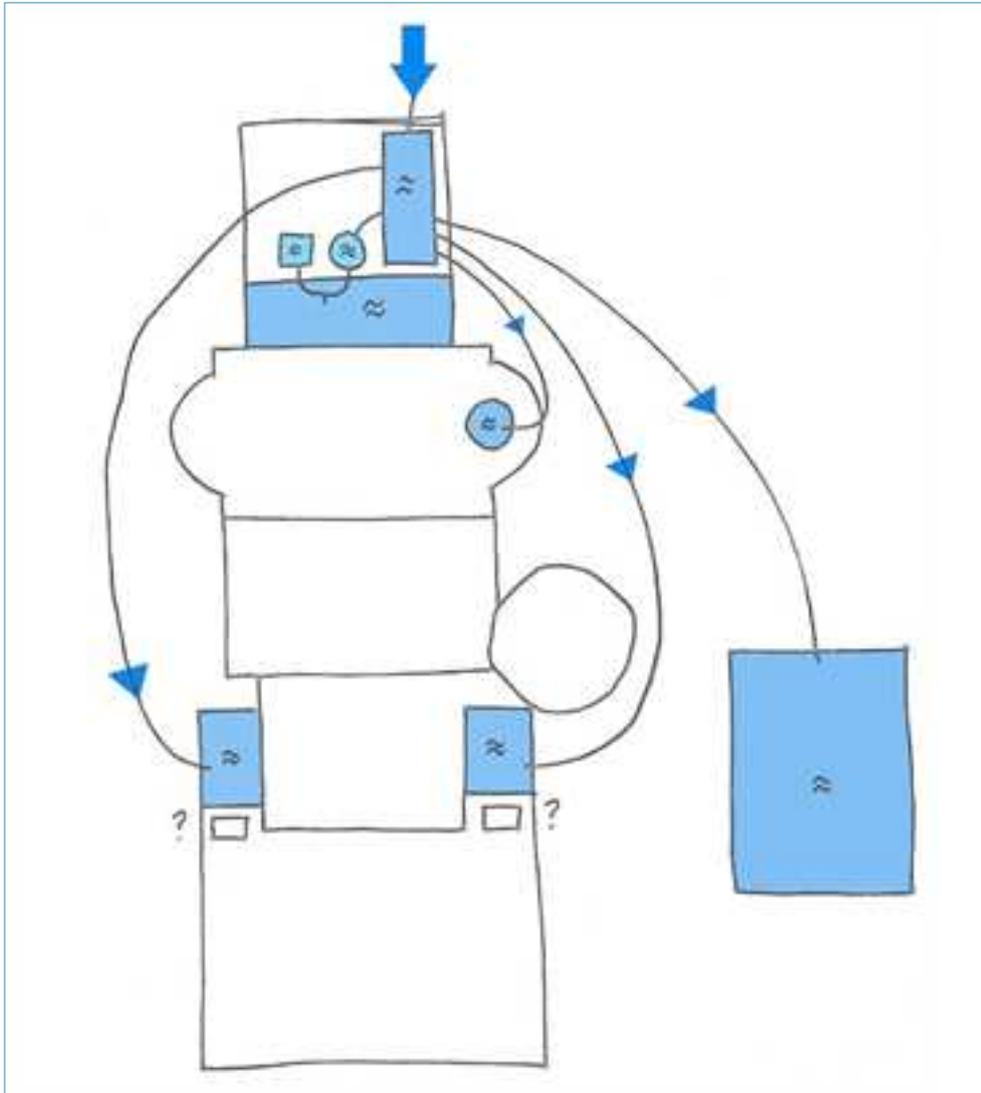
Figure 5.19 Diagram of the water distribution system in the bathhouse (source: G. Jansen).

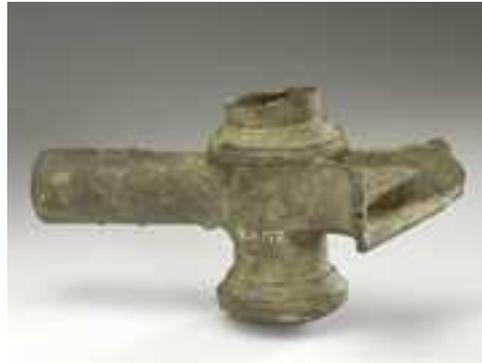
Figure 5.20 Nijmegen: bronze mixer tap. (source: National Museum of Antiquities, Leiden).

A system of lead pipes would have bronze taps. The Romans had control taps and end taps. Control taps were mounted in the pipeline to regulate the distribution of water. They were often positioned close to the point where the

water entered; in Boscoreale there was a control tap near the distribution tank. End taps, where water would be extracted, are less common. They were similar to the taps we have today. In the Rhine-Meuse region 23 complete or partial bronze taps have been found.²⁸⁹ Several of them were end taps, some were even mixer taps. This last type of tap could supply hot or cold water, or mix the two. They were therefore ideal for a bathhouse (Fig. 5.20). No bronze taps or lead pipes – not even fragments – were found at the bathhouse in Heerlen, however.

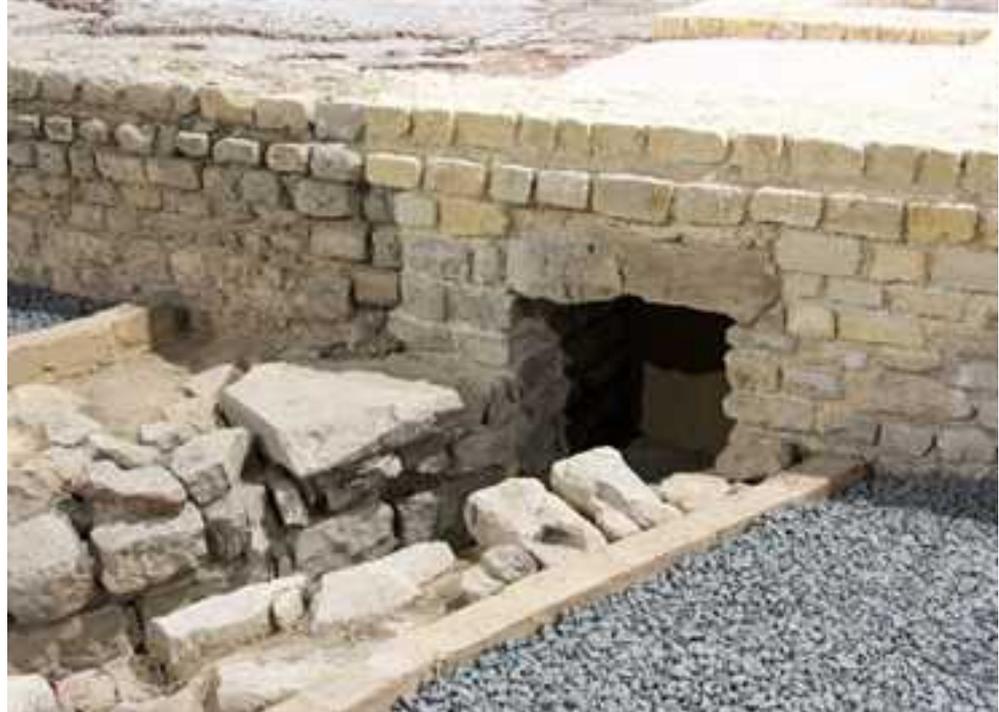
Figure 5.22 The main drain (#26) breaks through a pre-existing exterior wall of the bathhouse (the flat stones along the top are a modern reconstruction) (source: Thermenmuseum, A. Steen).

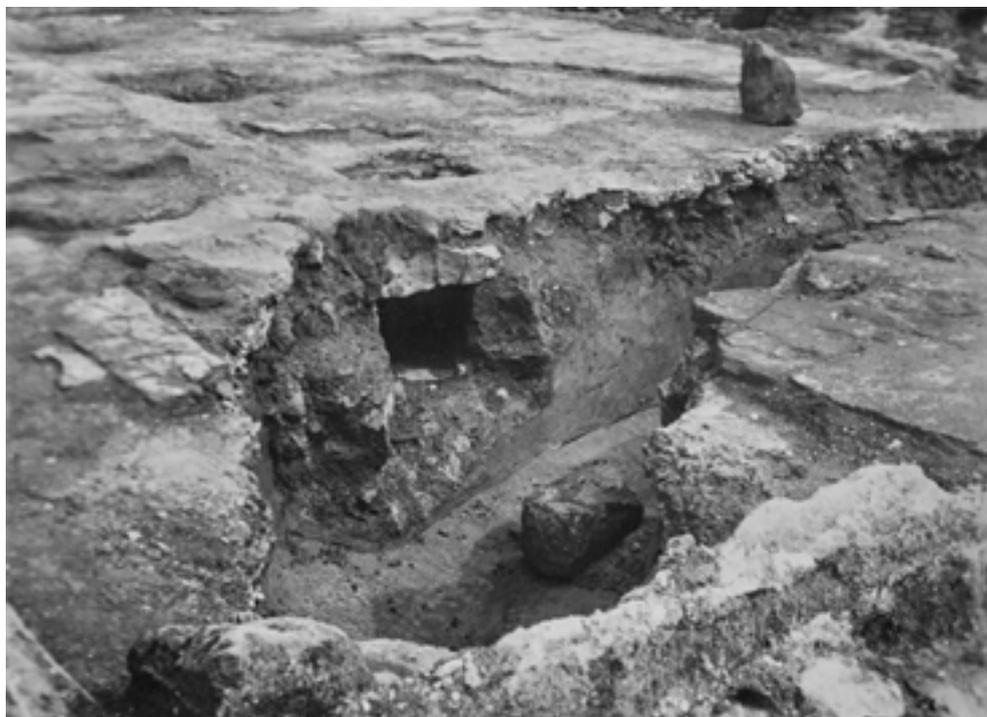
Figure 5.23 The main drain (#26) line with a terracotta plate on the bottom, and covered by a large stone slab. Situation in 1941 (source: Thermenmuseum archives; original photo by GIA Groningen).

The main drain of the bathhouse starts at the eastern *piscina* (#4). This drain is lined with roof tiles on the bottom, has stonework sides and is covered in stone slabs (Fig. 5.23). The first water that emptied into the drain came from this *piscina*, discharged when the bath was cleaned,

and probably also the water that continuously overflowed from the pool. The drain then runs beneath the *frigidarium* floor where it collected waste water from the floor of this room via three holes positioned in a perfectly straight line. A slight impression of a square lid, which has now disappeared, can be seen around each of these holes (Fig. 5.24). This was probably a plate decorated with rosettes and small holes which served as a grate. Such covers are common in *frigidaria* (Fig. 5.25). The western part of the *frigidarium* floor has been disturbed. It is unlikely there were more drainage holes here, as after the last hole the drain bends towards the northwest, from which point the remains of the drain are not preserved.

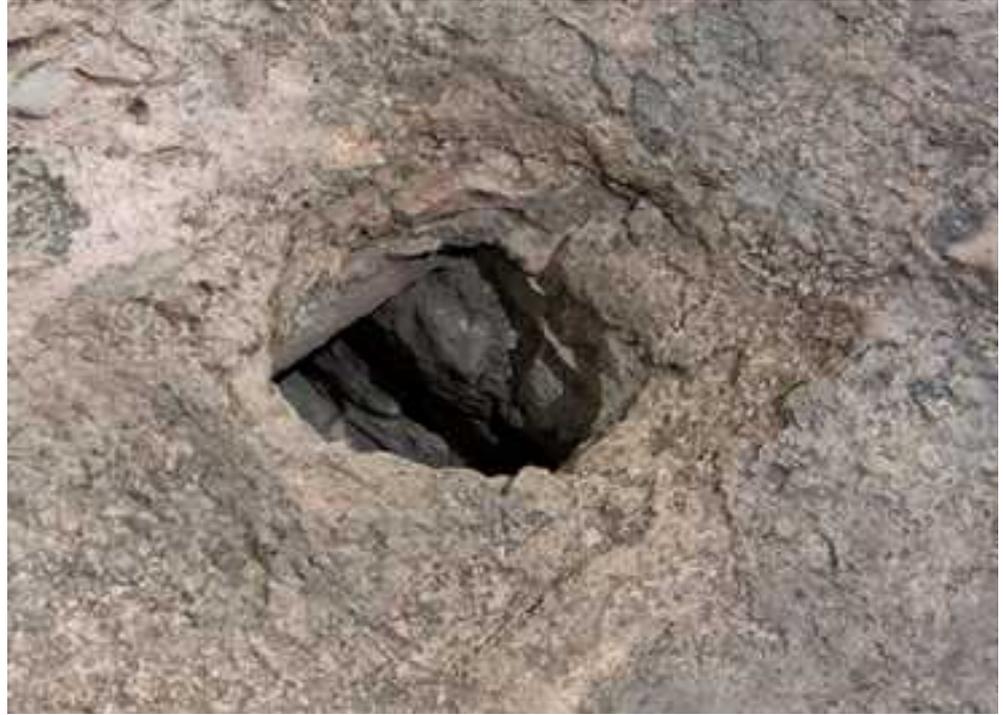
Figure 5.24 The main drain (#26), detail with visible indentation in which the decorated grate would have sat (source: Thermenmuseum, A. Steen).

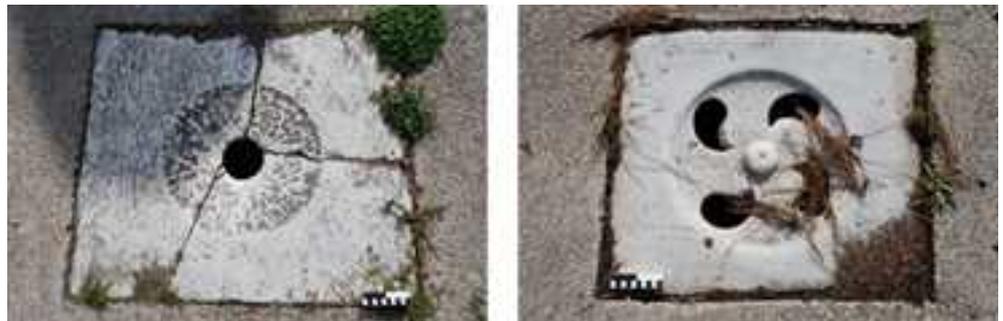
Figure 5.25 Ostia, Forum Baths: examples of decorative grates over drains (source: G. Jansen).

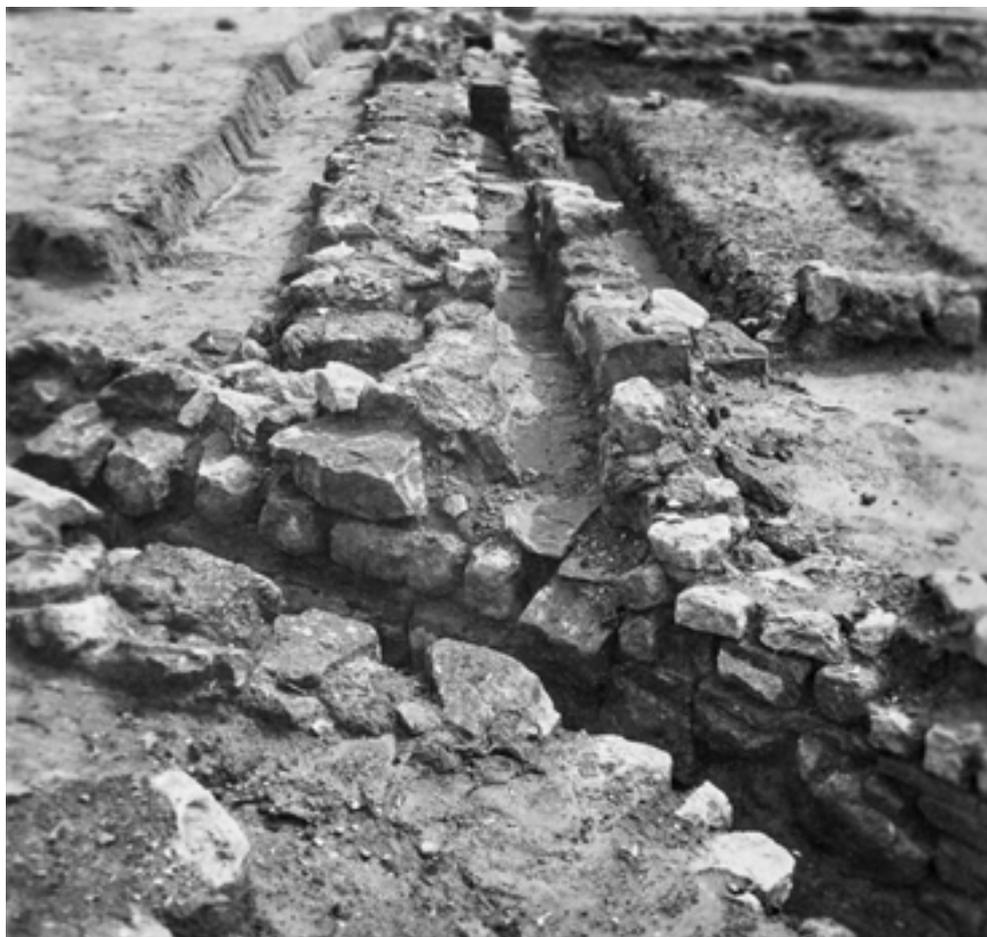
Figure 5.26 The small drainage channel (#27), partially built over the east wall of the *natatio*, view to the south. 1941 situation (source: Thermenmuseum archives; original photo by GIA Groningen).

A small channel partially covered with tiles runs from *praefurnium* II (#12) to the main drain (Fig. 5.26). Drains from *praefurnia* are common, and would have been used not only to remove the water from boilers and tanks, but also the ash from the furnaces along with this water.³⁰⁸ This drain might also have removed waste water from the later *alveus*. It was probably just below the Roman ground surface, or perhaps the covering tiles were just visible. The workmanship of the channel is shoddy, with excessive amounts of mortar and irregularly cut stones. It also consists partly of the east

wall of the *natatio*, which was no longer in use when the channel was created. The bottom and the west side of the channel are positioned over the fill of the *natatio*. The bottom consists of *tegulae*. One *tegula* was placed against the side of the *natatio* and a small wall without foundations was built at the end of the tile. It would seem that the fill collapsed after construction and the entire west side of the channel subsided. The weight of the small wall caused the tile to tilt. The route of this drain was determined by the wall of the *natatio* and the position of the main drain. The channel is 29–33 cm wide on average, with an occasional narrower 24-cm section (not including mortar).

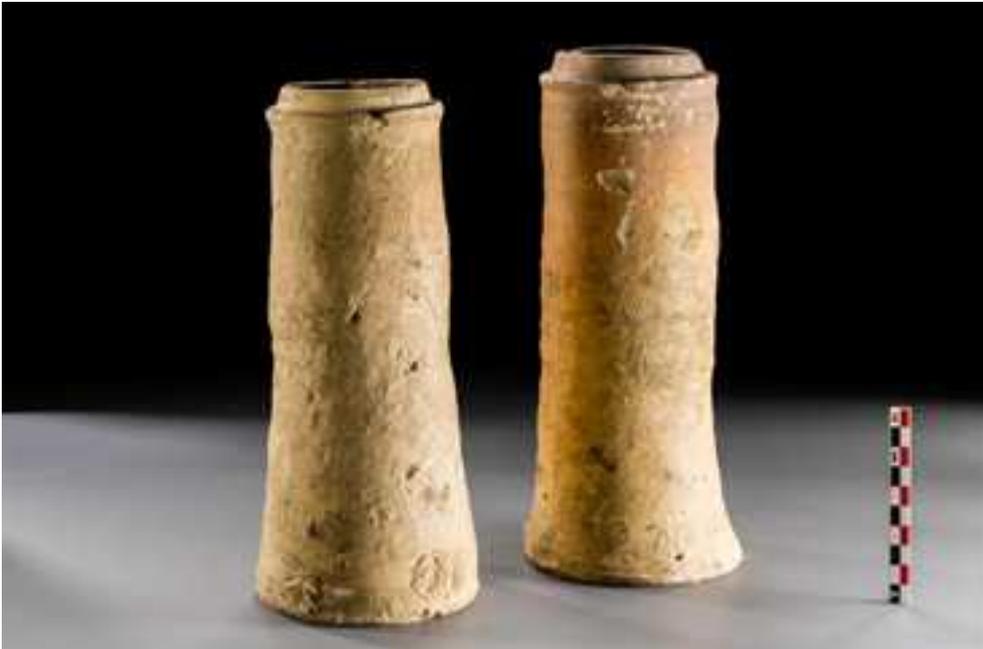
Figure 5.27 Possible Roman terracotta pipes with flange, from the repository of the Roman Baths Museum (source: Thermenmuseum, Ph. Debeerst).

Rain would also fall on the *palaestrae*, which together had an area of approx. 1.250 m². It is important in terms of understanding the drainage to determine what these courtyards looked like. Research has shown that most courtyards in Roman bathhouses across the Roman Empire were paved, with mosaics, *opus spicatum*, stone or marble slabs.³¹² A surface made of compacted earth or grass would have been more comfortable for playing sports. According to Karen Jeneson (and previous curators), the surface was made of compacted soil. Water could have drained away via terracotta pipes. The sections of pipe, which would usually be thrown on a potter's wheel, would be connected and then sealed with mortar to create a watertight drain. The Roman Baths Museum has a number of terracotta pipes in its collection. Most of them are not Roman. Two flanged pipes, which were not fired until completely hard, but were also not made on a potter's wheel, may be Roman, however (Fig. 5.27).

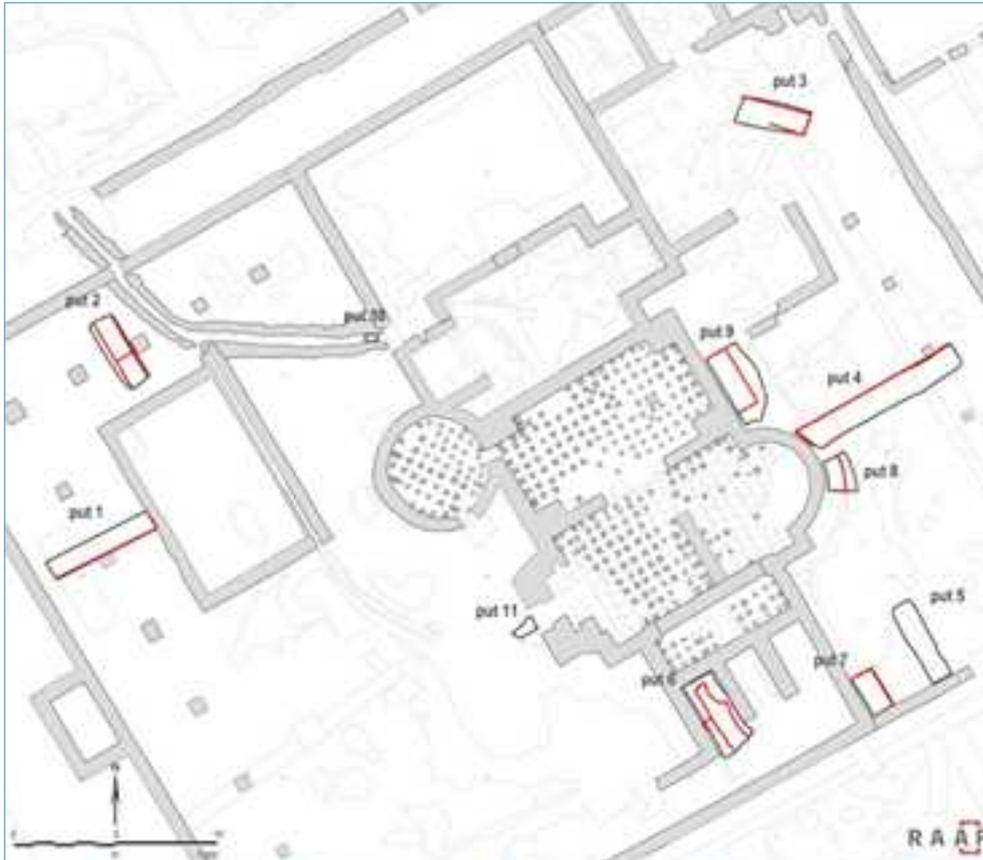
Figure 6.3 The Roman baths with a cleaned-up version of a plan drawing by Van Giffen in light grey showing only foundations (no discoloration) (Van Giffen 1948) and the position of the trenches, with documented sections shown in red (source: RAAP, G. Tichelman).

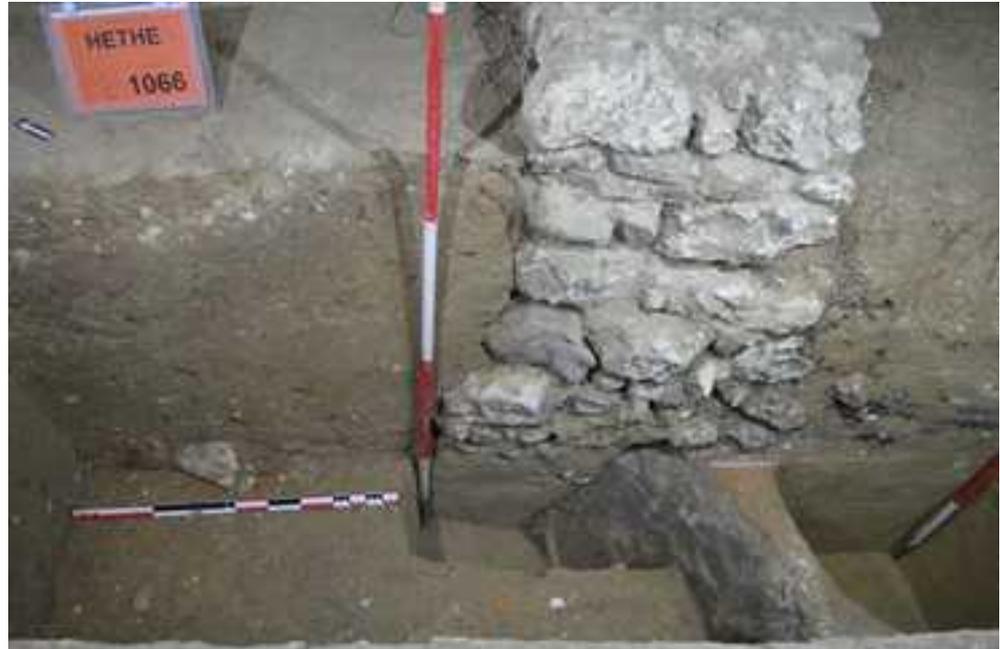
Figure 6.4. Pillar foundation on top of the remains of a lime kiln in trench 2 (source: RAAP, G. Tichelman).

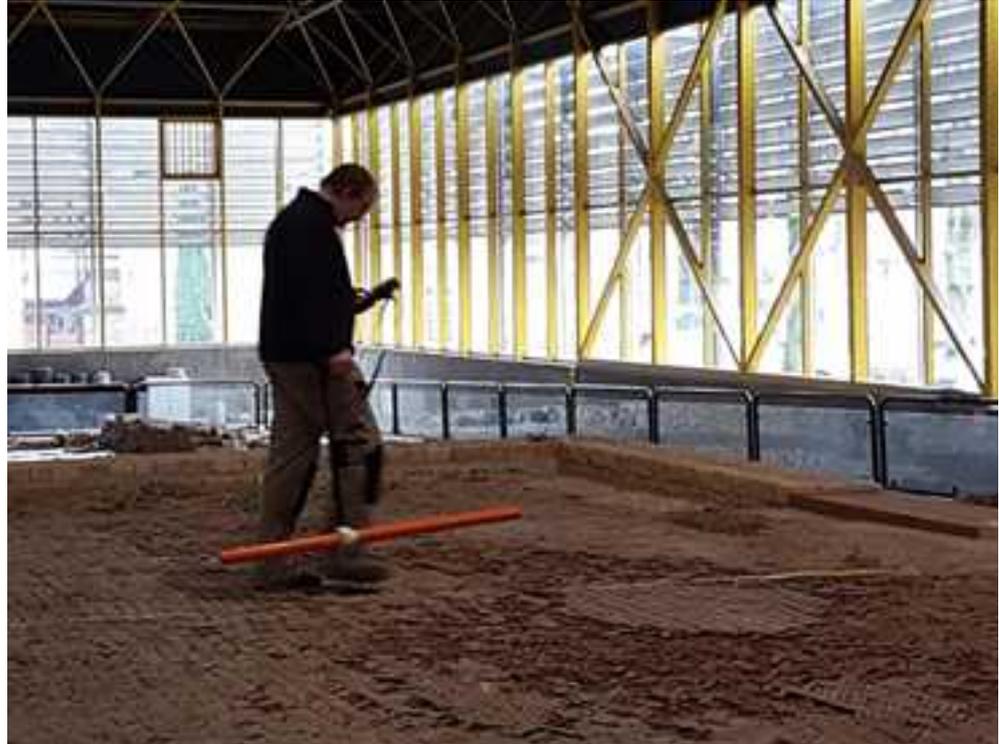
Figure 6.5 Electromagnetic survey being performed at the Roman Baths Museum (source: ArcheoPro, J. Orbons).

A combined approach was taken to the area under investigation. All the flat areas of substantial size were surveyed using ground-penetrating radar and equipment for measuring ground conductivity (EM, Fig. 6.5). Several areas were also investigated using a magnetometer, but the steel frame of the museum building meant that this did not produce any useful results. No resistivity survey was performed, given the dryness of the area under investigation.

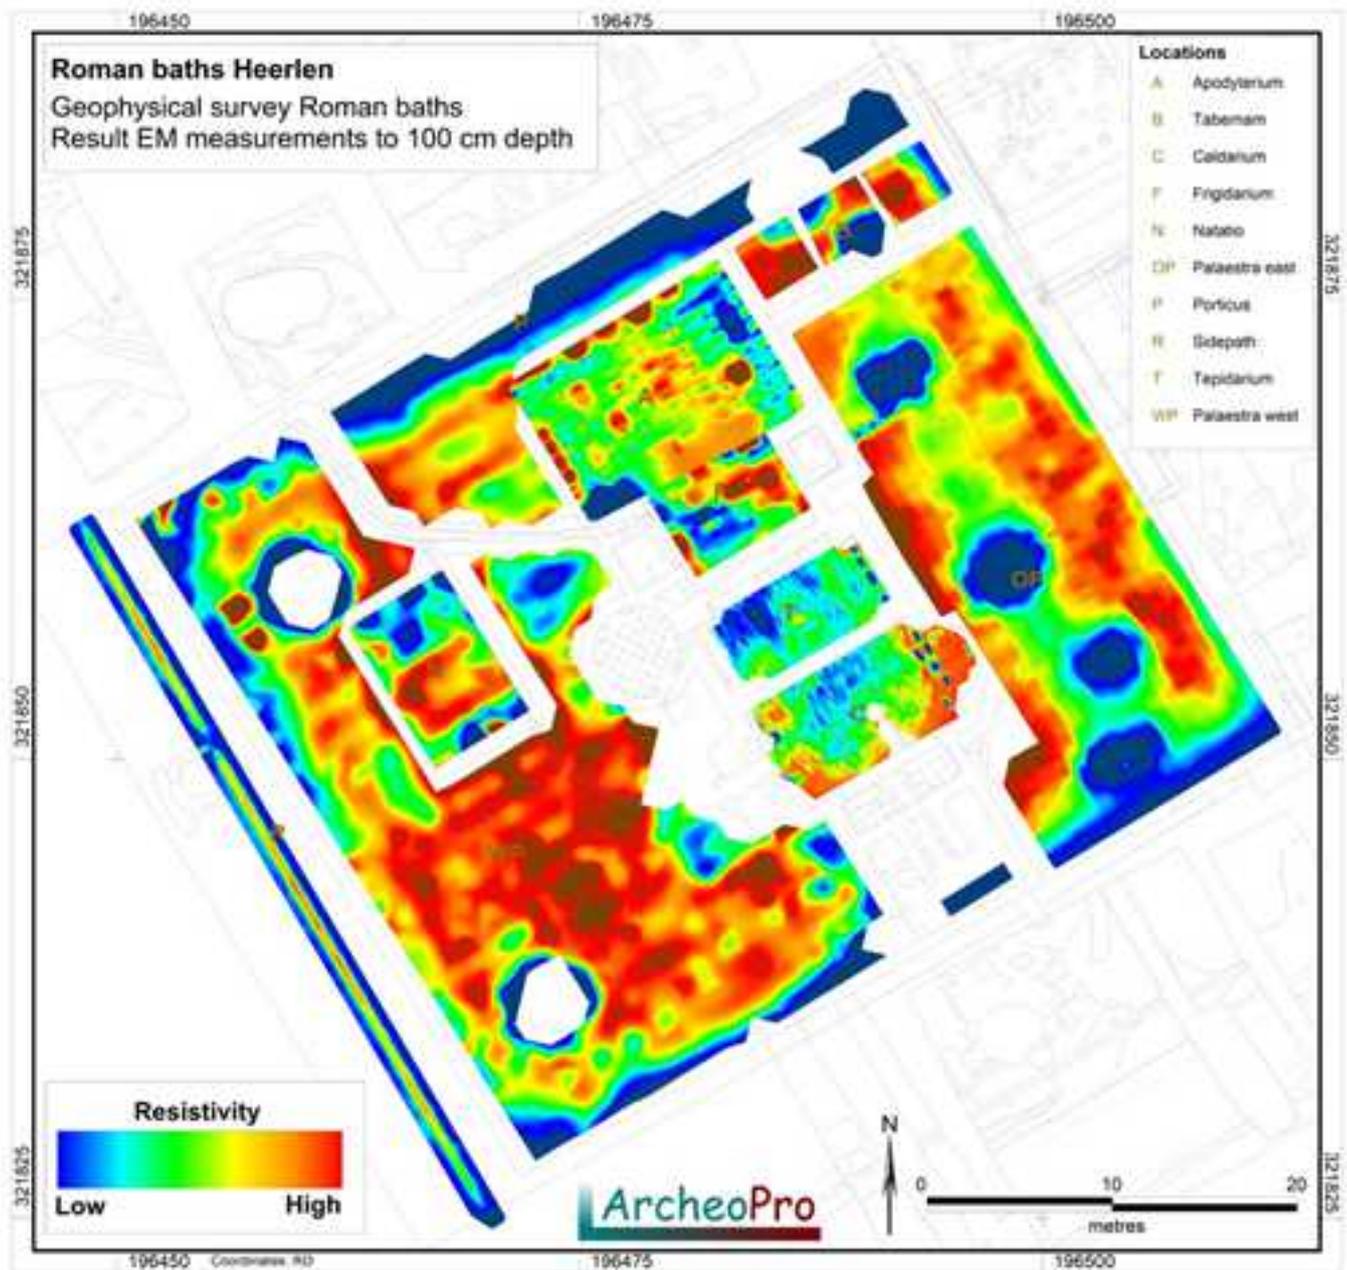
Figure 6.6 The results of the geophysical electromagnetic survey (source: ArcheoPro, J. Orbons).
