Nederlandse
Archeologische
Rapporten

Roman bathing in Coriovallum

The thermae of Heerlen revisited

K. Jeneson and W.K. Vos (eds.)

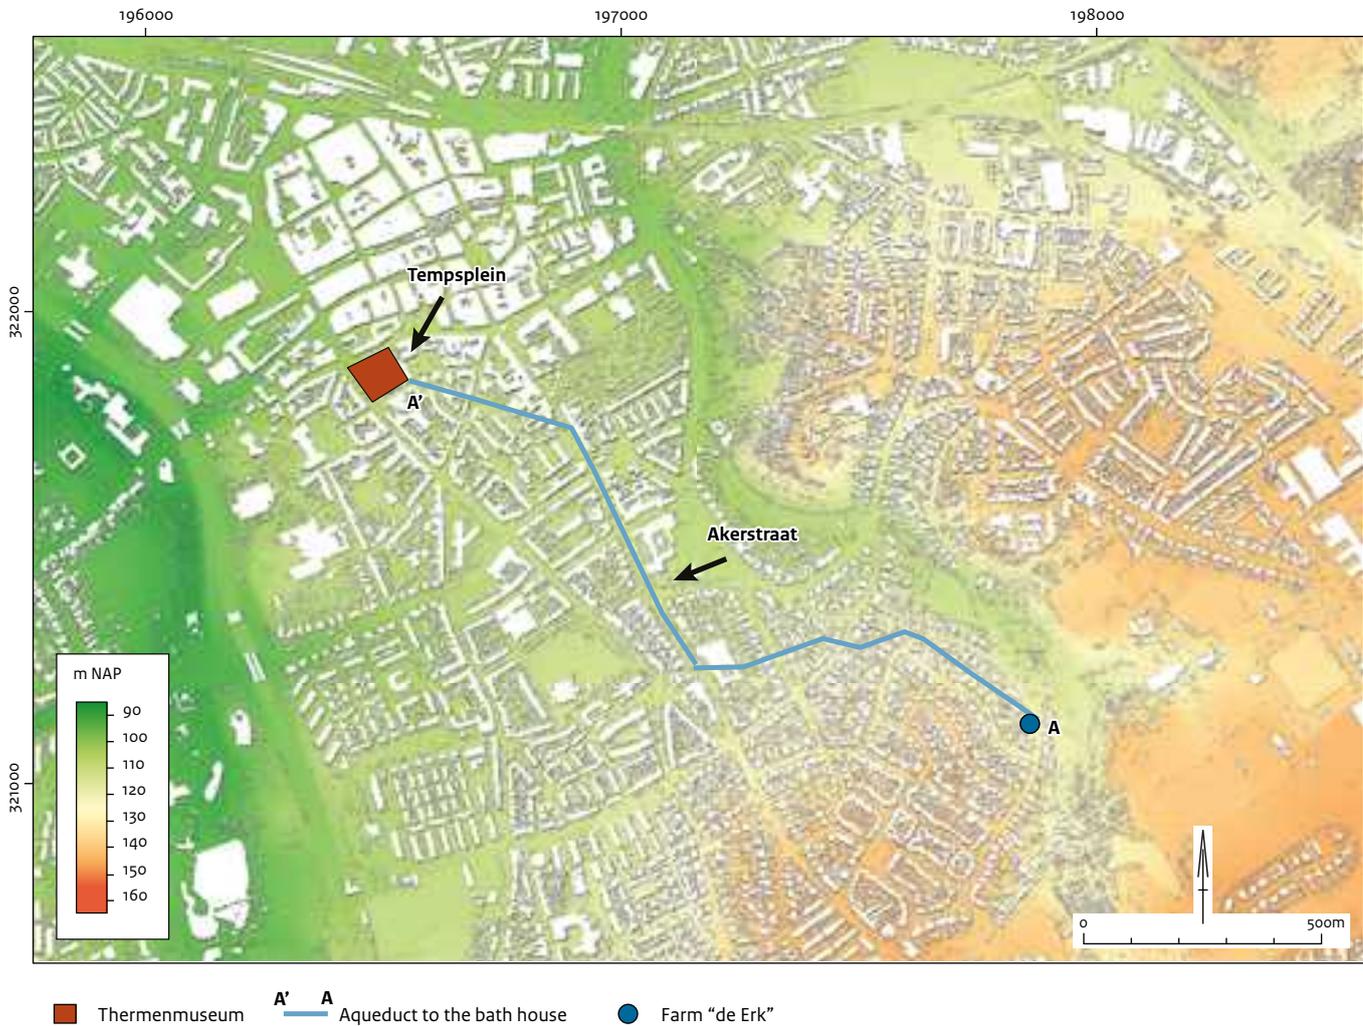
Figure 7.2 The reconstructed position of the proposed water supply to the baths complex on the elevation map, starting at De Erk farm (A) and ending at the Roman baths (A') (source: <http://ahn.arcgisonline.nl/hoogteprofiel>, M. Haars).

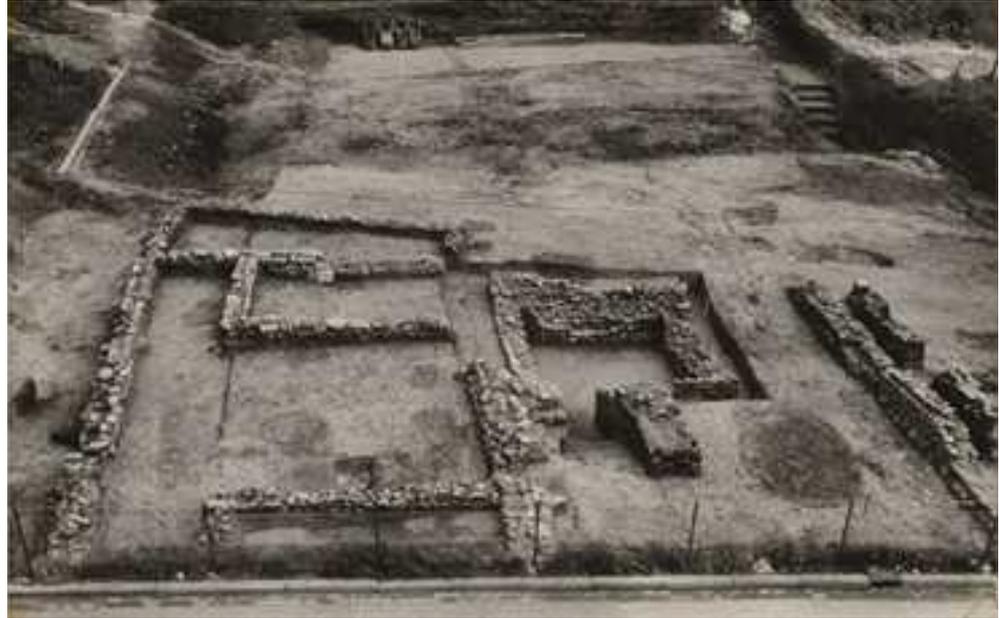
Figure 7.3 Remains of a stone building exposed during the ROB investigation in 1956; view to the south (source: Thermenmuseum archives; original photo by ROB).

Remains of buildings were found to the north and east of the bathhouse. They were built of stone, and standing masonry several dozen centimetres tall was found during the excavations (Fig. 7.3). The contours of several individual houses could be discerned in the remains of the walls, which were 40-50 cm wide. The houses vary in size and possibly also in function. The houses had an elongated shape and were built in consecutive rows, as ‘striphouses’. The most striking features of the

stone structures are, firstly, a deeper part in the centre of the houses that can be interpreted as a cellar and, secondly, the building line along the front of the house plans at an oblique angle to the longitudinal axis.

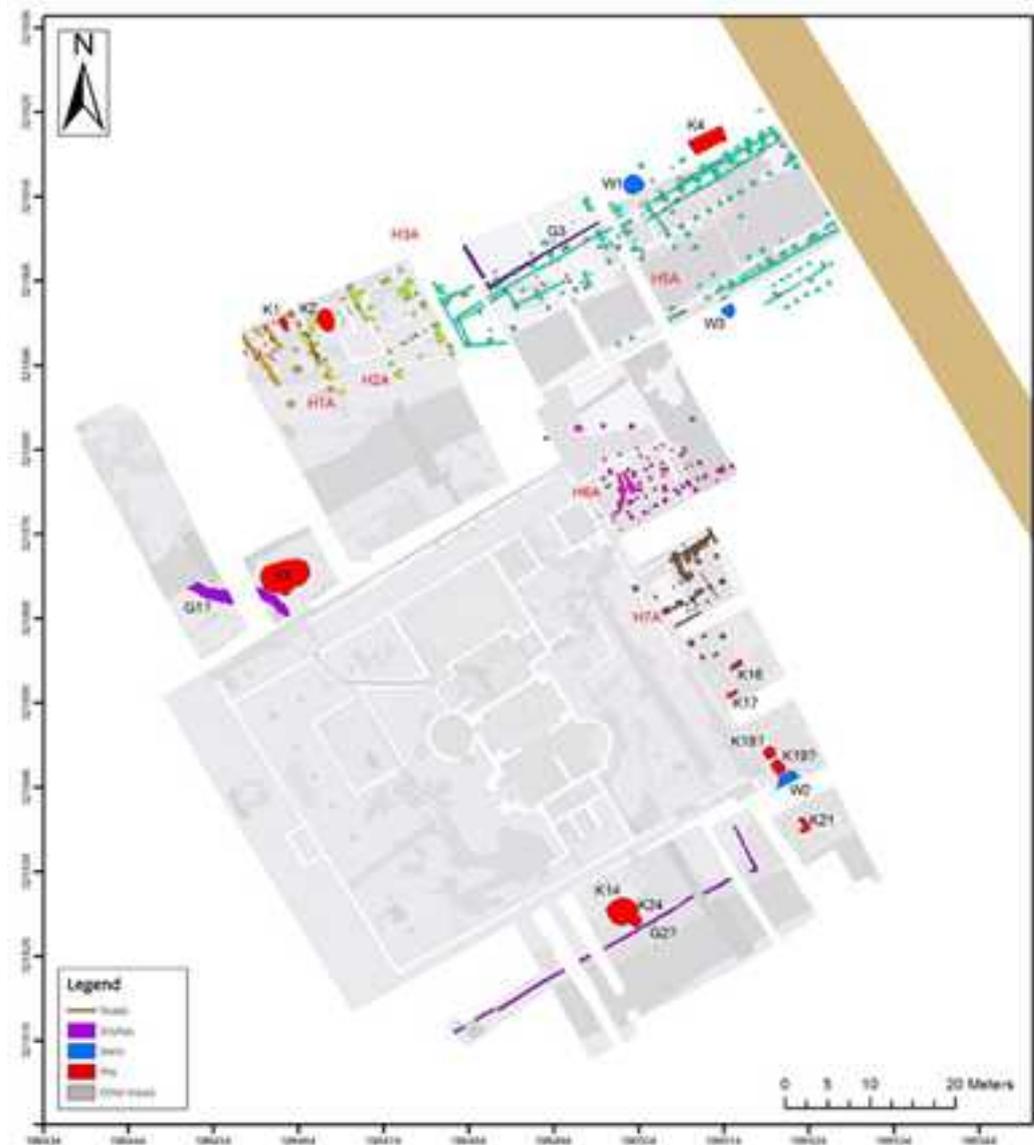
Figure 7.5 Reconstructed occupation phase for the wooden buildings in the vicinity of the baths in the period AD 50-100 (source: W.K. Vos).

The precise ground plans of the wooden buildings are not easy to reconstruct (Fig. 7.5). It is for example unclear whether walls were shared between buildings, or each structure

Other interesting features around the Roman baths site (Fig. 7.5) are a ditch (G2) to the south (perhaps for the water supply or drainage?), a large number of pits containing bone fragments and horn cores (tanning?) to the east, and several roads. One of the roads ran east-west to

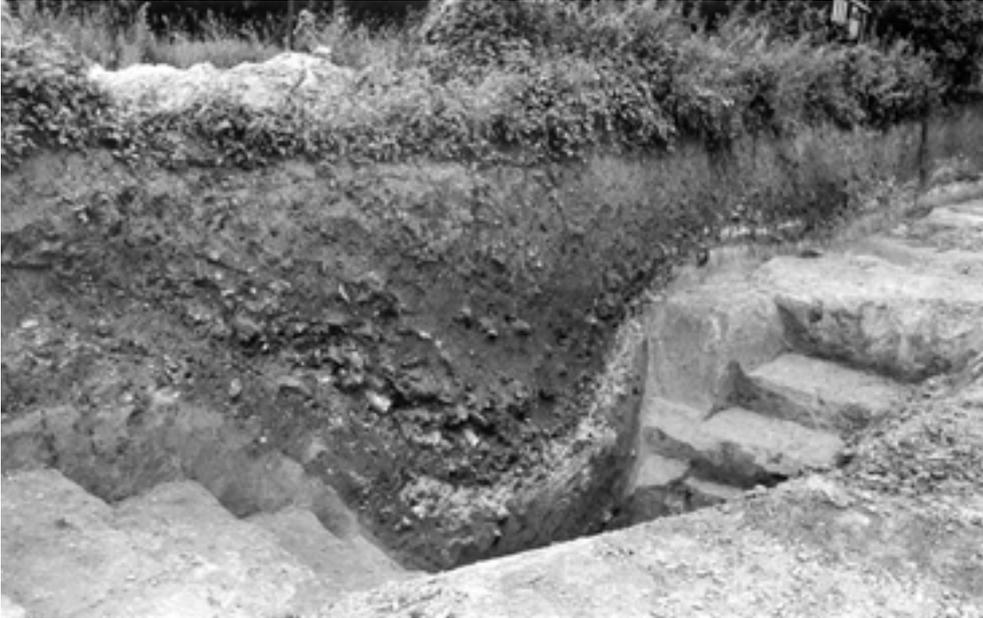
Figure 7.6 Cross-section of the V-shaped ditch drawn during the ROB investigation at the Roman baths site in the 1950s (photo: Thermenmuseum archives; original by ROB).

until a deep V-shaped ditch transected the route (Fig. 7.6). Given its function, and the find material, the ditch can certainly be dated to Late Antiquity, when many open urban settlements developed into more enclosed sites (*burgus*). The enclosure may have been in the form of a wall, as in Maastricht or Tongeren, but nothing has been found in Heerlen to suggest this. There is also no sign of any palisade, but a deep V-shaped ditch could have helped to protect the settlement. The date of the ditch fill suggests it must have been dug sometime in the third or fourth century. We have the impression that the bathhouse, and probably also other structures to the east of the complex, were brought together in some kind of refuge. This was apparently necessary, though it is not entirely certain that the Roman baths would still have been used as such at the time. A small military unit may have been stationed at the site enclosed by the ditches, which measured an area approx. 200 x 60 m. However, no concrete evidence of this unit has been found.

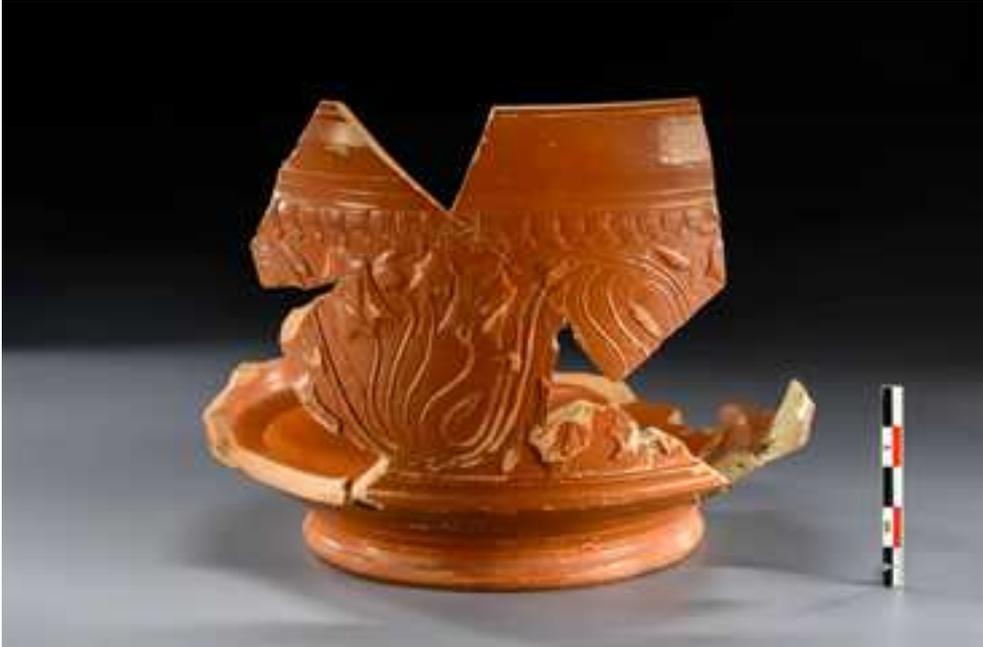
Figure 8.5 Large part of a cylindrical beaker Dragendorff 30 with a scroll ornament dated c. AD 45-70. The bottom right half of a carefully drilled hole can be seen, which served to repair the evidently once broken beaker with a lead or copper-alloy strip (source: Thermenmuseum, Ph. Debeerst).

More than fifty fragments have traces of repair (Fig. 8.5), wear and weathering. These pieces are not evenly distributed over time, but appear to reflect periods when there was a smaller supply of sigillata. Identification marks have been scratched onto 24 pieces: eleven on South Gaulish sigillata and thirteen on Central or East Gaulish ware. Large quantities of such

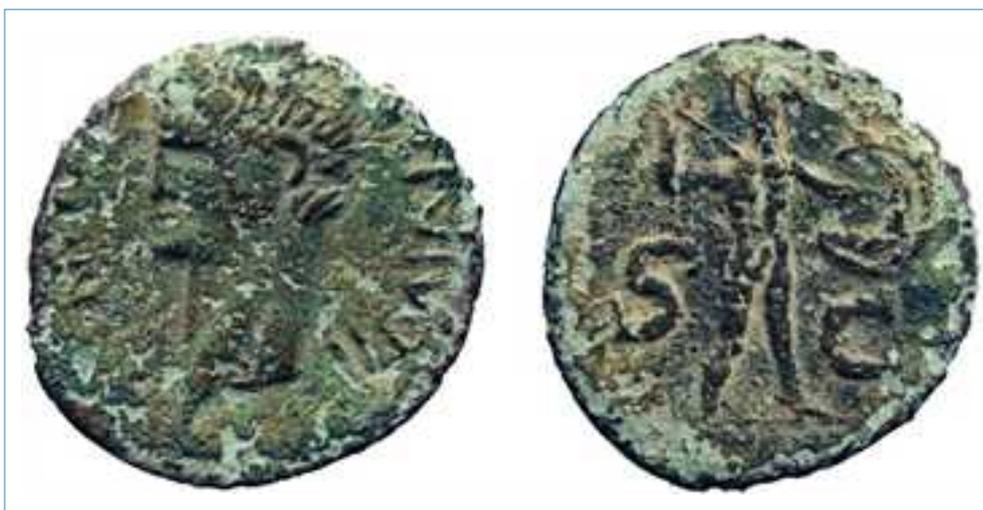
Figure 8.7 Copy of an as (left: obverse; right: reverse) of Claudius (41-54), struck c. AD 41-54 in Gaul (inv.no. 7417, NUMIS 1125787). During the Claudian period there was a lack of low value coins in the western parts of the Roman Empire. This problem was solved by using locally produced copies alongside official Roman coins (bronze; 4.67 g; 24.9 mm) (source: P.A.M. Beliën).

that a relatively large number of coins from the Claudian period (AD 14-68) have been found, which is probably related to the construction or rebuilding of the building housing the baths (Fig. 8.7). A considerable number of coins were lost at the Roman baths site up to approximately AD 170, which suggests undiminished and continuous activity there. After this the northwest of the Roman Empire experienced more difficult times in economic terms, and barely any coins from this period have been found at the site. The local economy recovered at the time of the Gallic Empire (AD 260-274), and the coin numbers rise spectacularly. We must however consider the fact that there was not only an economic recovery, there were also changes in the Roman coin system that meant large numbers of low value coins came into circulation. Coin loss continued uninterrupted from AD 260 to the latest Roman coins, that give the coin assemblage at the Roman baths site a *terminus post quem* of AD 393 (Fig. 8.8). Since the supply of coins to our region ceased shortly thereafter, the coin finds do not tell us how long the site continued to be occupied.

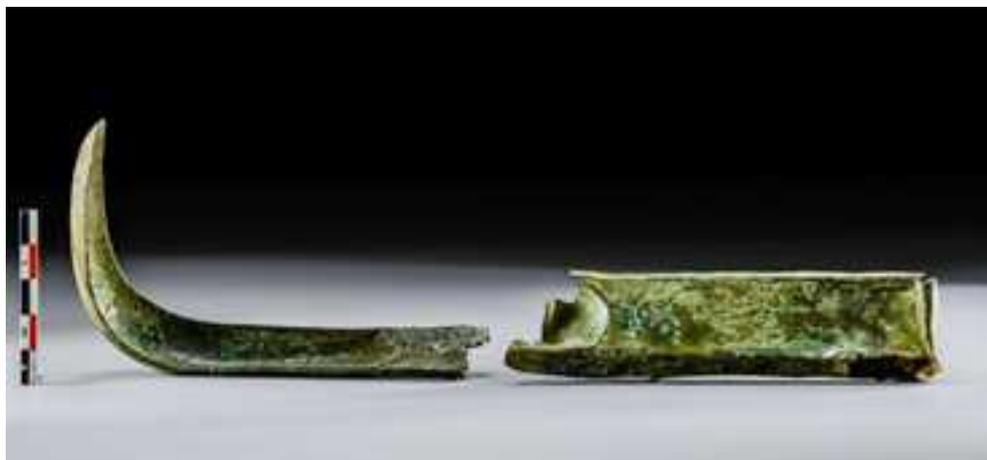
Figure 8.12 Bronze scraper (strigil) made from several parts (scraper, shank, handle with lead filling). On the handle are two small tabula ansata-shaped stamps, one containing the name of the manufacturer: T A P P I (= T(itus) Appius) and the other depicting the staff (caduceus) of the god Mercury (source: Thermenmuseum, Ph. Debeerst).

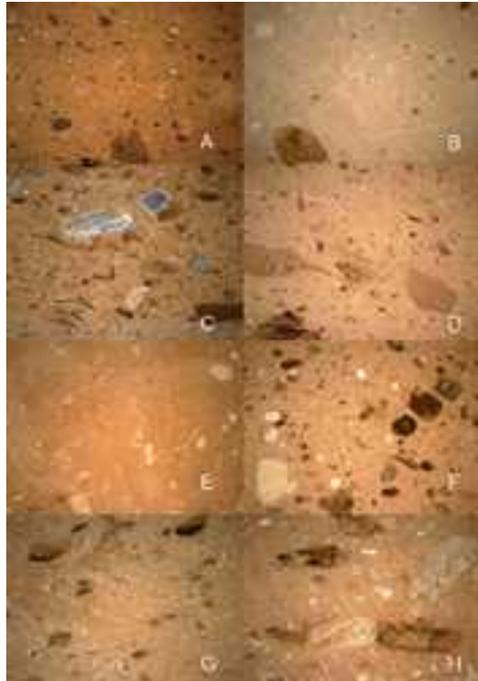
Figure 8.18 From left to right, and from top to bottom: fabric group A, B, C, D, E, F, G and H. (source: T. Vanderhoeven, E.A.K. Kars & B.J.H. van Os, this volume Appendix XV, 21-22).

The fabric analysis found 25 fabrics that were macroscopically categorised into eight different groups (Fig. 8.18). These fabric groups are made of three different types of clay. Group A is most probably made from the Reuver Base Layer (Waalre Formation). Group B probably comes from the Brunssum Base Layer (Kieseloolite Formation). The third group encompasses the

A large quantity of ceramic building material was also used for the construction of the bathhouse. It was made using clay from several locations within a 30 km radius of Coriovallum (Fig. 8.18). The absence of stamps on roof tiles in this phase is striking. The many different fabrics identified in the material *in situ* suggest that ceramic floor, wall and roof tiles were made in several locations and used in combination for the construction of the bathhouse.

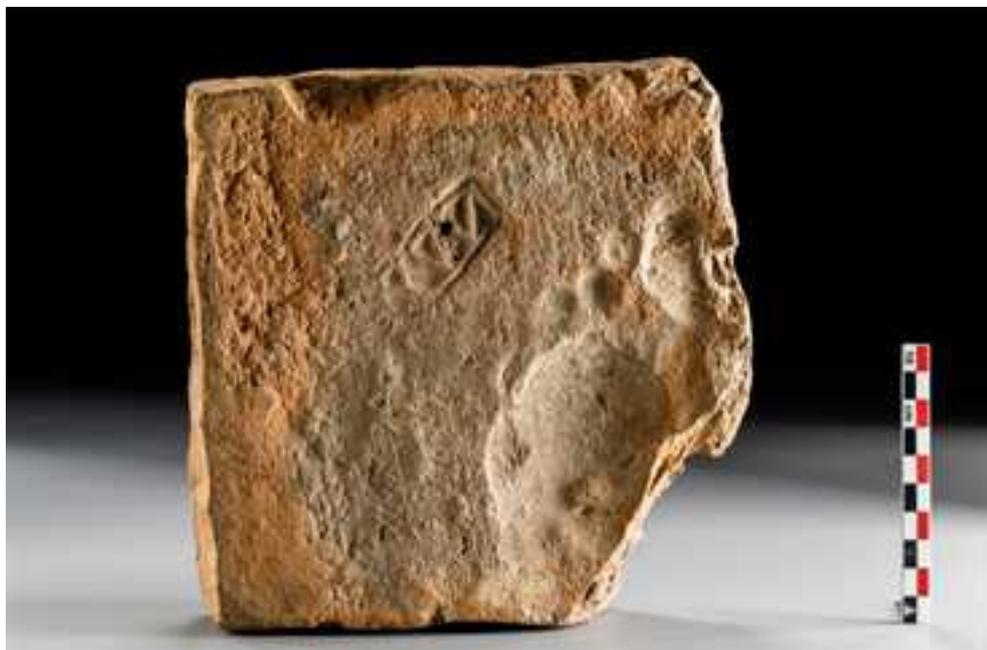
Figure 8.20 *Bessalis* with partial stamp [L.XX]XVV and imprint of a human left foot (source: Thermenmuseum, Ph. Debeerst).

(CTEC, MHF and L.XXXVV) (Fig. 8.20). This is striking. It is generally assumed that the stamp refers to the manufacturer. It is possible that different manufacturers used the same source of clay. This does not however explain why the tempering of the fabric, with its specific inclusions, hardness, finishing and surface treatment are so similar. The hypothesis that a stamp refers to a manufacturer is thus thrown into question. It could be that the stamp referred not to the manufacturer, but to the name of the merchant, builder or client. The presence of different stamps on the same fabric suggests that these are not from a small local

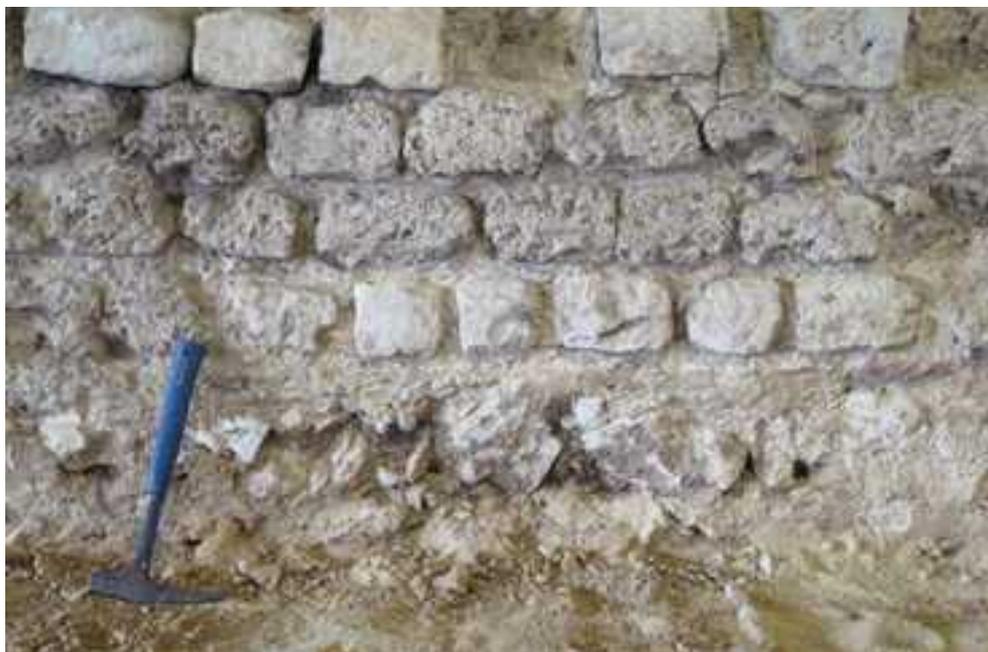
Figure 8.21 Piece of ashlar from the southern wall of the bathhouse, consisting of cut blocks of Kunrade stone (white) and sawn blocks of porous calcareous tufa (beige) over an inner wall of rough blocks of Kunrade stone (source: R. Dreesen).

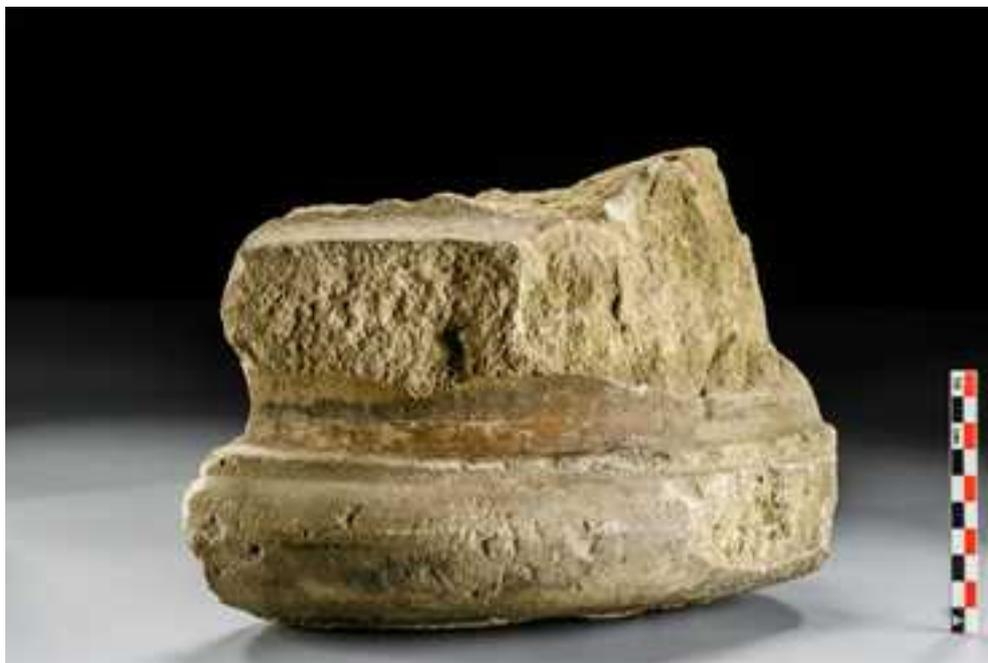
Figure 8.22 Fragment of column made of Norroy limestone with traces of brownish-red ochre paint (bathhouse *lapidarium*) (source: Thermenmuseum, Ph. Debeerst).

Both local and regional white-coloured stones were used for monumental parts, such as columns and capitals, and for decorative architectonic elements or inscriptions, e.g. in the *porticus* and in the *palaestrae* of the bathhouse. Besides the Kunrade stone described above, we also identified Nivelstein sandstone, an ash-white quartzarenitic sandstone quarried in the vicinity of Heerlen, and Norroy limestone, a creamy-white pseudo-oolitic limestone imported from Lorraine, Northern France (Fig. 8.22). The latter two stone types might well have

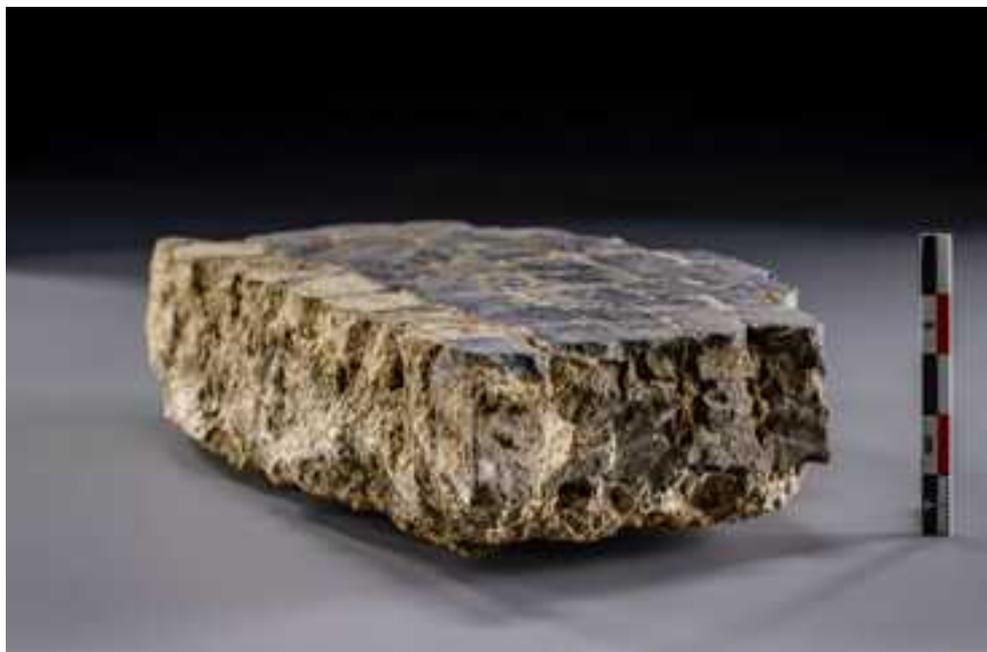
Figure 8.23 Fragments of the black-and-white mosaic floors of the bathhouse, consisting of white Kundrade stone and black marble from Theux (source: Thermenmuseum, Ph. Debeerst).

pavement in the *apodyterium* and *frigidarium* are made of black marble from Theux. The white *tesserae* in the same black-and-white floor mosaics are made of the local Kundrade limestone (Fig. 8.23). The re-use of large blocks of Norroy limestone in more recent building phases, such as in the drainage channels (*cloaca*) of the bathhouse, is also quite remarkable.

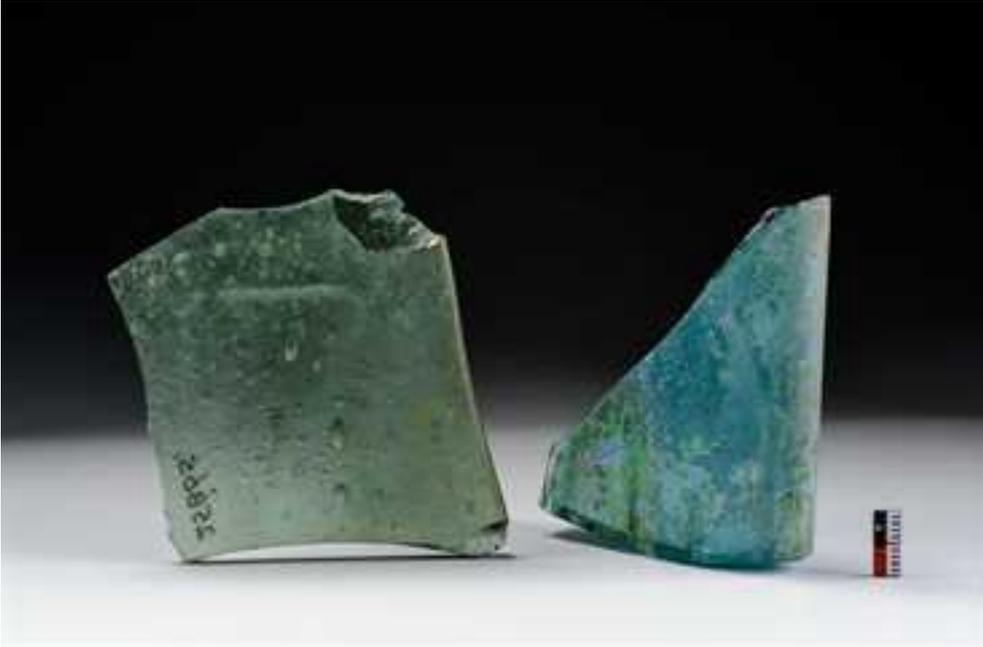
Figure 8.24 Two fragments of window glass from the Thermenterrein site (source: Thermenmuseum, Ph. Debeerst).

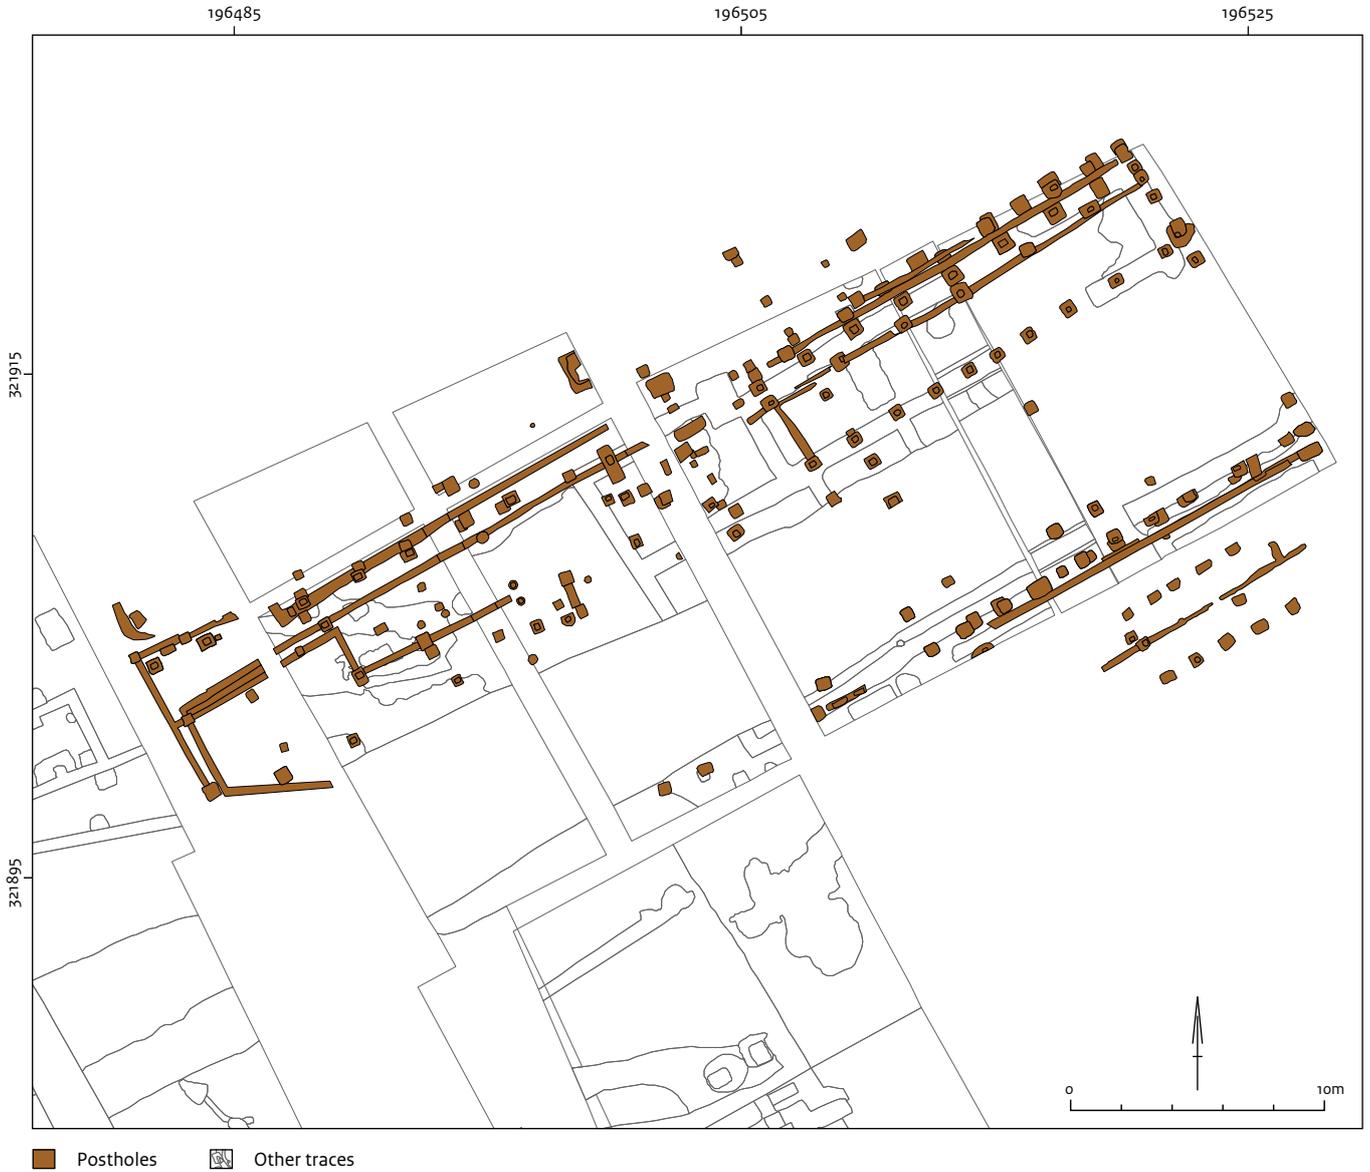
Figure 9.7 The very first building on the Thermenterrein in the Augustan phase (source: W.K. Vos/M. Haars).

There was occupation at the Thermenterrein site from the early Augustan era, although we do not know the precise nature of it. Traces of an elongated building oriented southwest-northeast have been discerned (H5A; Fig. 9.7). It might have been part of a larger complex

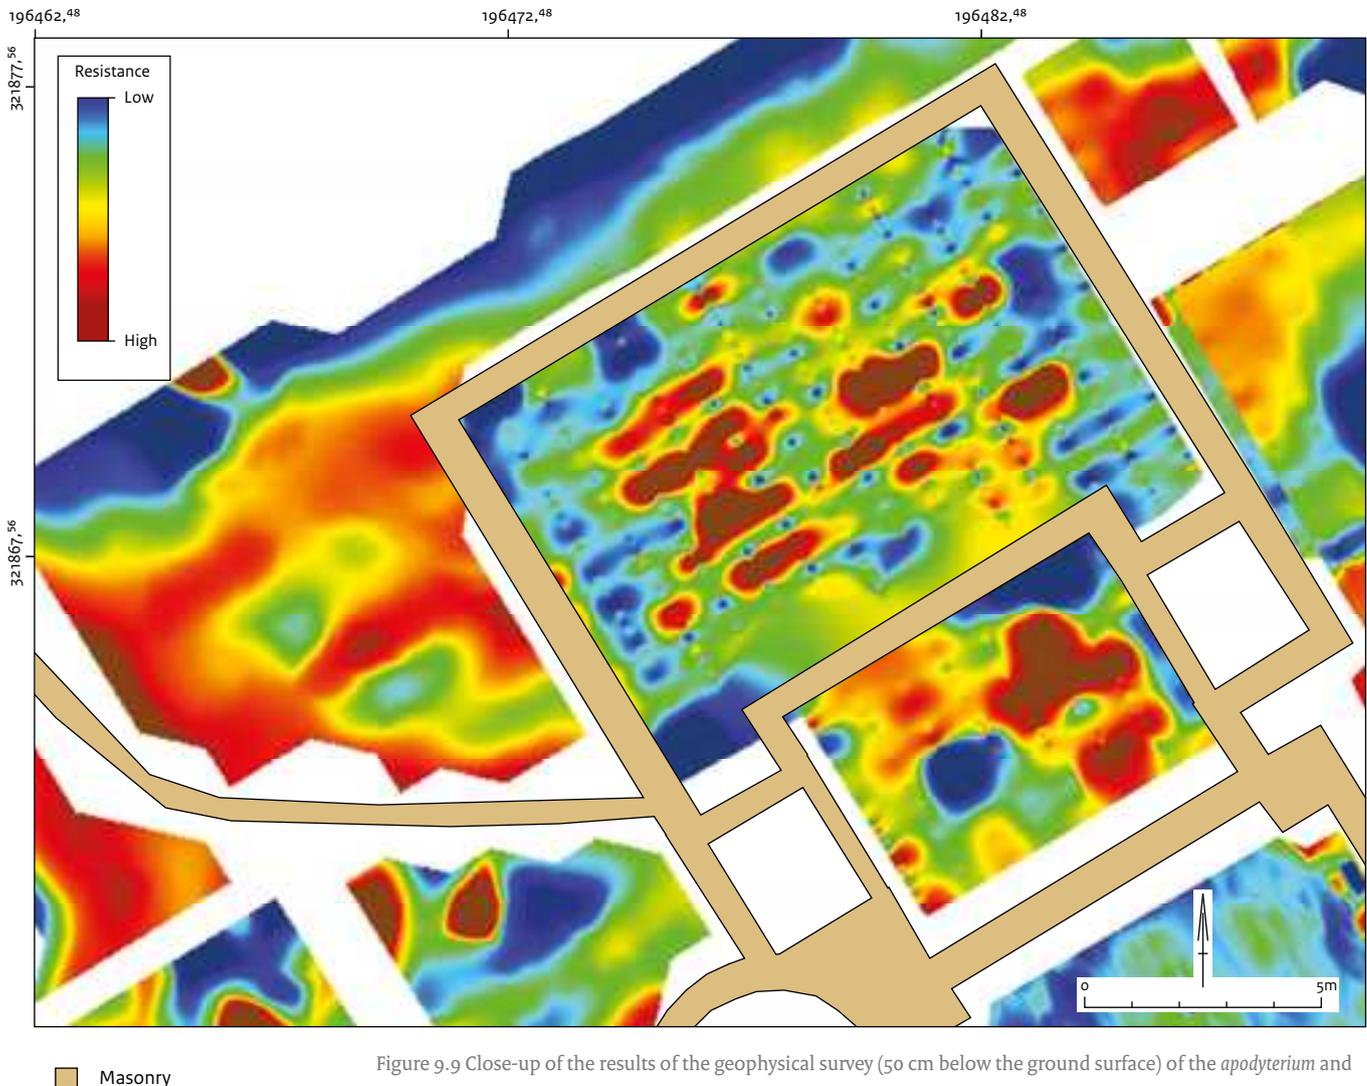
Figure 9.9 Close-up of the results of the geophysical survey (50 cm below the ground surface) of the *apodyterium* and the *frigidarium* (Source: J. Orbons, this volume Section 6.1 and Appendix V/K. Jeneson/M. Haars).

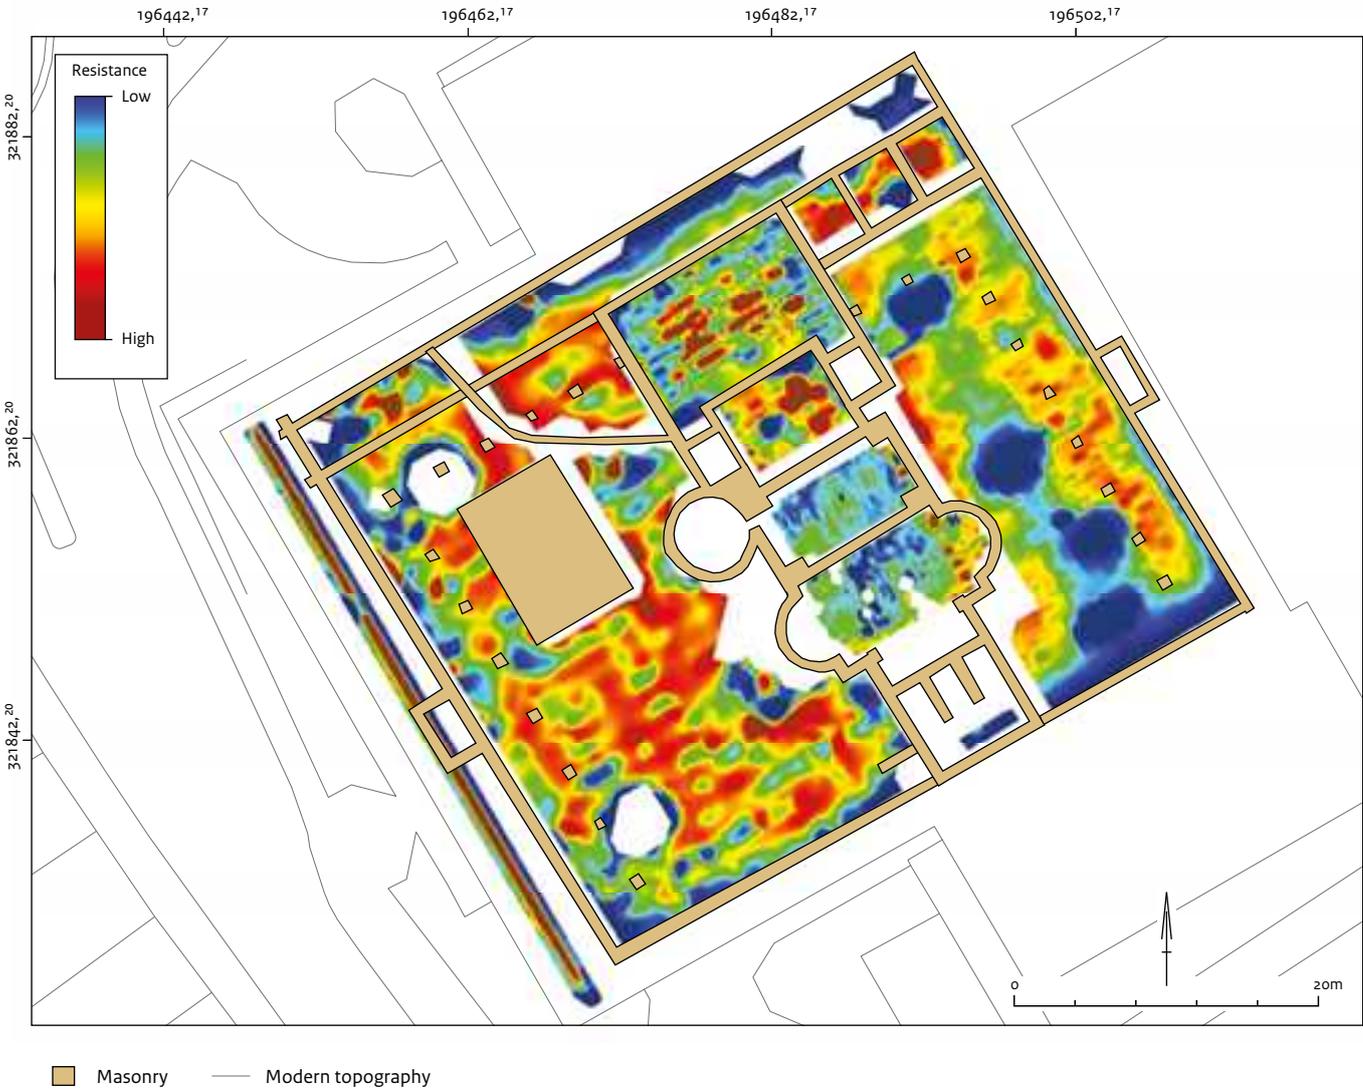
Figure 9.11 Results of the geophysical survey (50 cm below the ground surface) showing the rectangular phenomenon (in orange-red) in the west *palaestra*. (Source: J. Orbons, this volume Section 6.1 and Appendix V/K. Jeneson/M. Haars).

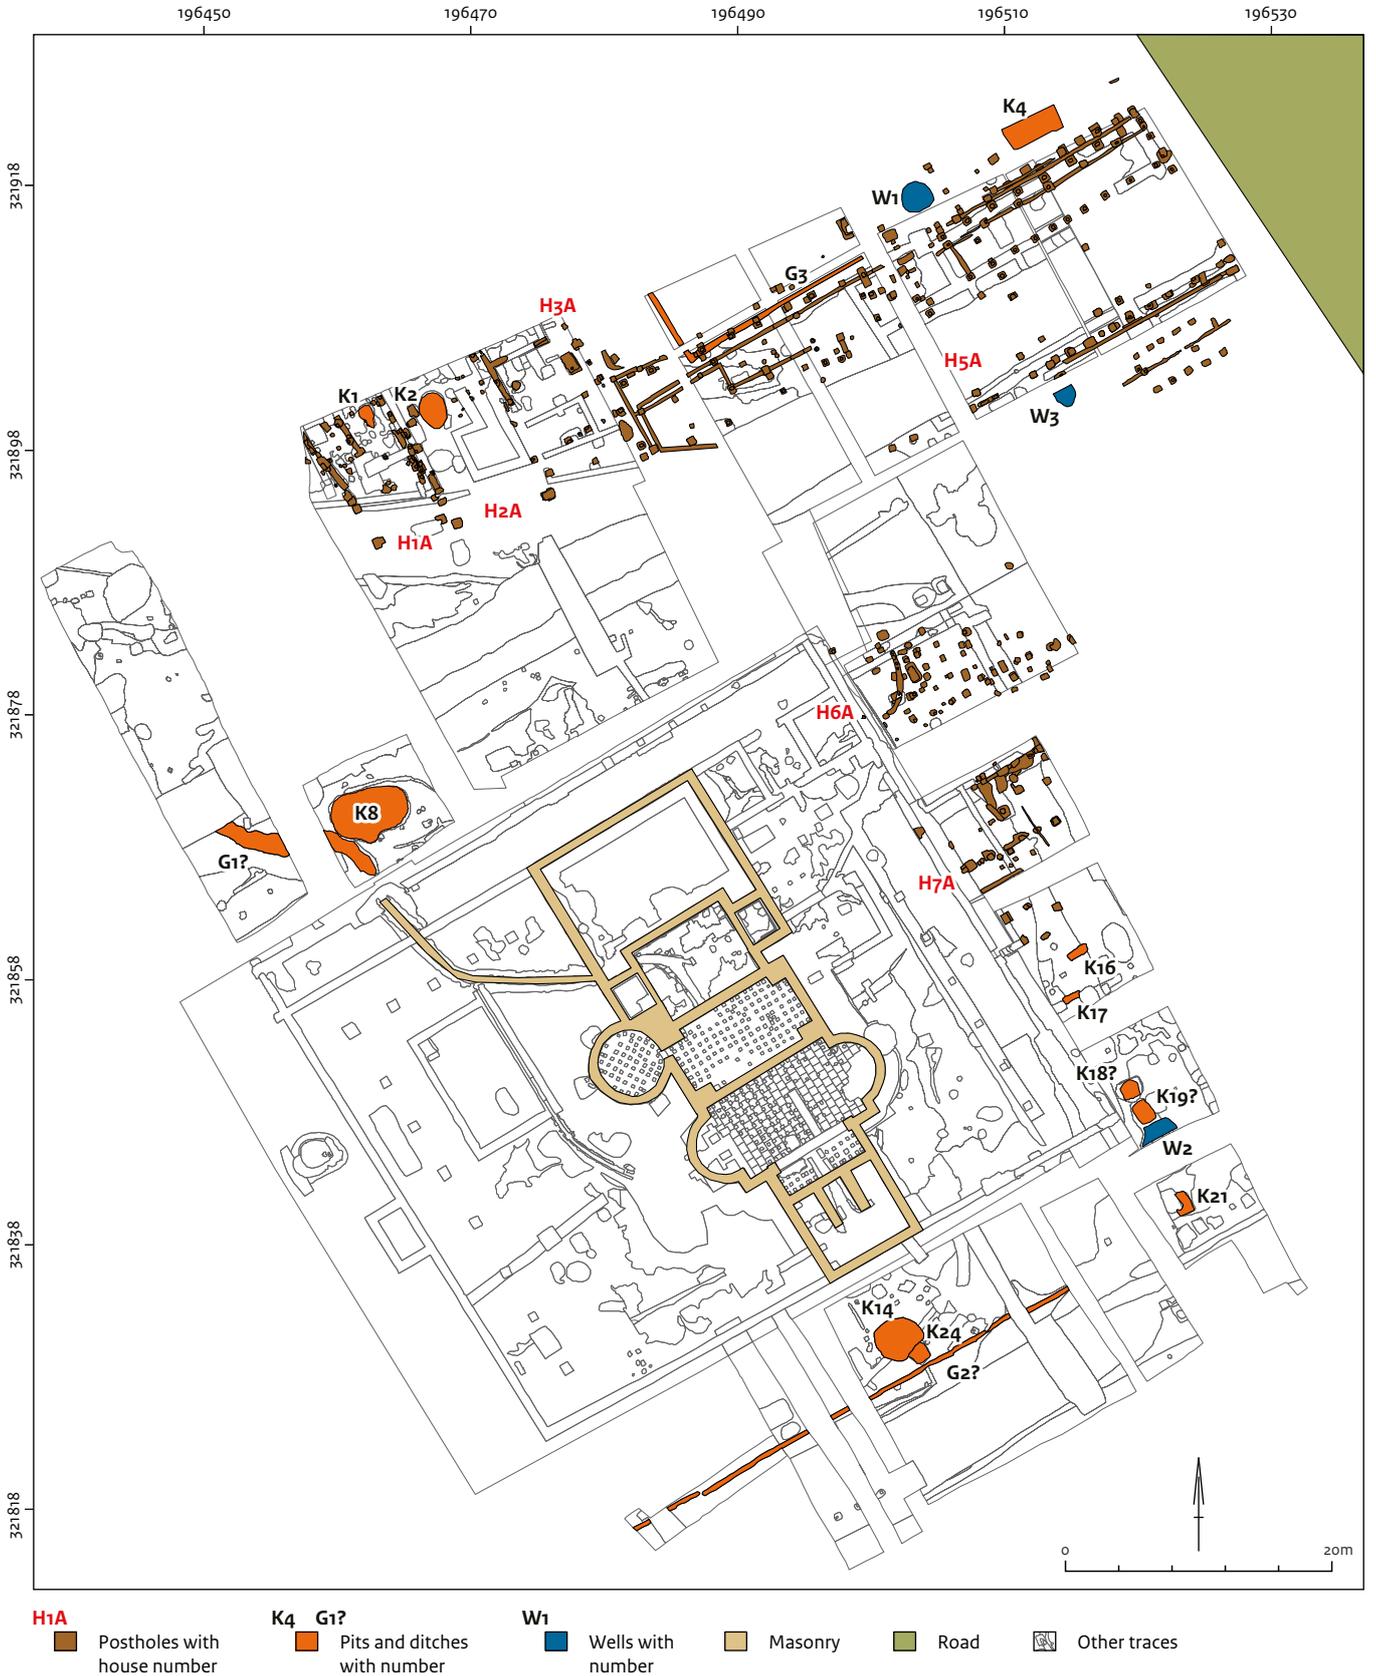
Figure 9.12 Map of the Thermenterrein site from AD 65-73 onwards (source: W.K. Vos, this volume Section 7.2 and Appendix VII/M. Haars).

consider is when these structures disappeared. Though we do not intend to address this question at this juncture, we should recall the posthole cluster of a building immediately to the north of the baths site (Fig 9.12).³⁸³ If it was contemporaneous with the bathhouse, this building would have stood right in front of the entrance to the *apodyterium*. This is unlikely, so this building must have been demolished for a bathhouse to be built on the site. Unfortunately, we are unable to assess and verify these hypotheses yet, and all we can do is present them as such. But it is clear that there is something going on in the subsurface just to the west of the site where the core building of the bathhouse stood.

spolia, as they are known, were found near the bathhouse (Fig. 9.12). The reference to Tiberius Claudius could mean that the bathhouse was built in his honour, but was not paid for by him, which might indicate that his successor Nero gave the orders for it to be built.³⁸⁴ However, the name might also refer to an unknown governor or legionary commander. Nor can we rule out the possibility that the inscription originally came from another building in Coriovallum.

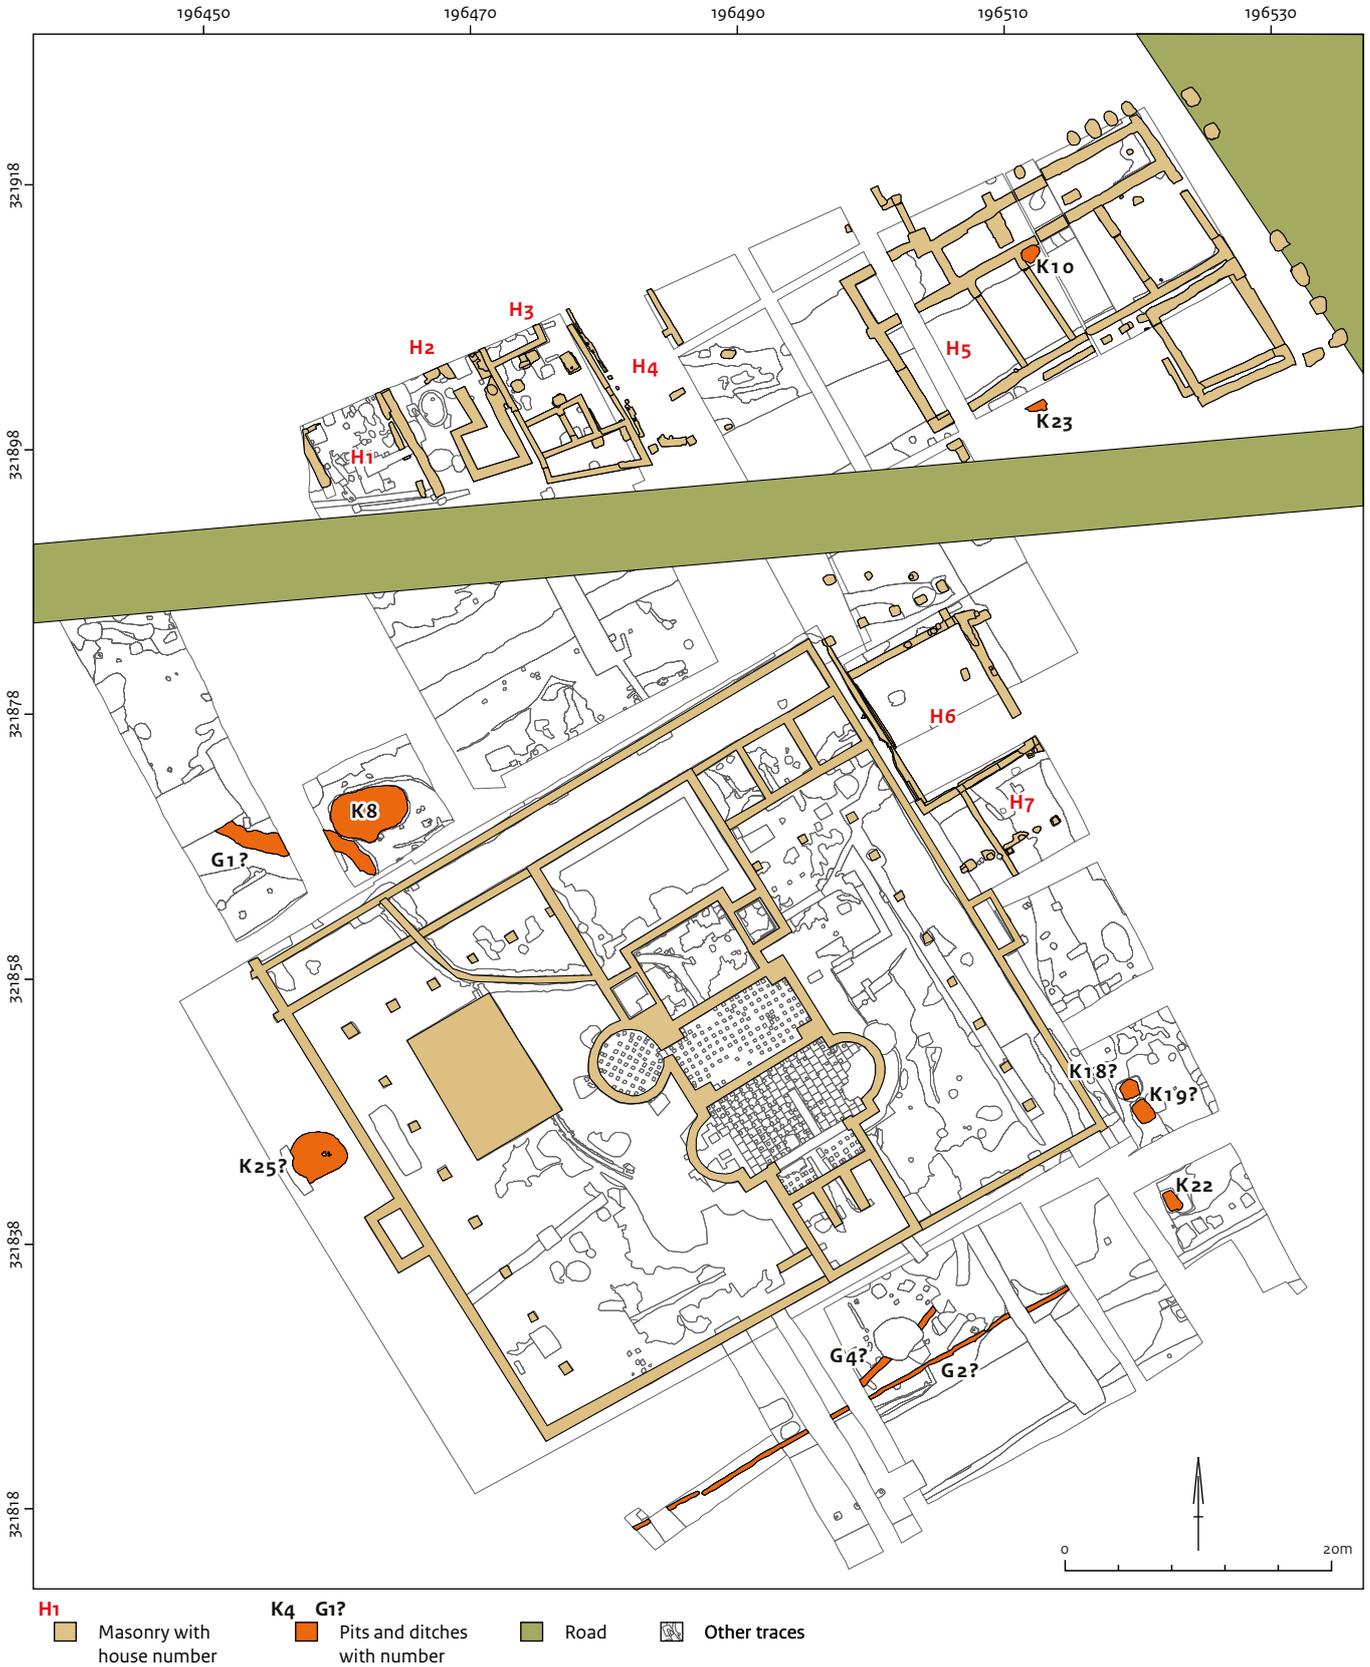
Figure 9.14 The bathhouse and its surroundings in phase 3 (Source: W.K. Vos, this volume Section 7.2 and Appendix VII/M. Haars).

Whether it was a consequence of the formation of the province in AD 84-85, or the founding of Colonia Ulpia Traiana roughly a decade later, the expansion of the complex in the late first century is an established fact. The archaeology shows not only that developments occurred in the bathhouse itself, but also that urban structures outside the complex were radically altered. Roads were rerouted, a public square was created, the entire area was systematically raised – probably after first being levelled – and timber-framed houses (which may have been vulnerable) were replaced by more robust and durable stone buildings (Fig. 9.14).

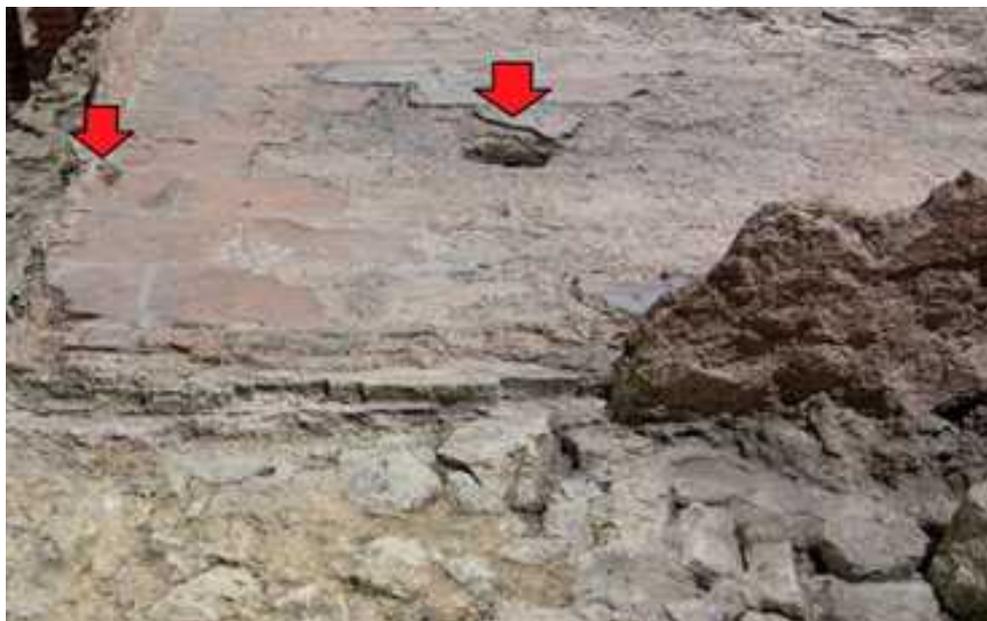
Figure 9.16 The possible entrance between the *frigidarium* and room #14. The remains of the removed raised cordon and the wear on the tiles in the *frigidarium* can clearly be seen. the arrows indicate the secondary holes made in the floor, which were presumably related to the new entrance (source: Thermenmuseum, A. Steen).

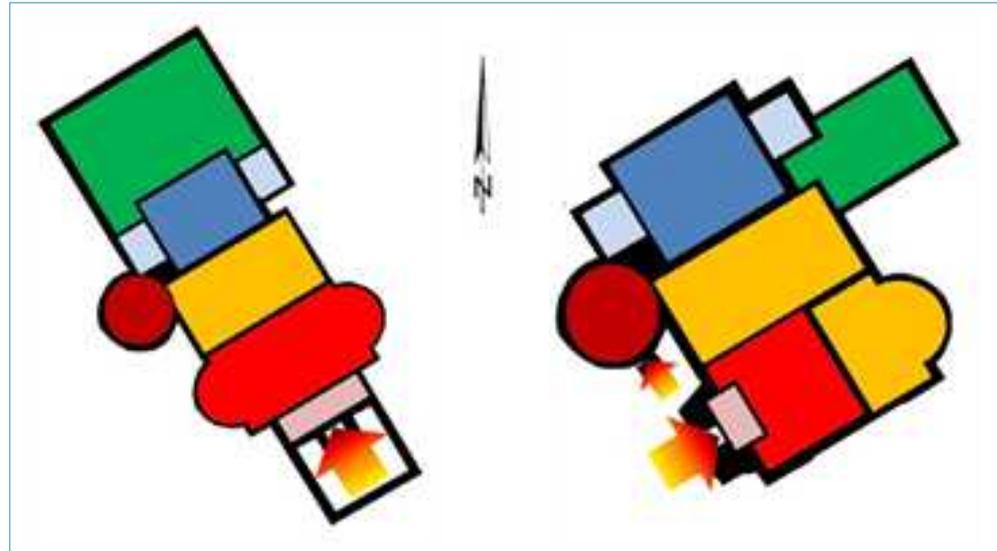
Figure 9.17 On the left, the situation before the major alterations, on the right the situation after the alterations. Red = *caldarium*; orange = *tepidarium*; blue = *frigidarium*; dark red = *laconicum*; green = *apodyterium*; light blue = cold water bath; pink = hot water bath; red and yellow arrow = *praeefurnium*. (source: K. Jeneson).
