Nederlandse
Archeologische
Rapporten

Roman bathing in Coriovallum

The thermae of Heerlen revisited

K. Jeneson and W.K. Vos (eds.)

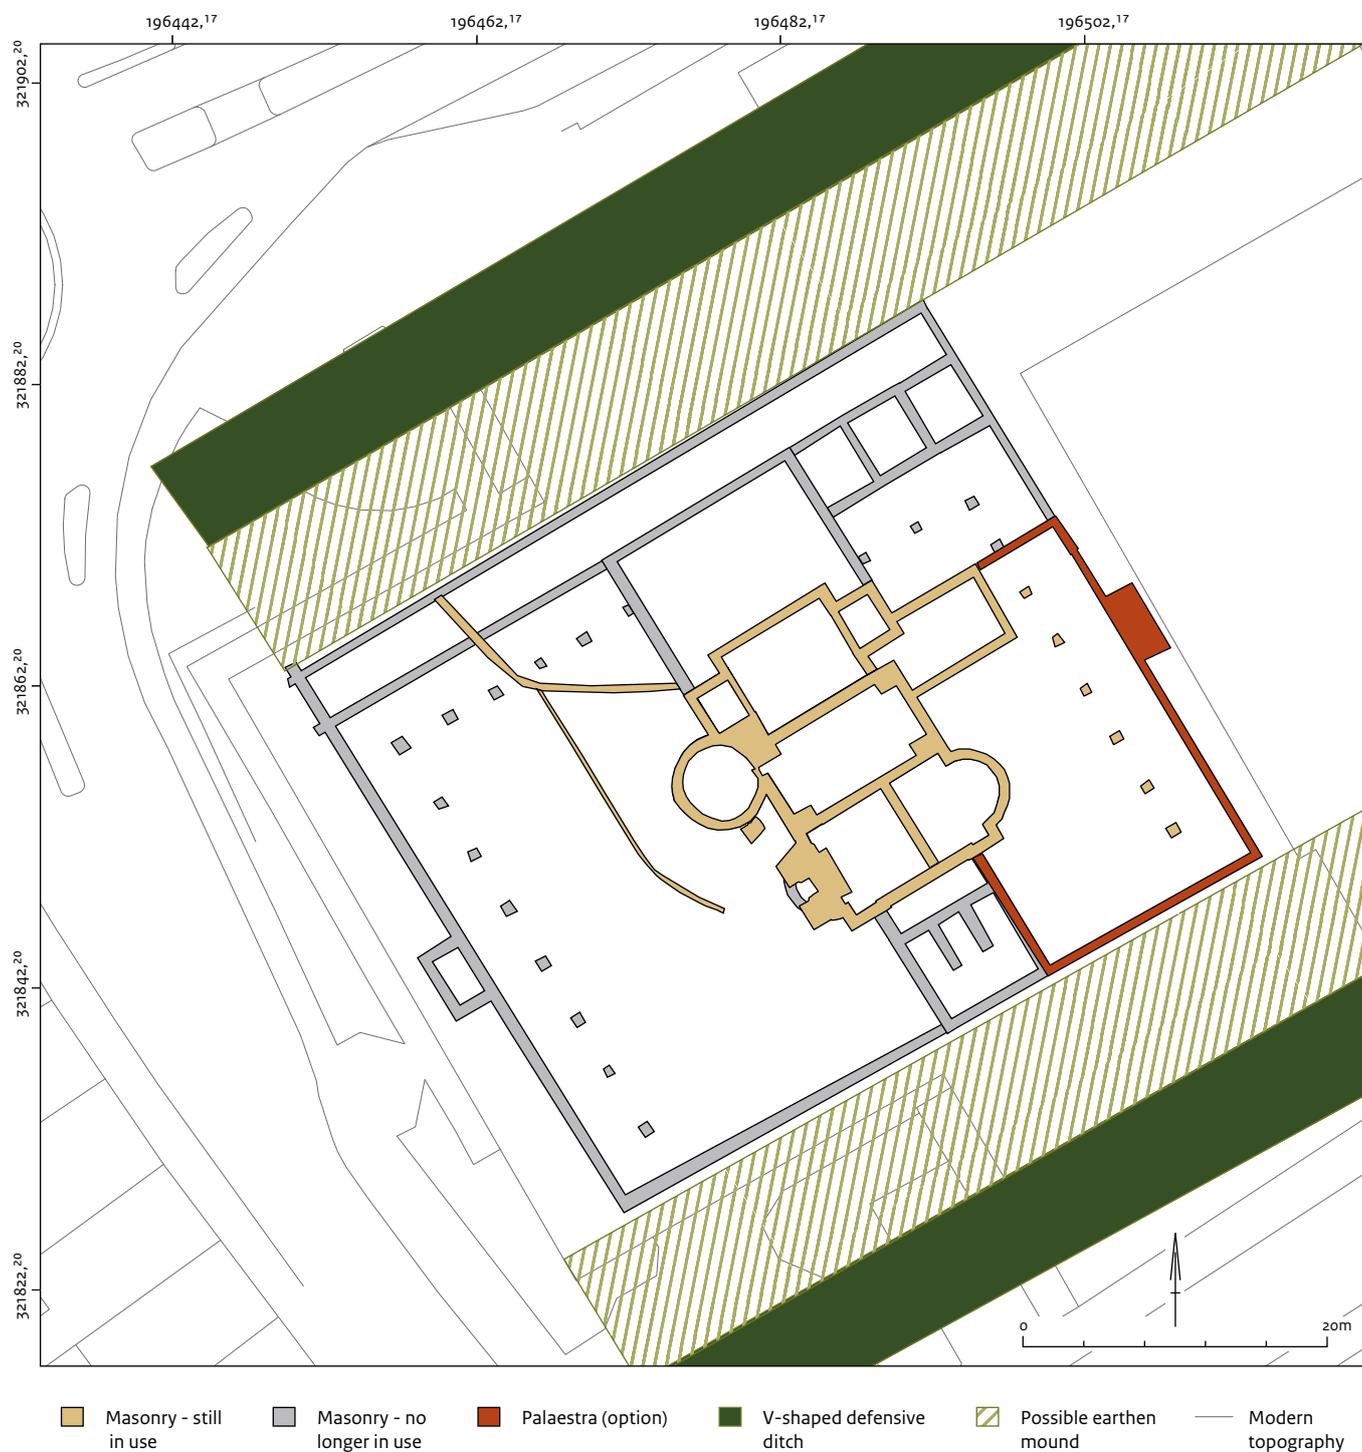
Figure 9.18 Reconstruction of the bathhouse in phase 4 showing, to the north and south, the ditch and the space between the wall and the ditch. The possible outdoor area at the bathhouse is reconstructed in red (showing part of the portico with eight footings) (source: K. Jeneson/M. Haars).

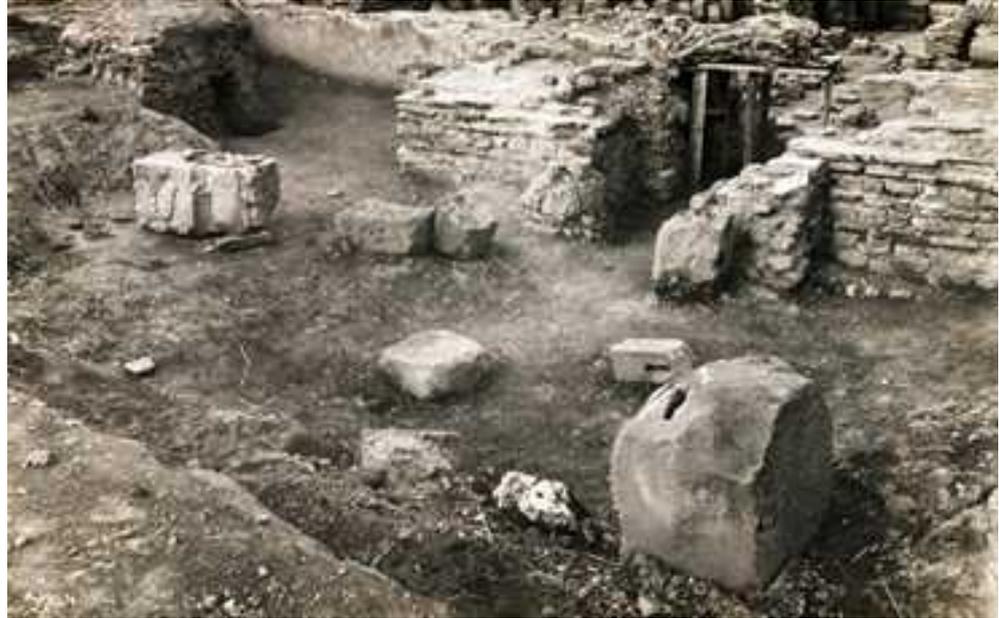
Figure 9.19 *Praefurnium* II during the excavation in 1940, with several spolia and on the right the large block of tufa (source: Thermenmuseum archives; original photo by GIA Groningen).

The most recent material from the baths site indicates that it was in use until the Roman period in Germania Inferior came to an end. We cannot however make a compelling case that the bathhouse was still fully operational as it had been in previous phases. We do however know that in the late fourth century a modification was made to *praefurnium* II, when tufa blocks were placed against the mouth of the furnace. The charcoal from a layer under this block dates this activity to after AD 390.⁴⁰³ Excavation photographs from 1940 show that several *spolia* lay around *praefurnium* II, several of which appear to be from grave monuments (Fig. 9.19). It is quite possible that during this

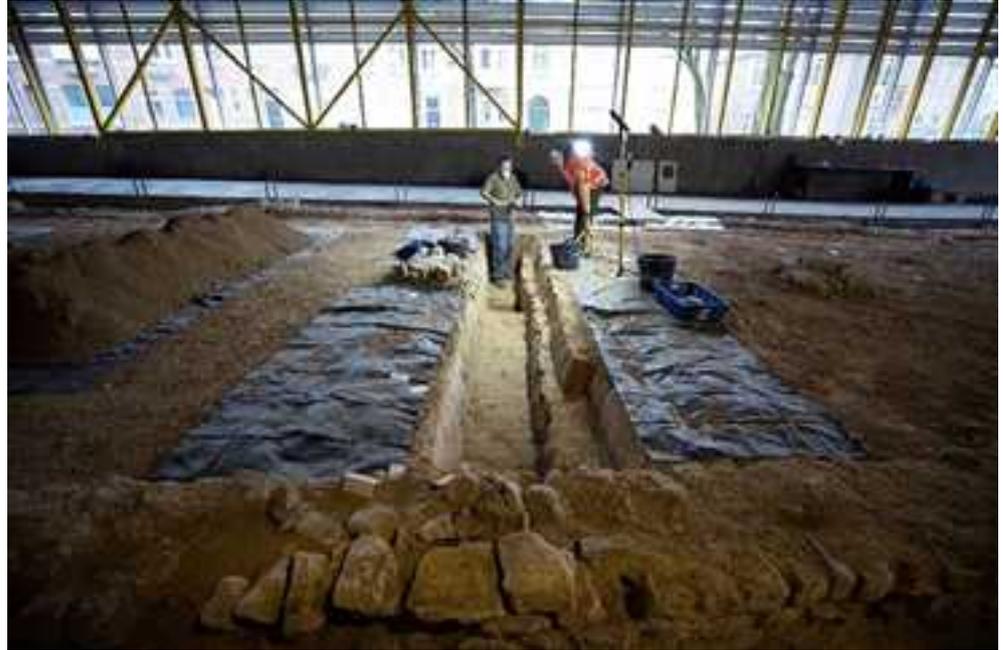
Figure 10.1 The trial trench survey, January 2019, trench 1 (source: Thermenmuseum archives).

The trial trench survey was another invaluable element of the project (Fig. 10.1). The decision to conduct such a survey was taken after it was found that some research questions could not be answered by analysis of the cleaned remains of the building or of material finds alone. New excavations on site would be needed to address some pressing questions. Since the complex is a listed monument, this trial trench survey, conducted with a particular focus on certain questions, was only limited in size. The excavation work, performed by the RAAP archaeological consultancy, produced a large amount of information that was essential for our understanding of the chronology of the complex, for example.

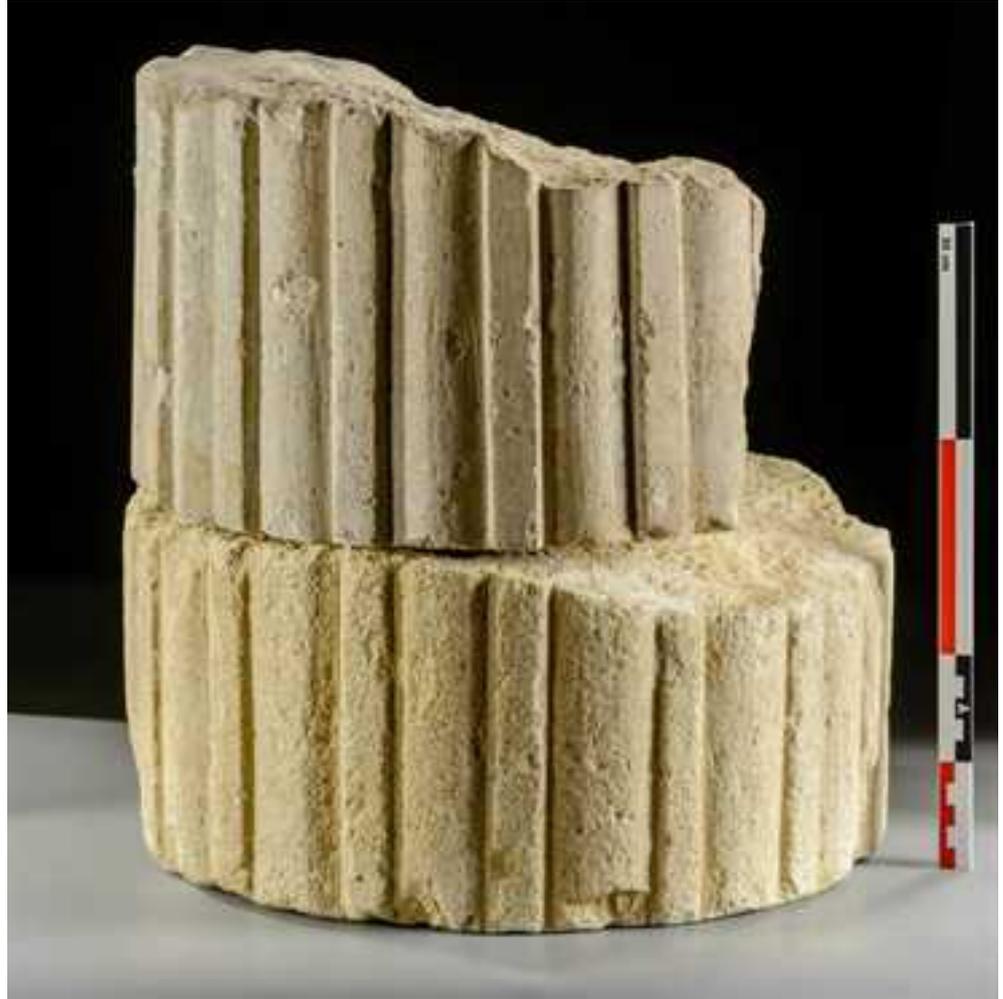
Figure 10.2 Two pillar fragments of Norroy limestone; above, the fragment found during the 1940 excavation; below, the one found in an excavation on Tempsplein in 2016 (source: Thermenmuseum, Ph. Debeerst).

a portico with *exedra*. The study also found, however, that this was not the only grand building in Coriovallum. In this respect, the fragment of a Norroy limestone pillar with alternating round and rectangular cannelures is interesting. It was the first 'find' ploughed up in June 1930 and since then it has always appeared in photographs on top of one of the Norroy limestone foundations on the front of the bathhouse. We have now discovered, however, that this pillar was never part of the bathhouse. The architectural study notes that this type of pillar is in fact too elegant for a functional building like a bathhouse, and would be more appropriate for a building of a religious nature. While the research on the bathhouse was in full swing, an archaeological watching brief connected with a project to

replace sewage pipes found an identical pillar fragment on Tempsplein (Fig. 10.2). The stone specialist working at the museum at that moment compared the recently uncovered fragment with the 'old' fragment from 1940, and it became clear that both were part of the same building. The fragment found at the baths site was probably brought there as a *spolium*. In this context, it is significant that the pillar was discovered during ploughing in 1940, indicating it must have been quite close to the ground surface. On the basis of our current knowledge, we cannot say which building the pillar fragments belonged to, but it is clear that meticulous analysis of the old investigation at Tempsplein is now required. There is now no doubt that the bathhouse was not the only large, impressive building in Coriovallum.
